# Pre-purchase Inspection Report

Prepared within the limitations and conditions specified in  
Australian Standard AS 4349.1 - 2007 Pre-purchase Inspections - Residential buildings

Property address	193 Tyler Street PRESTON VIC 3072
Report prepared for	Kurt sample 2/8 Sample Street IVANHOE VIC 3079
Client's contact details	Mobile 0421 888 888 Sample@hotmail.com
Real estate agent's details	Name Andrew Luzza Company Hocking Stuart Mobile 0401 319 622
Type of inspection report	Standard Inspection, Defect Only
Persons present	Agent's Representative, Pre-purchase Building Inspector, Pre-purchase Pest Inspector
Weather conditions	Fine
Inspector	Joe Noto, Bachelor Applied Science (Construction Mgt) (Economics) Registered Building Practitioner - Domestic Builder - Unlimited DB-U 28857

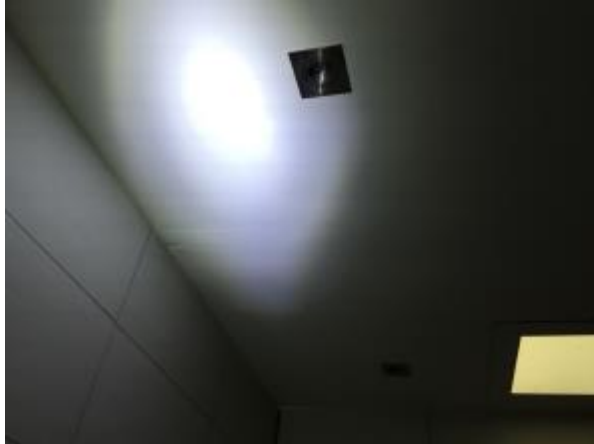
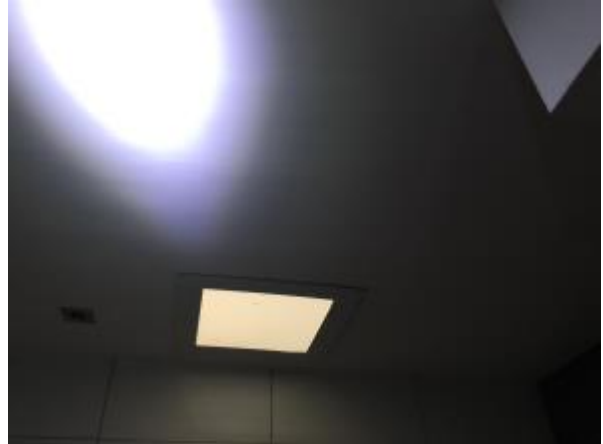
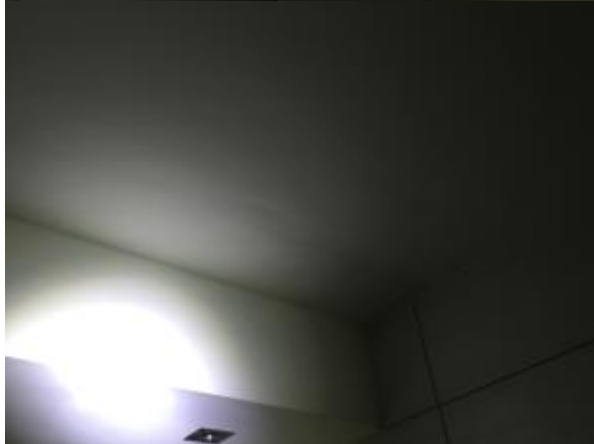
Leakage evidence

Minor Defect

Type: C

*Roof tiles are porous and have moved. Replacement roof tiles are highly recommended.*

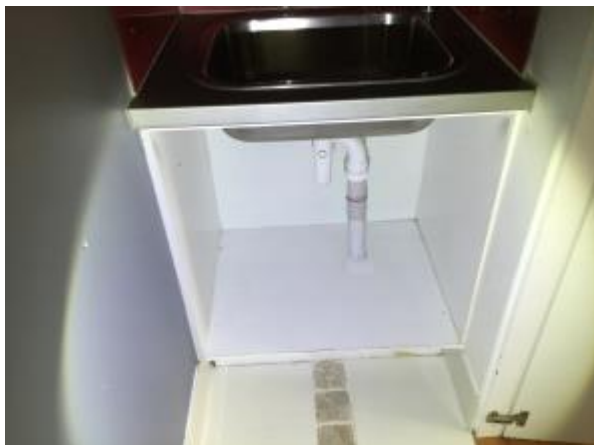
Trough cabinet/cupboard

Missing door

Minor Defect

Type: F

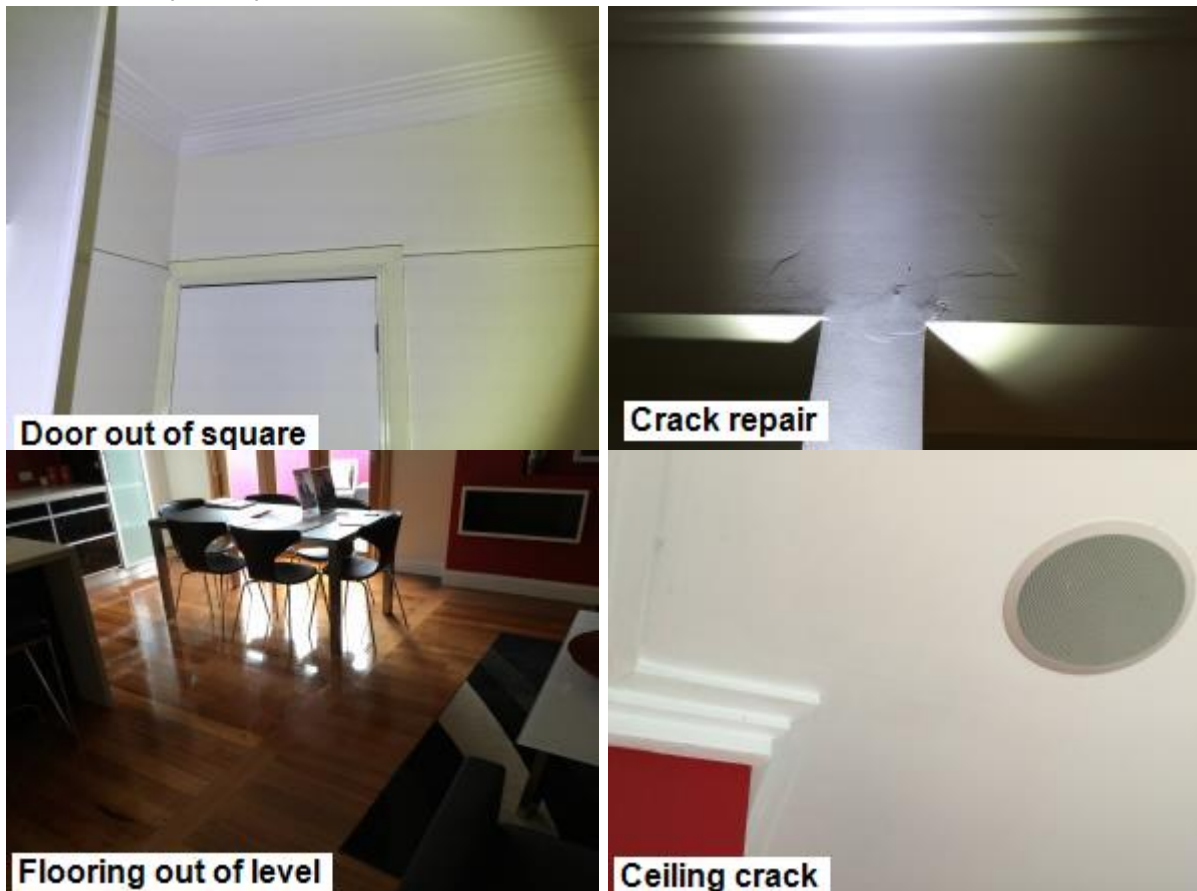
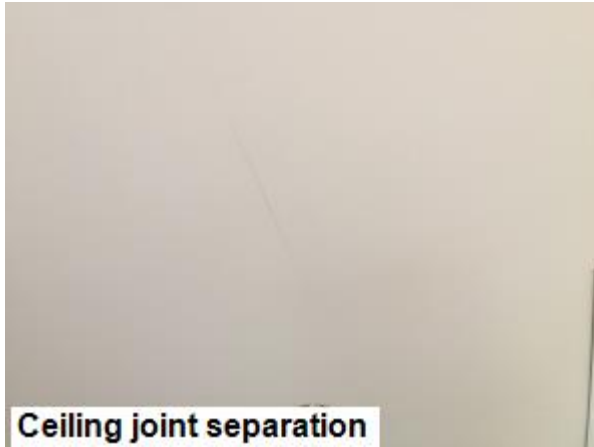
*Various movement defects including the following items have been recorded;*

*These defects have occurred as a result of movement through the foundations most likely as a result of natural movement over time and poor site drainage leading to residual defects such as decay & lateral movement/subsidence of stumps.*

- 1. Cracking to walls & ceilings - plasterer to patch cracks in a professional manner ready for paint.*
- 2. Movement of window & door opening's out of square - carpenter to square up timber frame.*
- 3. Movement of floors out of level - re-levelling of the sub-floor is not essential other to areas where re-tiling will be carried out.*
- 4. Ceilings out of level - no action required. Although re-levelling of ceiling joists can be carried out.*

*Rectification of the above mentioned items should only be carried out once site drainage issues have been rectified and re-stumping carried out.*

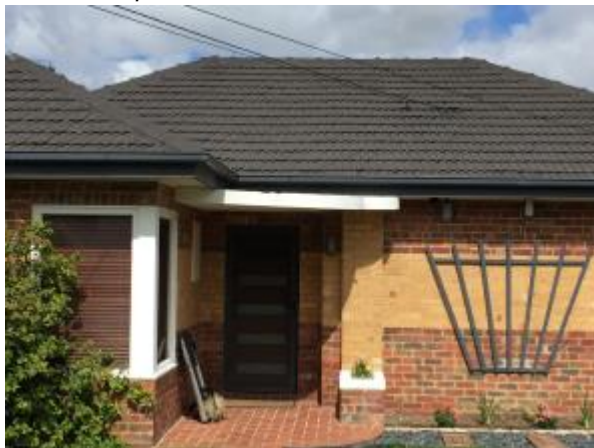
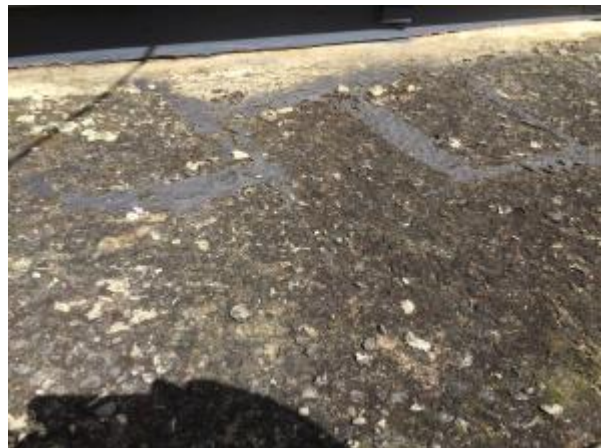
Suspended concrete roof out of level Safety Hazard and heavily decayed

Type: A, D, C

*Remove portico roof.*

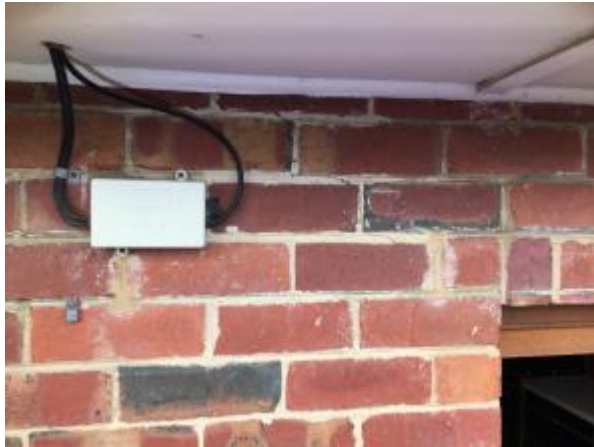
Walling

Cracking - category 1

Minor Defect

Type: A

*Has occurred as a result of subsidence of the clay foundations. Further movement may occur as moisture content in foundations changes through changing weather conditions. Regular monitoring is required over time and should further significant movement occur, additional inspection required.*

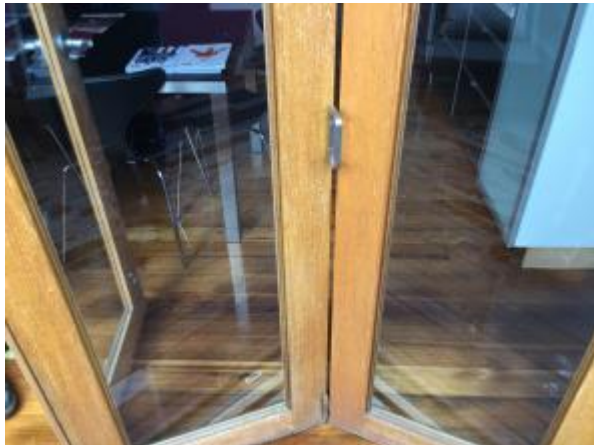
Doors

Doors installed back to front

*The door handle to the bi-fold door has been installed on the external face.*

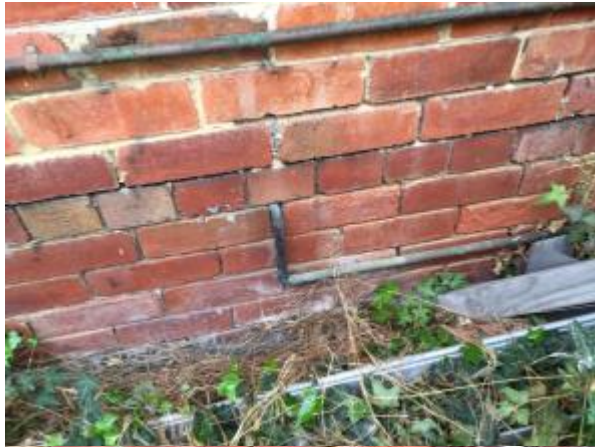
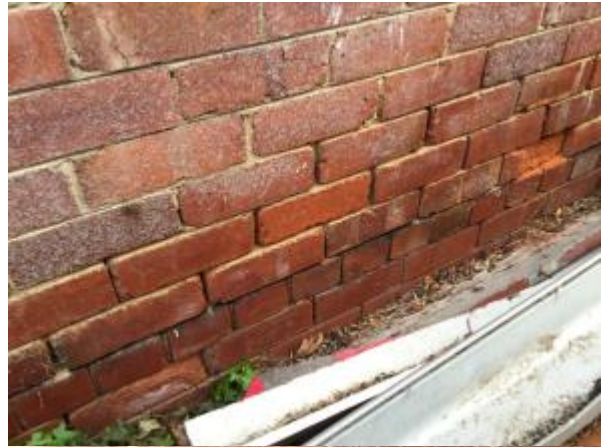
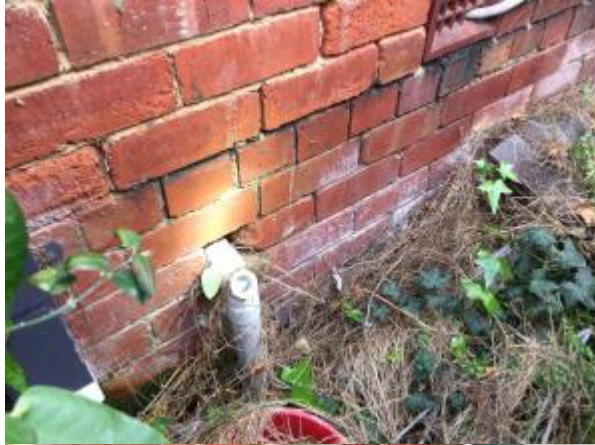
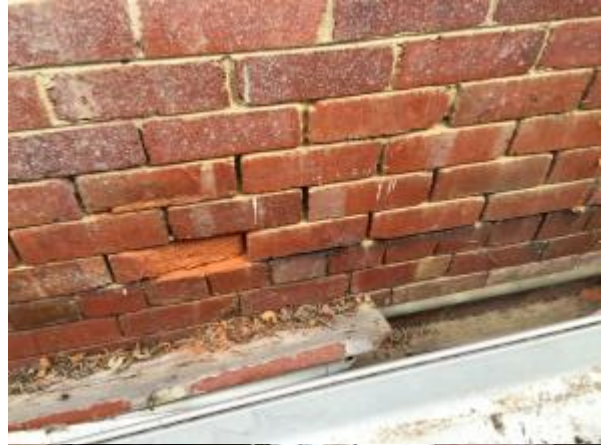
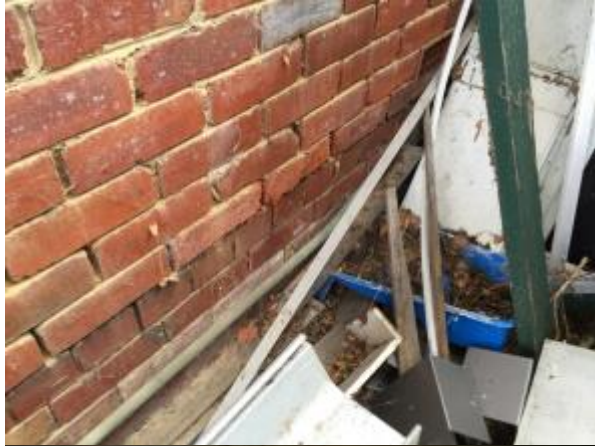
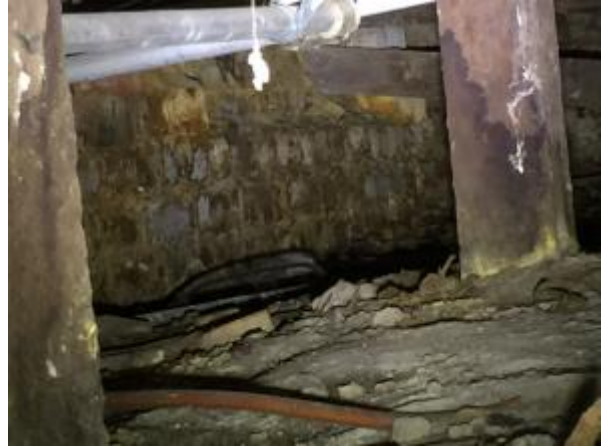
Minor Defect

*Ensure down-pipes are connected to storm water.*

*Replacement of the damp proof course is highly recommended.*

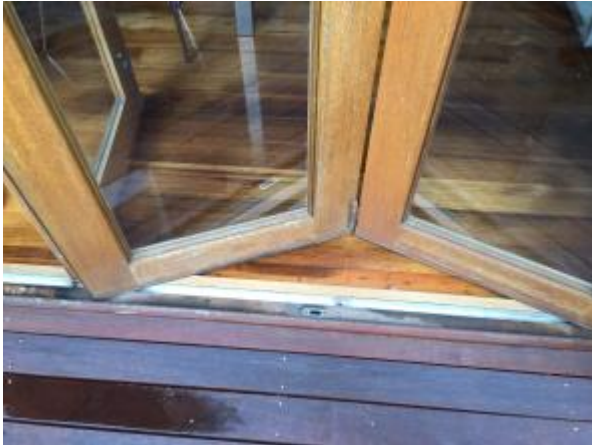
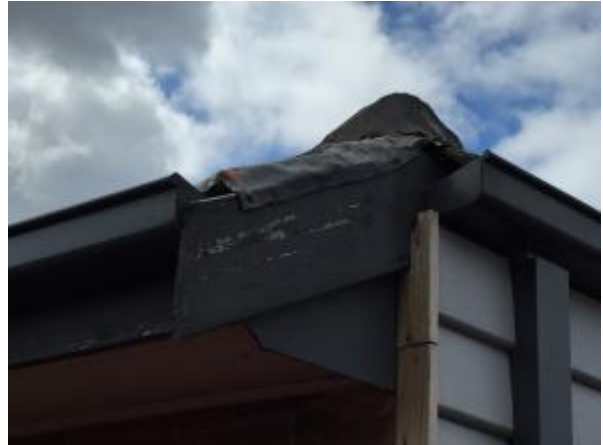
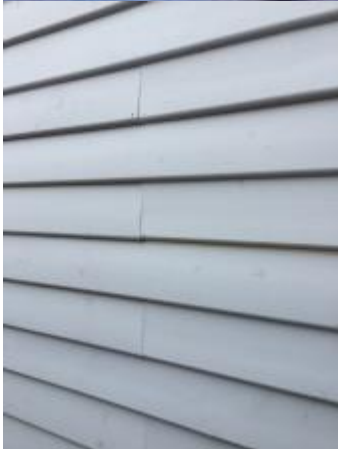
External timbers                      Timbers susceptible to rot                      Minor Defect                      Type: D, C

*Application of sealants, paints or flashings required to protect external timbers from moisture ingress to prevent further decay/rot to exposed timbers.*

*All timber glazing beads to external window faces require sealant to prevent further decay.*

*All non-treated timber in contact with the ground should be replaced with treated timber to prevent rot and damage.*

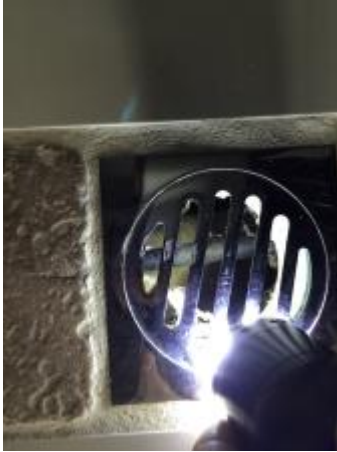
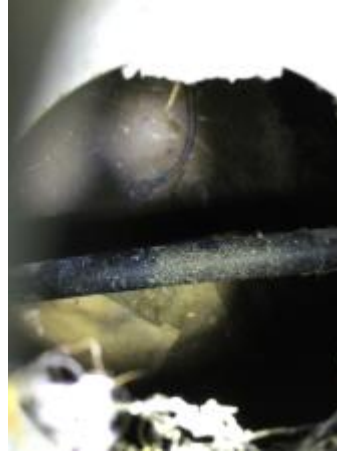
Plumbing                      Floor waste to laundry floor not connected                      Further Investigation Type: F

*It is highly recommended a licensed plumber carry out further investigation on the plumbing system. This type of defect is significant evidence of a substandard renovation.*

*The plumbing compliance certificate for new works should be sought although it is highly unlikely one exists.*

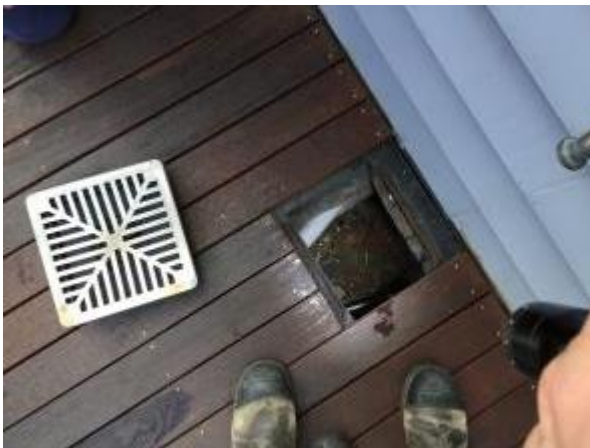
Plumbing                      Floor waste to rear deck picking up garden tap not connected                      Further Investigation Type: F

*It is highly recommended a licensed plumber carry out further investigation on the plumbing system. This type of defect is significant evidence of a substandard renovation.*

*The plumbing compliance certificate for new works should be sought although it is highly unlikely one exists.*

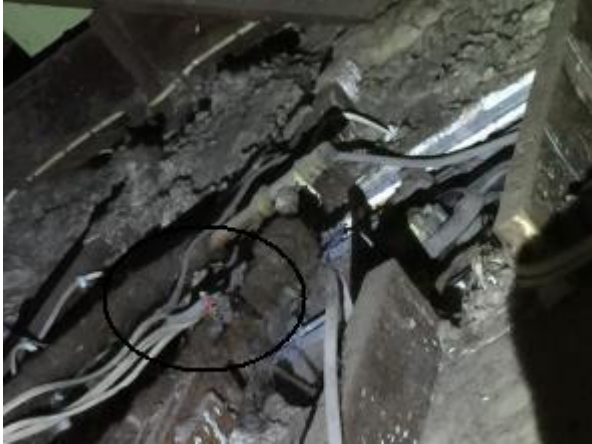
Electrical                      Exposed live parts in roof void                      Safety Hazard                      Type: F  
*Licensed electrician to undertake a safety inspection prior to making the purchasing decision.*

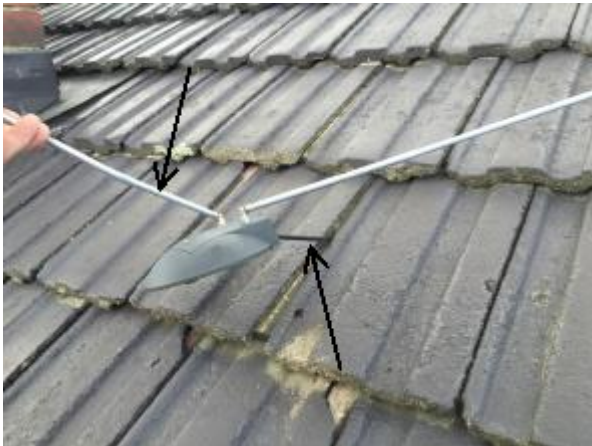
Electrical                      Replacement TV antenna required                      Minor Defect                      Type: F

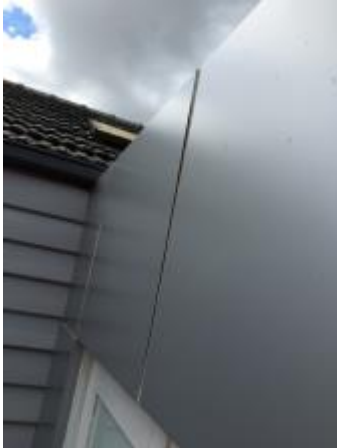
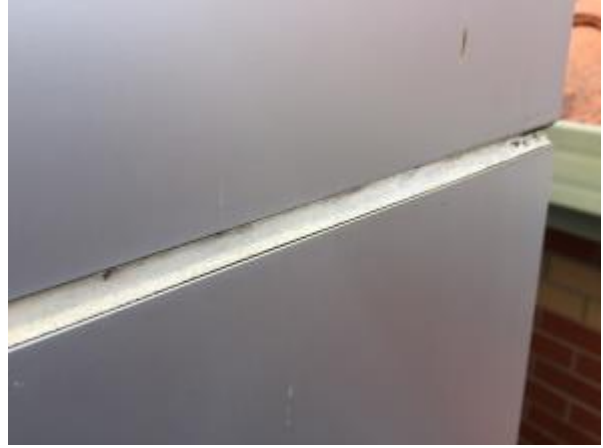
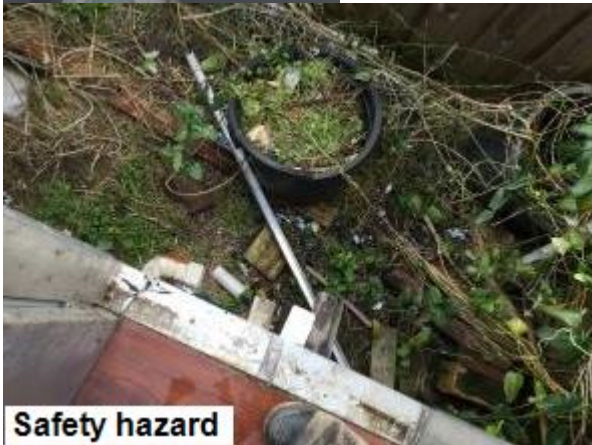
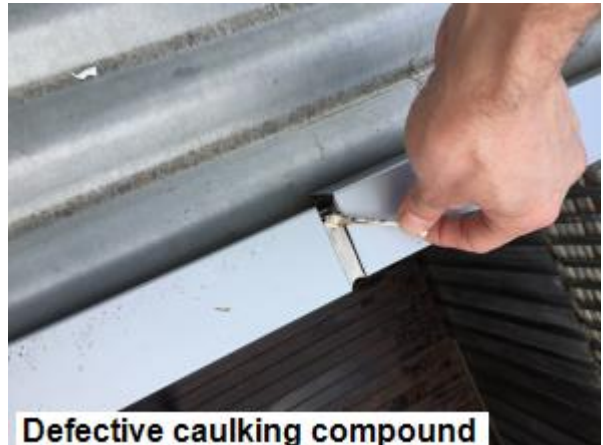
General condition      Various items      Further Investigation Type: A, F

*Installation of external cladding is very poor quality.*

*Electrical services need to be thoroughly inspected by a licensed electrician.*

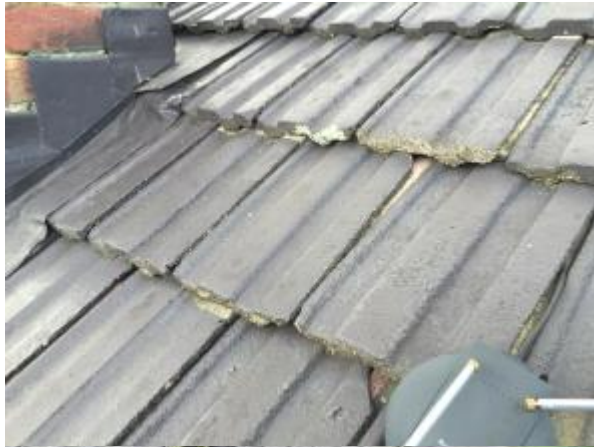
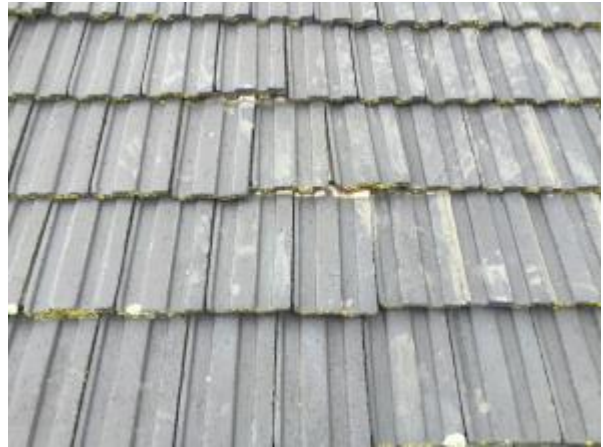
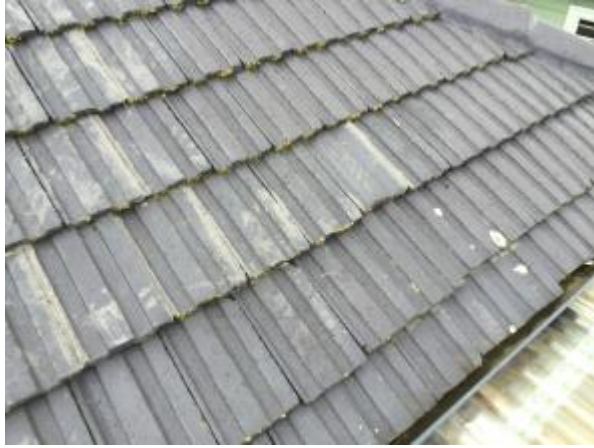
Roof tiles      Some roof tiles need re-seating      Minor Defect      Type: A

*Re-seating required to prevent further dilapidation and leakage.*

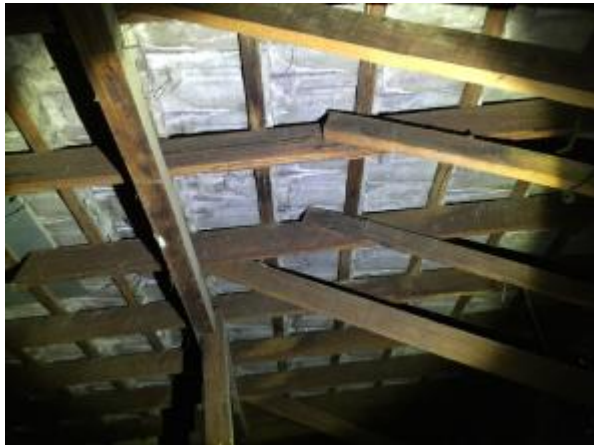
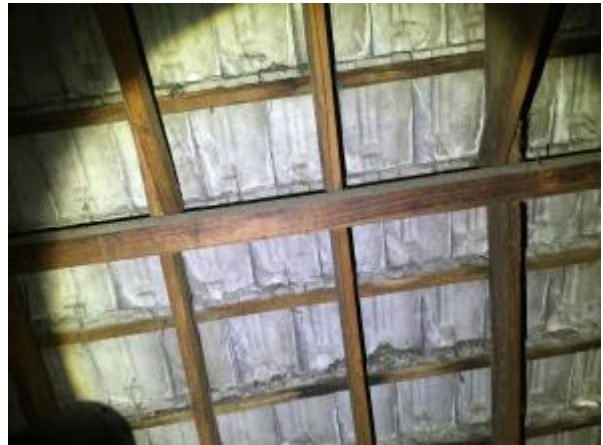
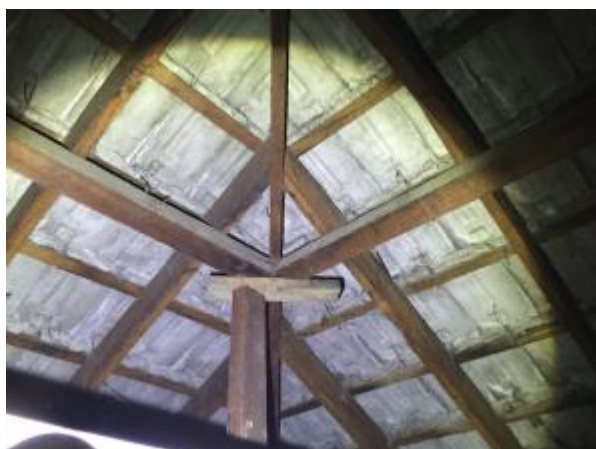
Roof tiles

Porous concrete roof tiles

Minor Defect

Type: D

*Life span of concrete tiles has expired. Replacement tiles highly recommended.*

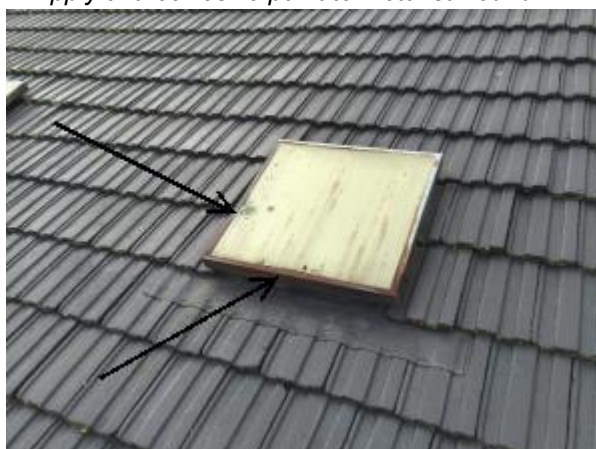
Skylights                      Surface corrosion to metal surround    Minor Defect                      Type: D  
*Apply anti-corrosive paint to metal surround.*

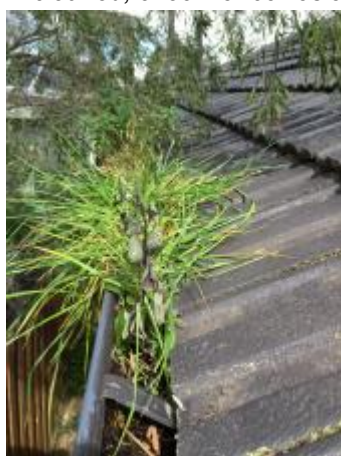
Guttering                      Gutters blocked with leaves, silt, moss etc                      Minor Defect                      Type: E  
*Clean out gutters to prevent blockage, potential for over-flow into eaves voids and corrosion. Once cleaned, check for corrosion and replace as required.*

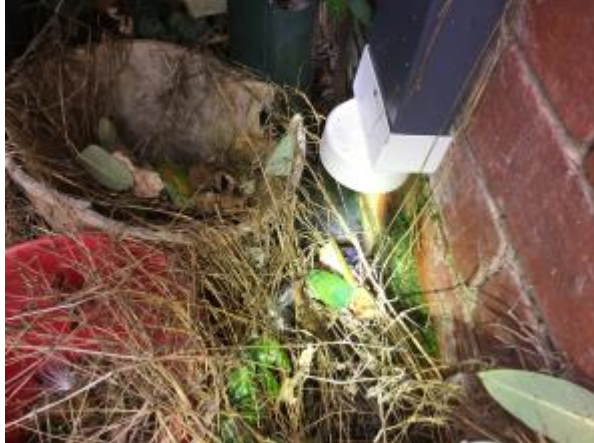
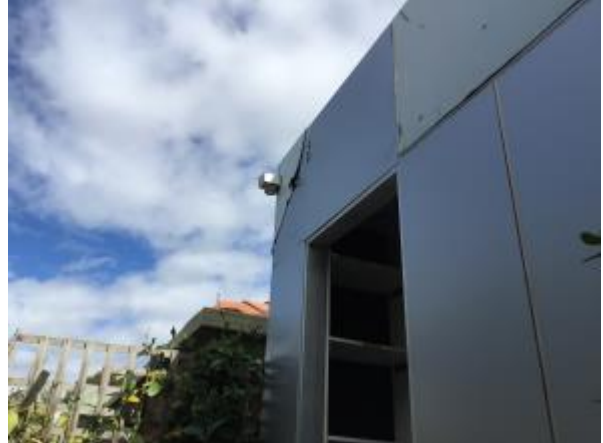
Down pipes                      Not connected to storm water system    Minor Defect                      Type: F

*Storm water points are required to be installed by a licensed plumber to pick up the down pipes to the East elevation. This will prevent water flow into the sub-floor and residual defects such as decay of stumps, rising damp and structural movement defects.*

*Ground levels relevant to the current storm water system are required to be taken by a licensed plumber prior to making the purchasing decision to ensure adequate gravity fed flow to the current storm water system can be made as new points will be required at the lowest level of the site. There may be a need for retention pit with a pit pump to push water flow up hill.*

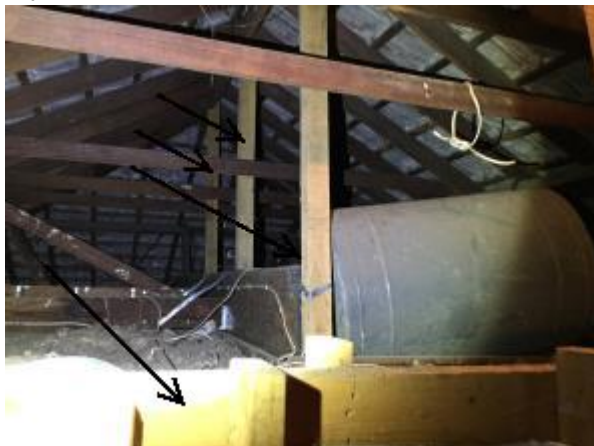
Roof framing                      New roof struts and hanging beams    Minor Defect                      Type: F

*Likely installed to straighten out the roof structure although timber pest such as borer may have been present.*

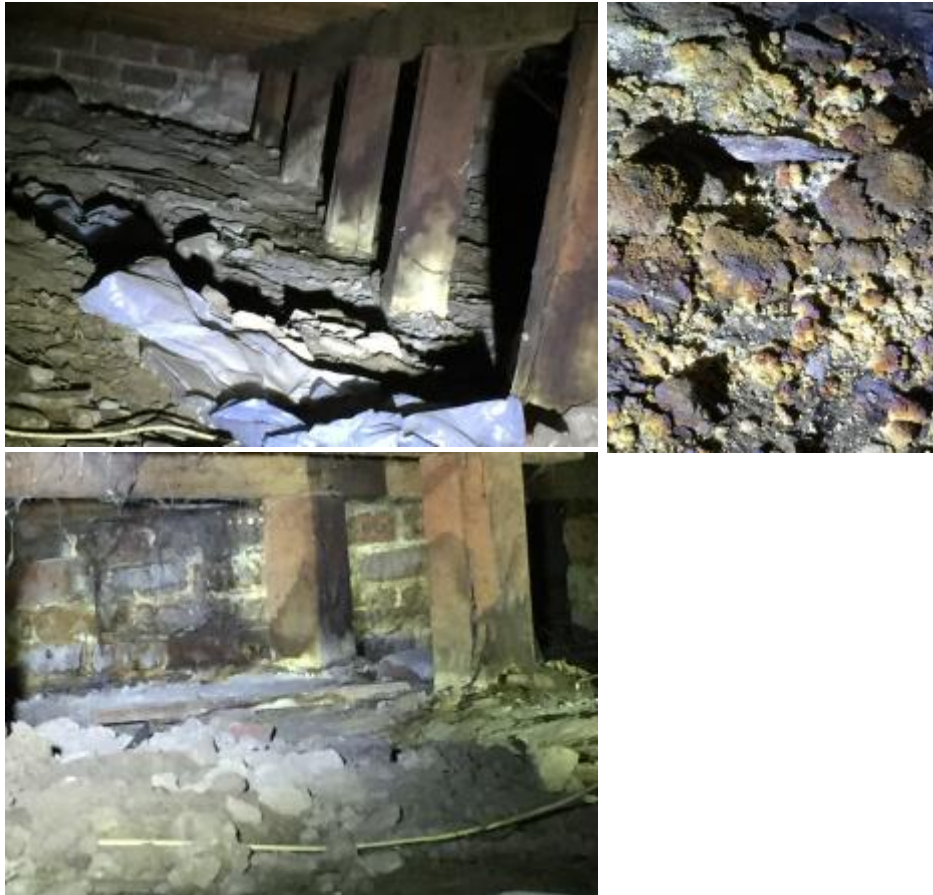
Moisture                      Moist ground under floor                      Major Defect                      Type: C

*Causing rot to timber stumps and rising damp. Rectification of poor site drainage is required.*

*Re-stumping is required.*

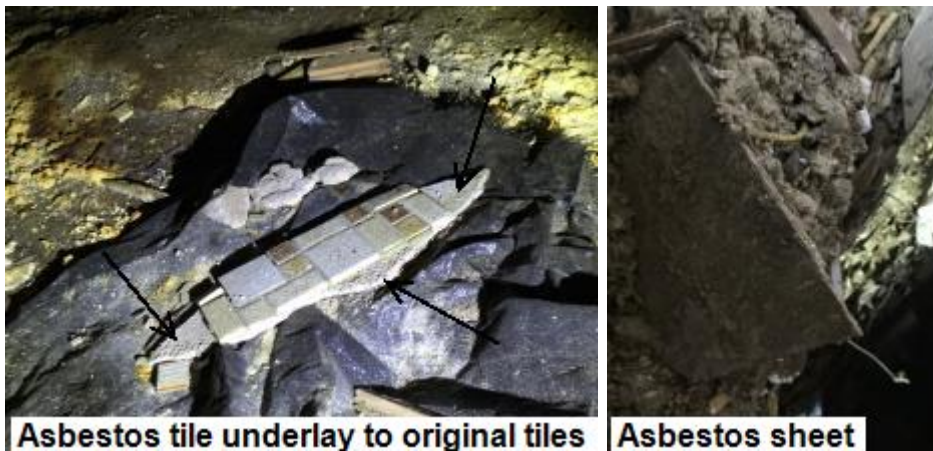
Under timber floor                      Loose / damaged asbestos sheet restricting access through the sub-floor                      Safety Hazard                      Type: F, A

**Asbestos tile underlay to original tiles**

**Asbestos sheet**

*An asbestos audit to the entire property is required to ensure all hazardous material has been removed prior to occupancy or renovation. Further inspection of the sub-floor will also be required once asbestos has been removed.*

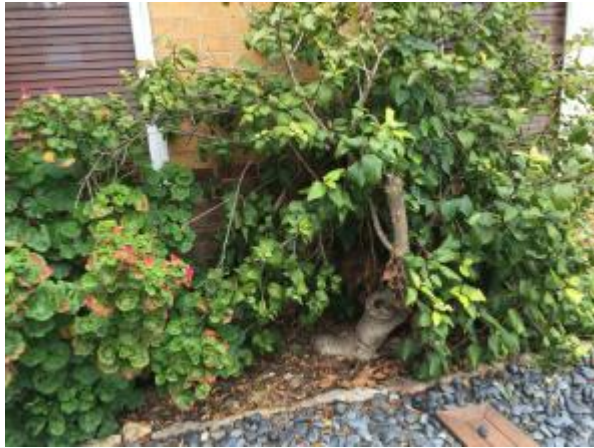
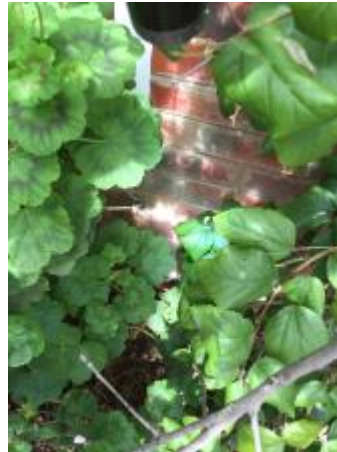
Trees                                      Close trees on reactive site may                      Minor Defect                      Type: F  
contribute to structural movement in  
the building

*New mortar joints to the front elevation perimeter wall have been recorded so it is likely some form of rectification as a result of movement has been carried out in the past. Remove tree and monitor over time.*

*It is recommended, tree's are removed as recommended by the CSIRO to prevent changing moisture content through the foundations and therefore structural movement defects over time.*

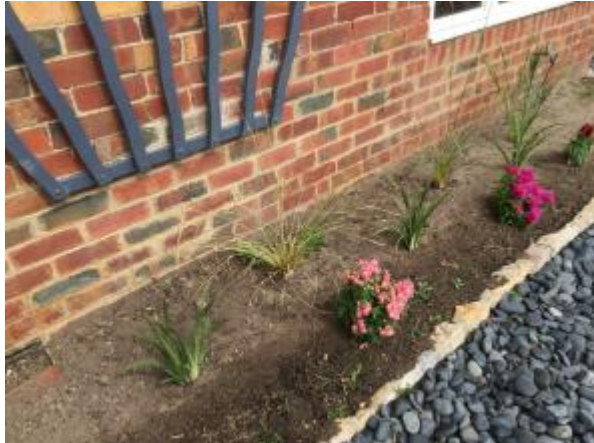
Gardens & grounds                      Gardens against house a dampness                      Minor Defect                      Type: F  
issue

*Gardens beds allow lateral moisture penetration through perimeter walls and eventually decay of these walls. Moist sub-floor soils may also occur as a result. It is recommended garden beds at the perimeter of the property are removed and replaced with a concrete hard stand area.*

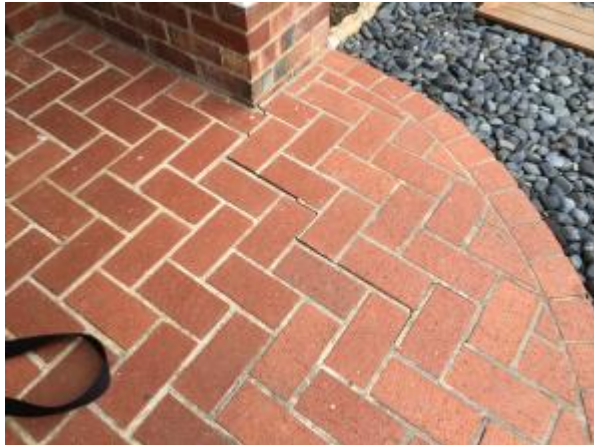
Pathways

Minor Defect

Type: A

*Re-install pavers on compacted ground.*

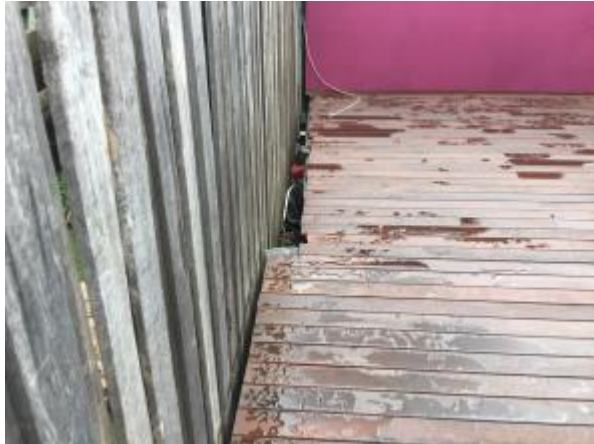
Damaged timber deck

Safety Hazard

Type: A

*Carpenter required to modify to prevent injury.*

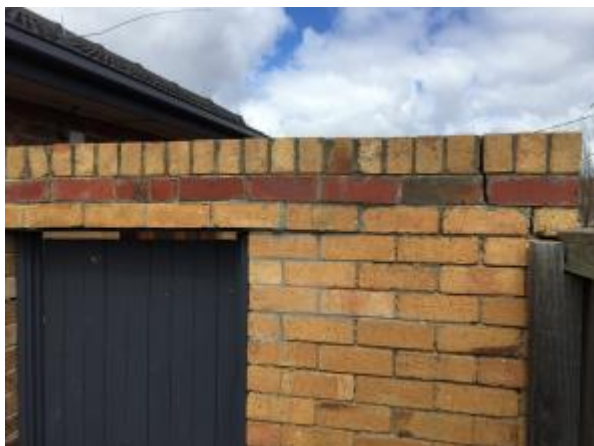
Damaged masonry fencing

Minor Defect

Type: A

*Re-brick damaged section asap. The top corner is loose and can fall on to the foot path at the West elevation.*
