Melbourne
PROPERTY INSPECTIONS

Date of inspection: Thursday, 07 April 2016 02:00 PM

Lock-up & Fix Inspection Report

| Property address | Lot 411 Frontier Avenue GREENVALE VIC 3059 | |

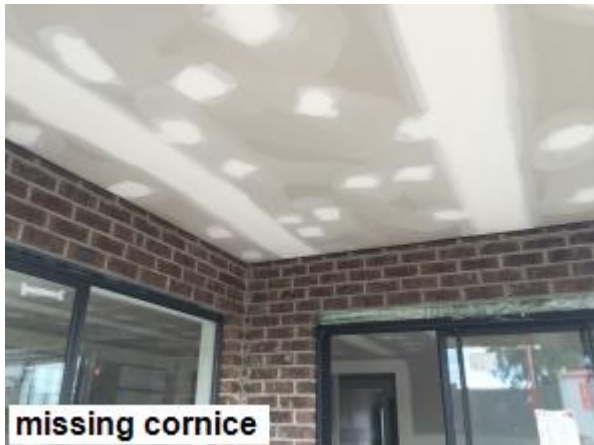
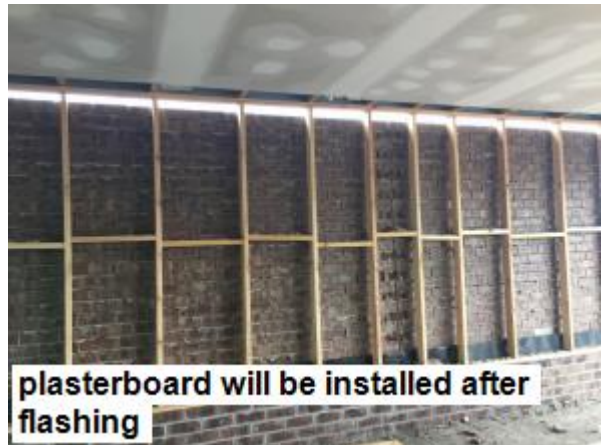
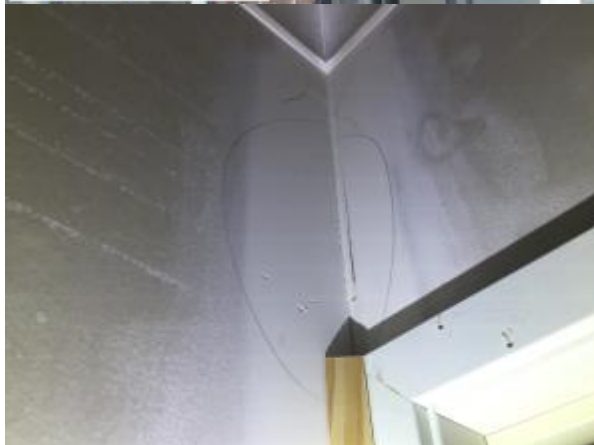
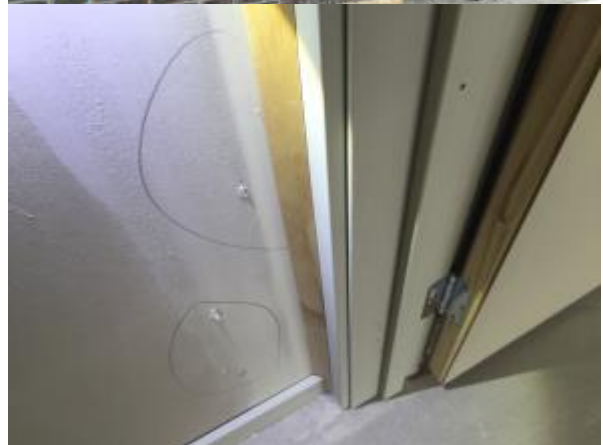
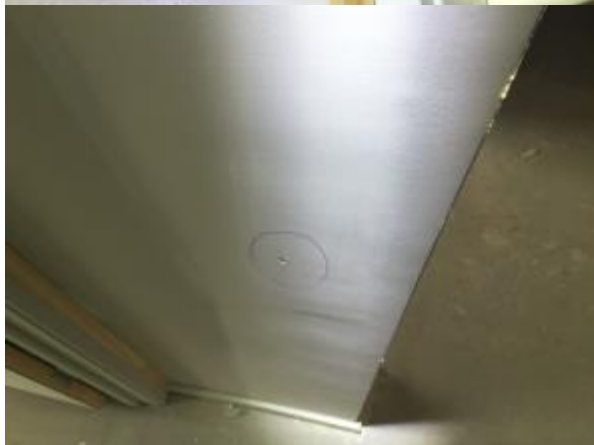
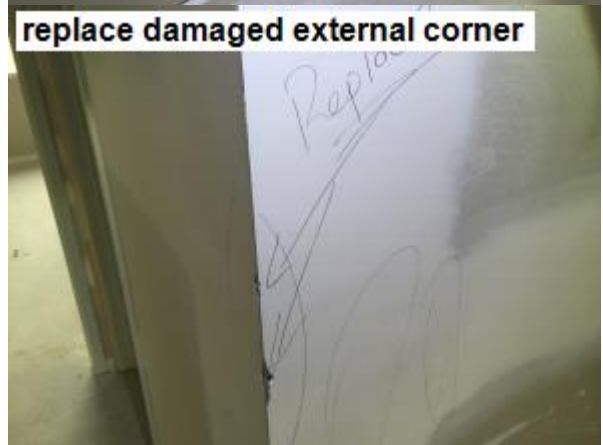
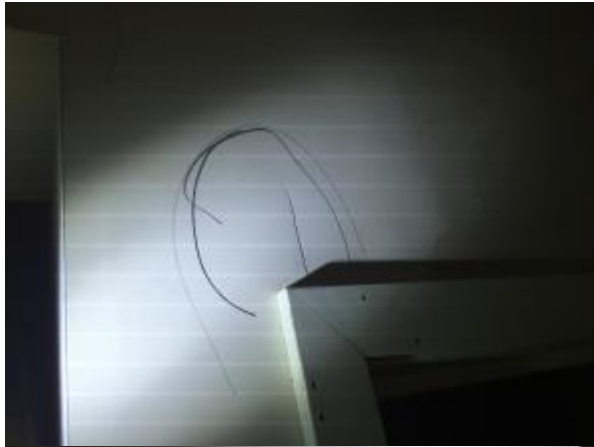
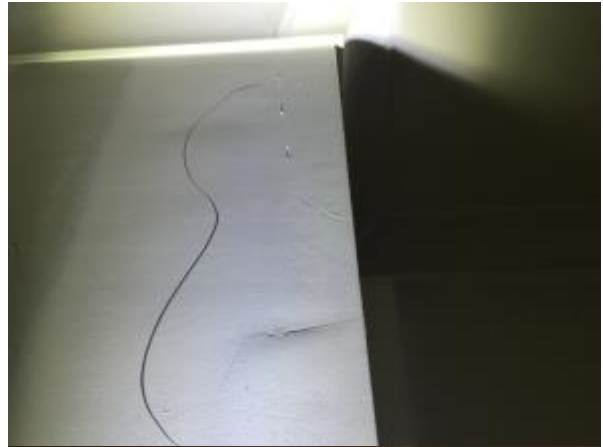
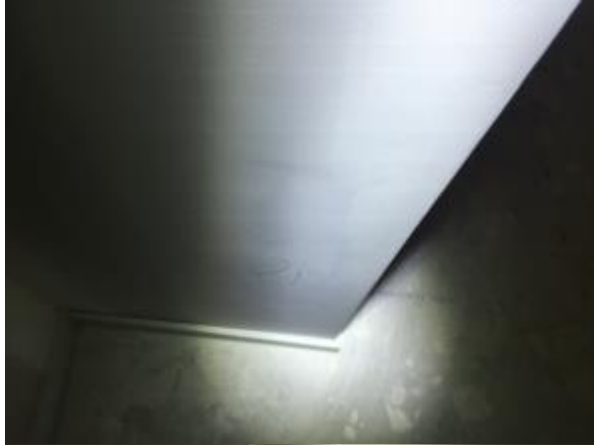
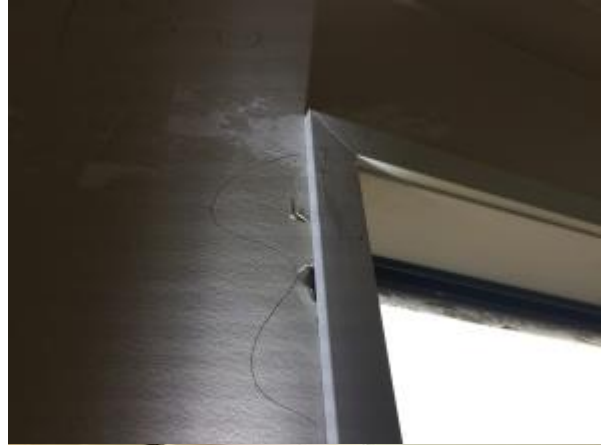
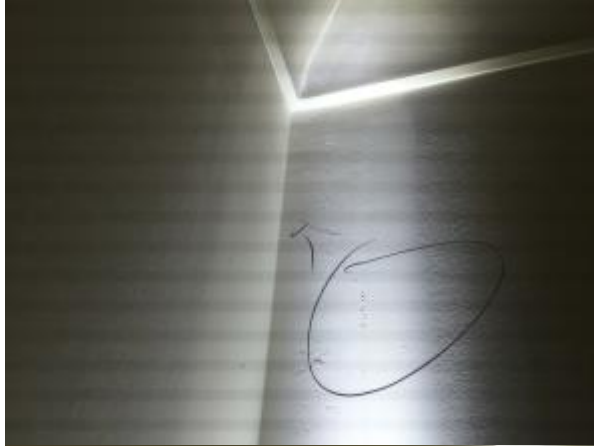
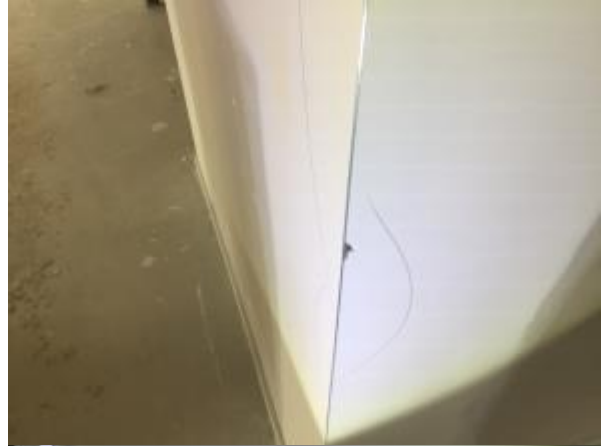
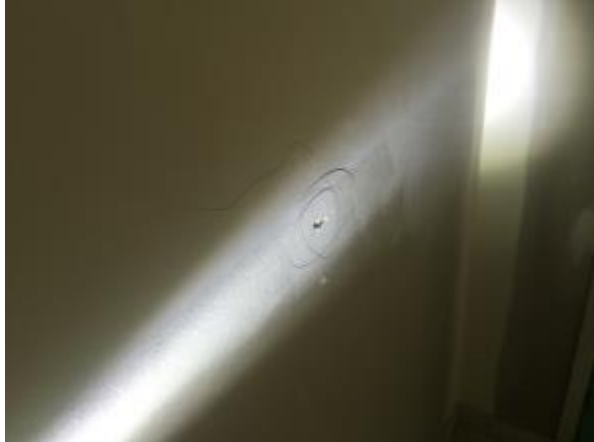
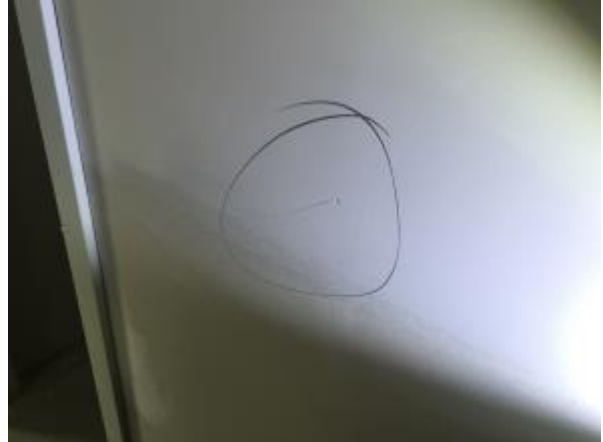
Walls and ceilings Various plaster defects Minor Defect Type: A, F

Additional plaster defects have been recorded on site. Rectification is required prior to painting. It is highly recommended an additional inspection is carried out once plaster defects have been rectified as a result of poor quality of work carried out to date.

Damaged external corners to the corridor require complete replacement - refer to photo below.

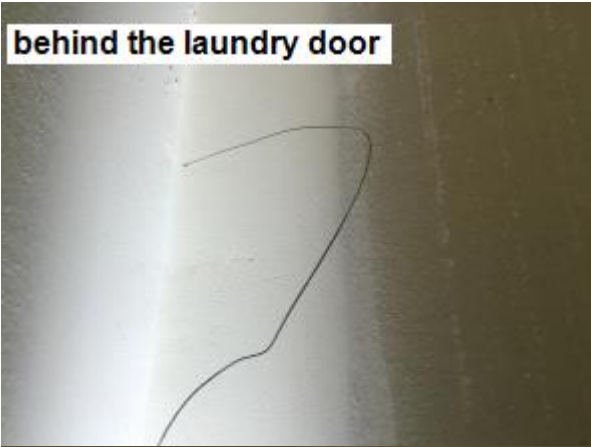
behind the laundry door

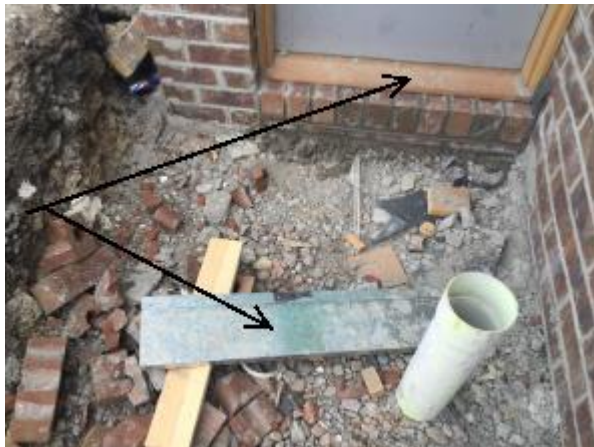
Sills

Timbers sill protection to be
reinstalled

Minor Defect

Type: F

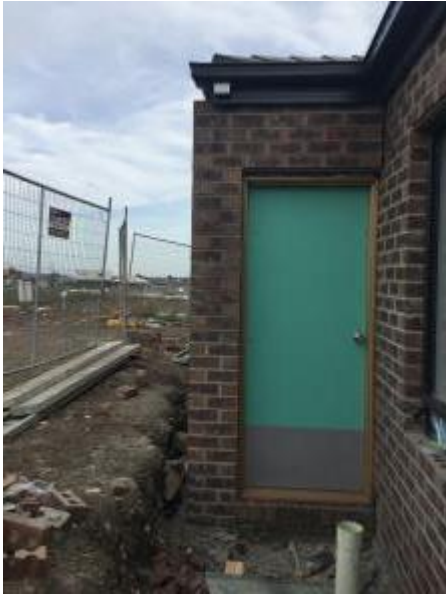
Doors

Timber door frame installed out of square

Minor Defect

Type: F

Timber framed to be squared up.

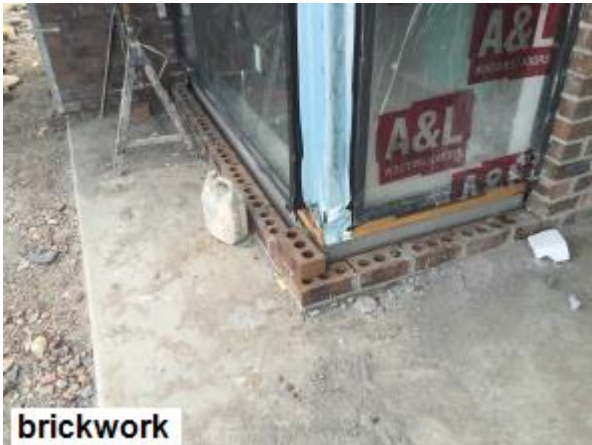
As of the inspection date the builder was yet to complete various lock-up stage items as recorded in the photos below.

brickwork

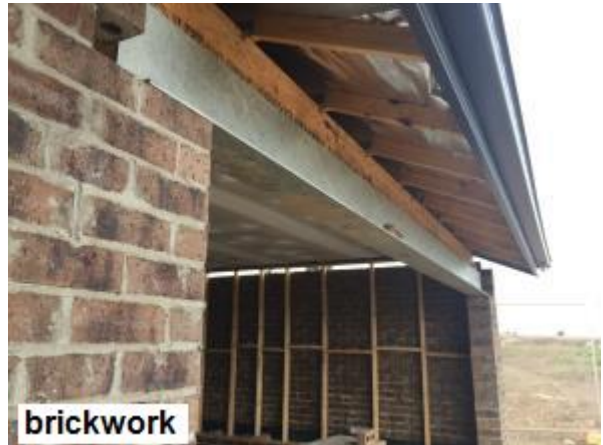
brickwork

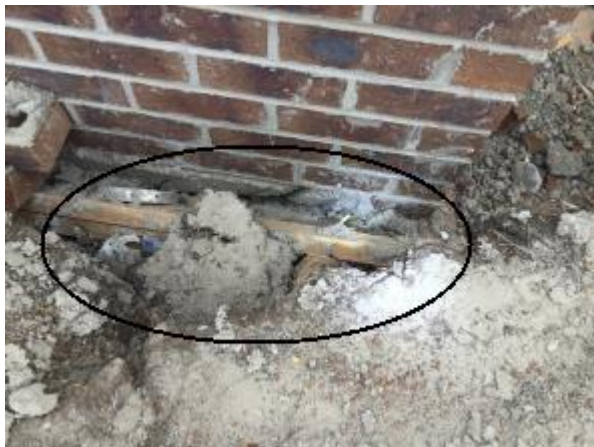
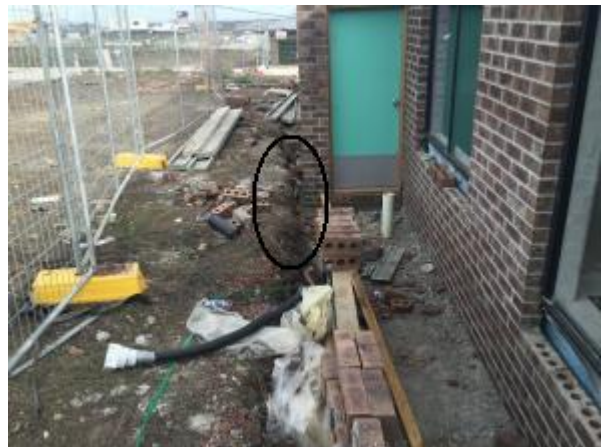
Slab edge Inadequate construction method Further Investigation Type: F

Visual access cannot be made unless excavation of the ground adjacent the slab edge is carried out. It is essential this investigation is carried out to determine adequacy of footing installation supporting the east elevation brick wall.

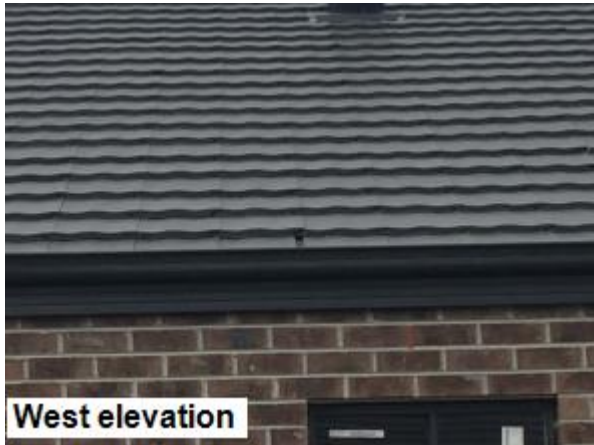
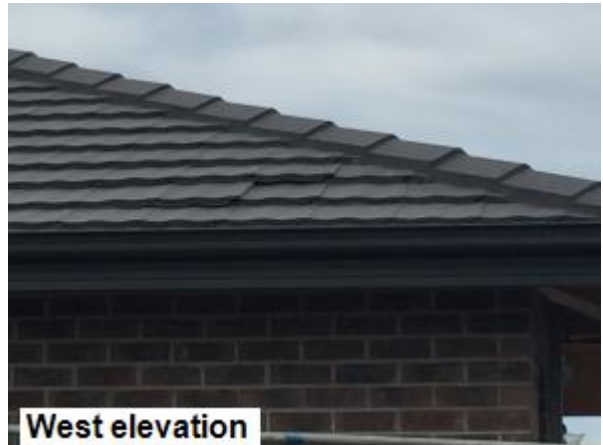
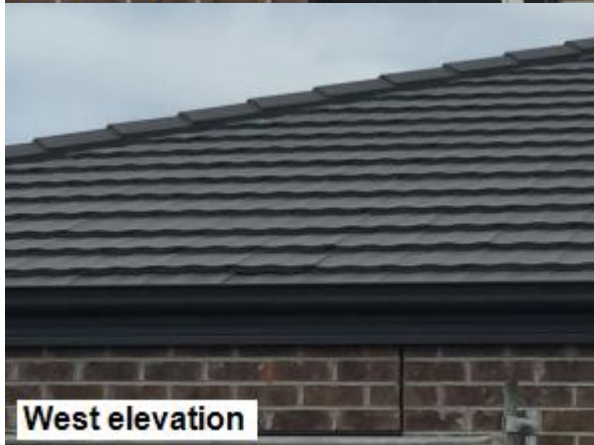
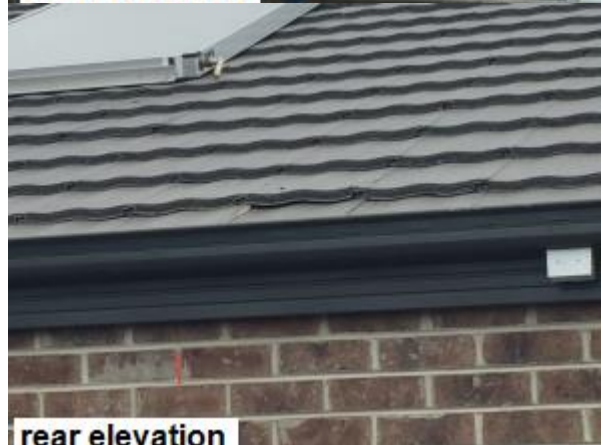
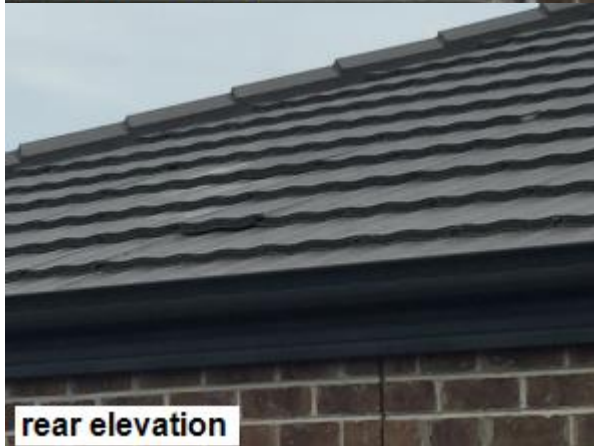
Roof tiles Some roof tiles need re-seating Minor Defect Type: F

A roof serviced by the roof tile installer is required.

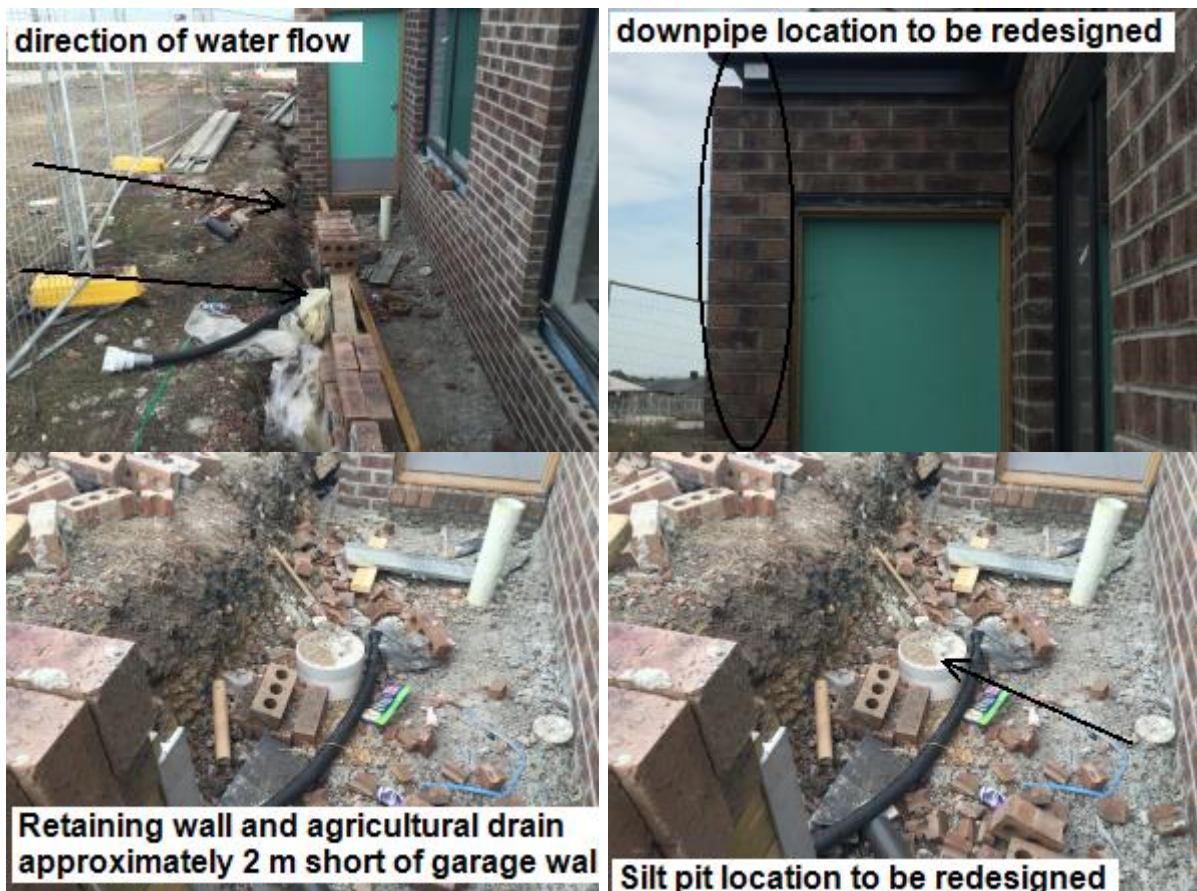
Surface water Ground slopes towards building & no provision for drainage Major Defect Type: F

It is the builder's responsibility to ensure good site drainage throughout the course of construction. In this case, water flows towards the perimeter of the waffle slab to the east elevation and the rear elevation.

A major defect has been recorded as major structural movement may occur should this defect be left unattended.

It is evident from the site plan the retaining wall, agricultural drain and silt pit has not been designed for to the rear elevation. It is highly recommended this is installed now with the clients design requirements in mind for their backyard in order to prevent possible movement defects after handover.

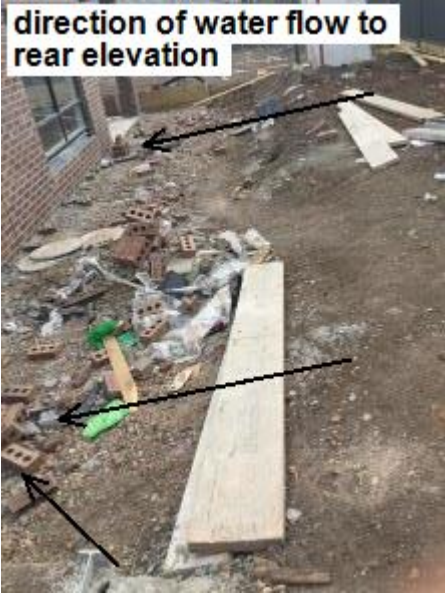
direction of water flow to rear elevation
