**STANDARD VISUAL ONLY TIMBER PEST INSPECTION REPORT PERFORMED IN ACCORDANCE WITH
AUSTRALIAN STANDARD 4349. 3. 2010**

Property Address

7 Carnarvon Street, Caulfield North

Report/Agreement #	181115023860
Inspection Date:	18 Nov 2015
Inspection Time:	01:00 PM

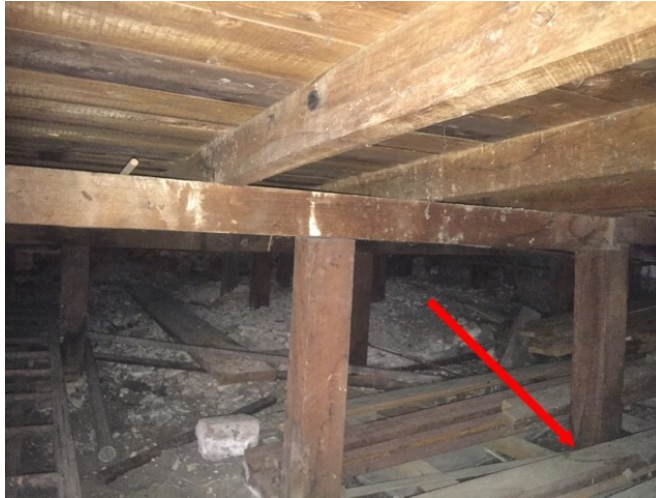
NOT INSPECTED

No inspection was carried out to any timber stumps below the surface of the ground. It is important that the client understands that timber pest activity and or damage may be evident to these concealed areas. The removal of soil from around timber stumps is not within the scope of the inspection. Termites can, if termites shields are not installed enter the property via the centres of the stumps and are sometimes undetectable to the inspector.

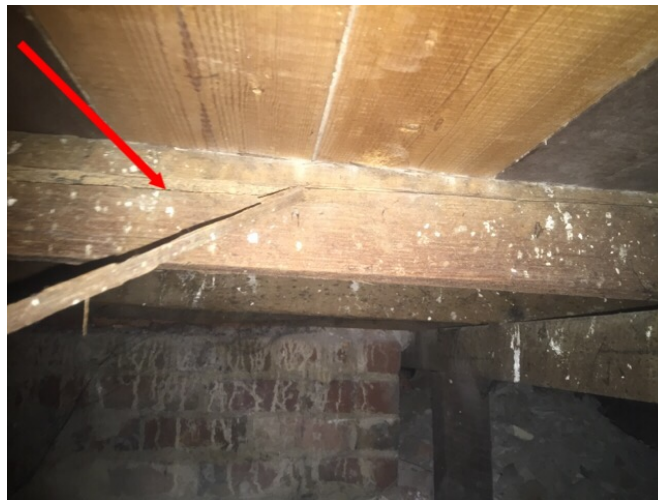
TERMITE DAMAGE AND/OR WORKINGS WAS FOUND

Evidence of termite workings and damage was found but not limited to the following areas.

Damage to a joist under the lounge room

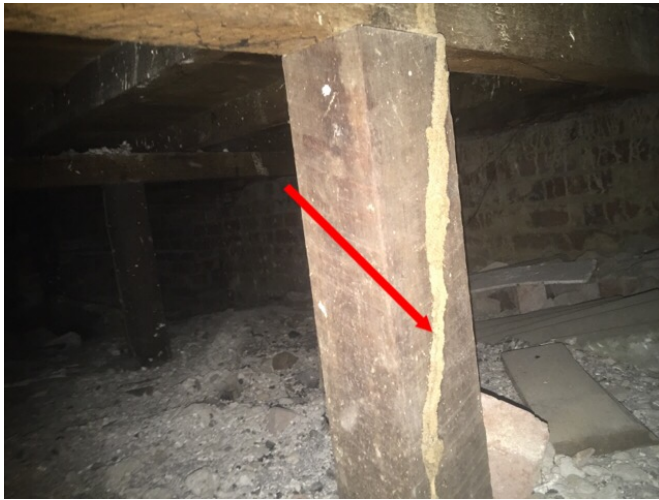
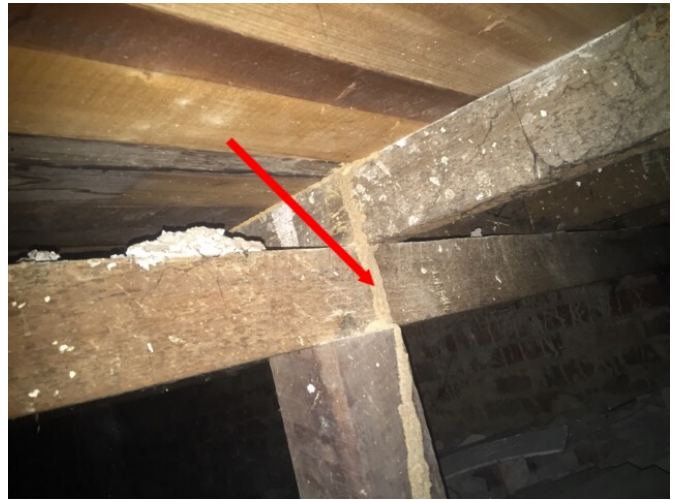
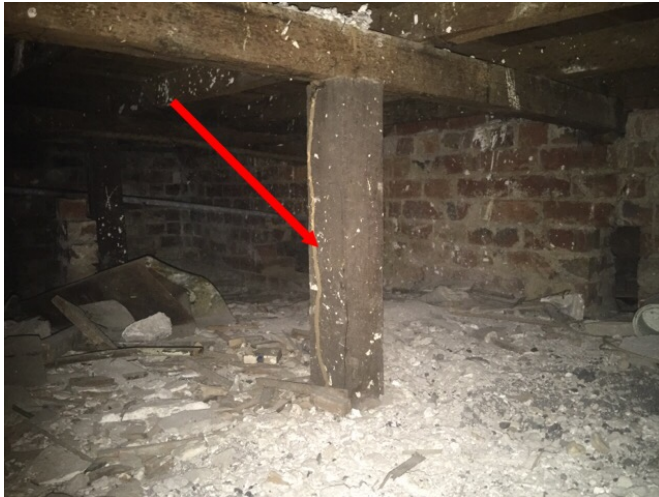
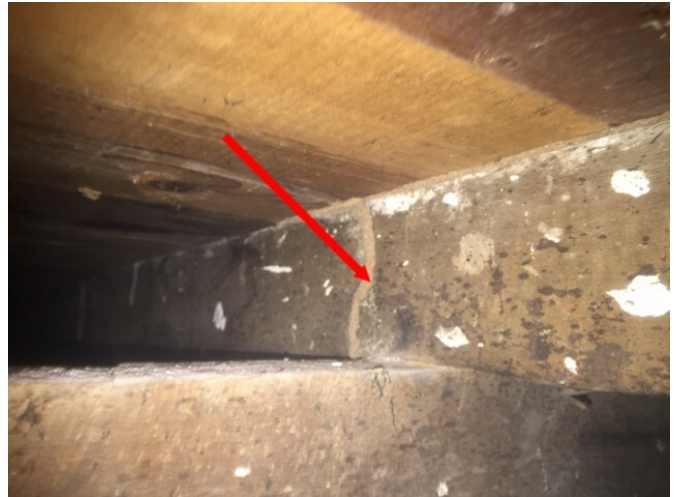
TERMITE MUD LEADS WERE OBSERVED TO THE SUBFLOOR AREA

Evidence of termite mud leads were observed in the subfloor area. Mud leads are constructed by subterranean termites these allow them to travel over obstacles and surfaces while remaining protected from the outside environment. These are typically constructed from "mud like" material of soil, faeces and re-worked building materials. Recommendations if there is no evidence of termite management program being carried out then I highly recommend that a treatment in accordance with AS 3660 is carried out. The client also needs to be aware that concealed termite damage may be evidence

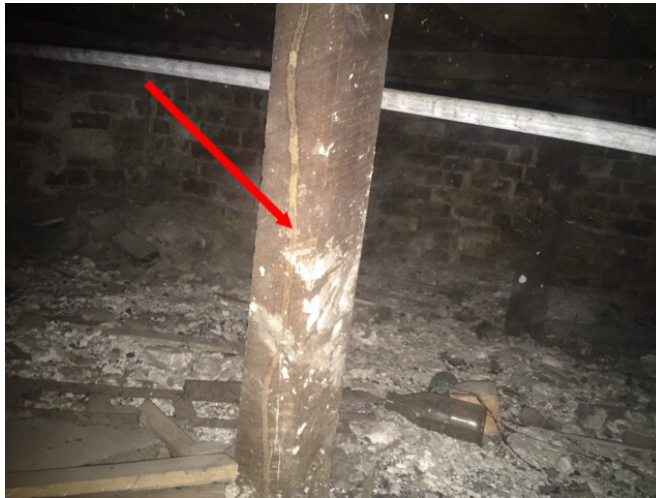
HISTORIC MUD LEADS WERE OBSERVED TO THE SUBFLOOR AREA

There is evidence of historic termite mud leads in the subfloor area. Mud leads are constructed by subterranean termites these allow them to travel over obstacles and surfaces while remaining protected from the outside environment. These are typically constructed from "mud like" material of soil, faeces and re-worked building materials. Sometimes these leads are removed for some reason it maybe that the leads have dried out and fallen off the stumps and or foundation walls or they may have been removed so that detecting evidence of termite is made harder for the inspector. Recommendations if there is no evidence of termite management program being carried out then I highly recommend that a treatment in accordance with AS 3660 is carried out. The client also needs to be aware that concealed termite damage may be evidence

We highly Recommend a treatment in accordance with Australian Stanard 3660 is carried out to help protect the property from any possible future termite attack. Please speak to the inspector that carried out this inspection

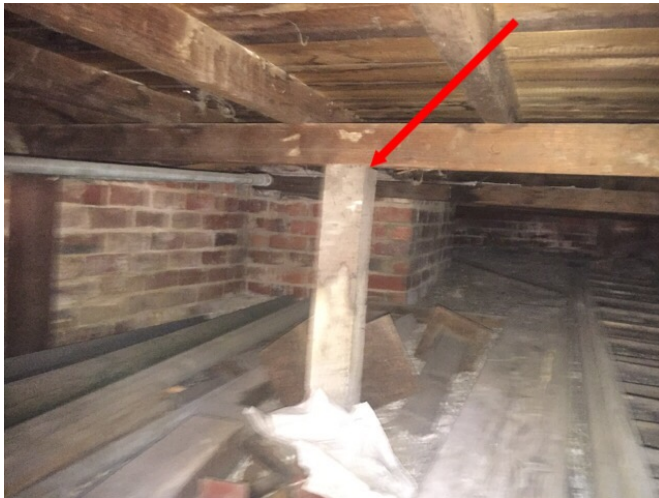
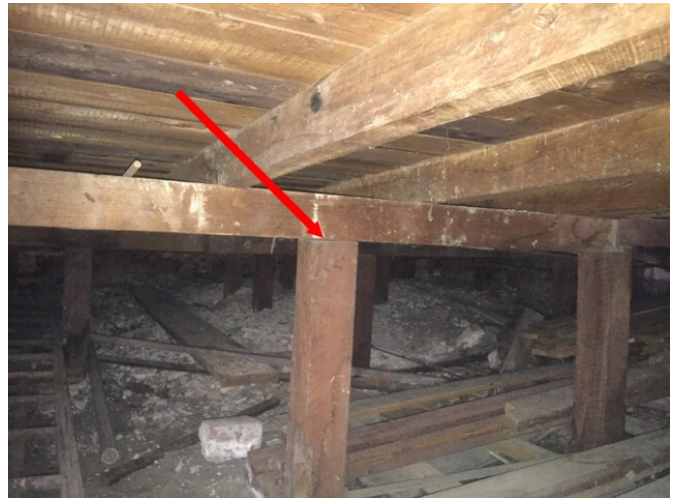
NOTE

There are no termites shields installed. Please Note although they do not prevent termite attack they do aid in their detection. If the property has timber stumps termites can gain entry into the property via the centres of these stumps undetected. Recommend that the client Either carries out a termite management program as per AS 3660 or have annual termite inspections carried at intervals not exceeding 12 months.

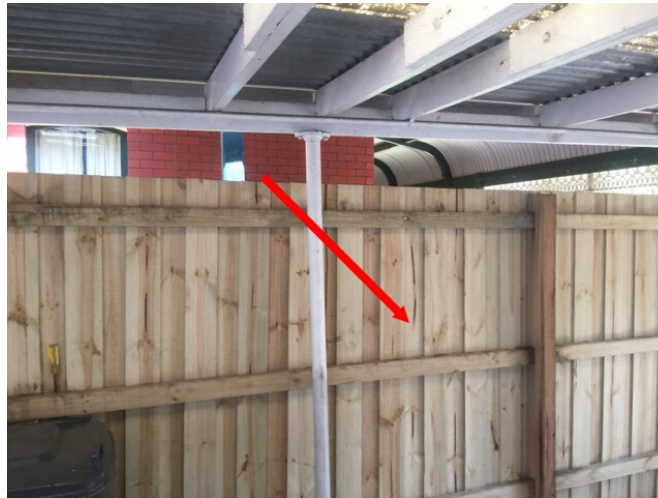
Evidence of new fencing timbers was observed

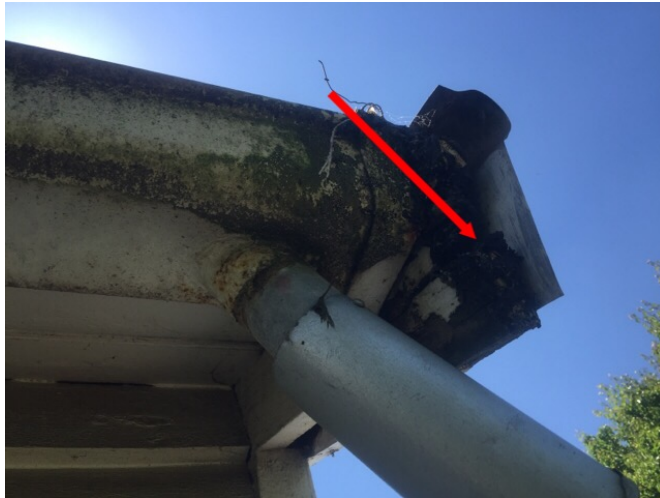
FASCIA BOARD(S)

Heavy fungal Decay Was Observed

Where evidence of fungal decay damage is reported it is recommended that any timbers affected by fungal decay are either repaired or replaced and the moisture issues causing the problem to be rectified. Please note most of the time fungal decay is caused through lack of general maintenance or using timbers not suitable for use in an outdoor environment. The client should seek advice either a licensed builder or qualified carpenter to have the affected timbers repaired or replaced the client may also have to engage a licensed plumber to rectify any moisture issues.

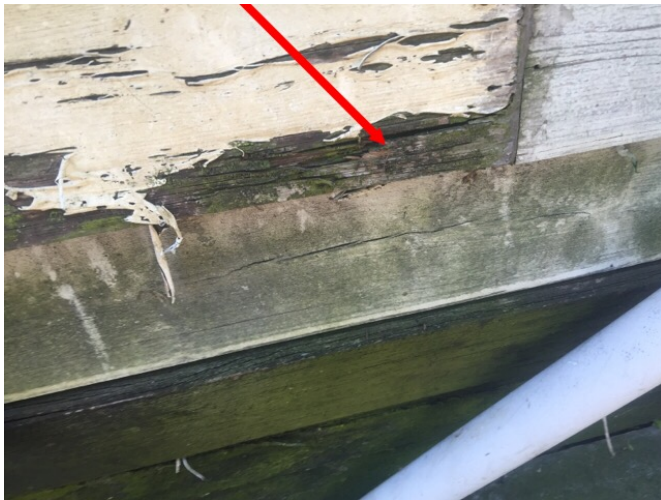
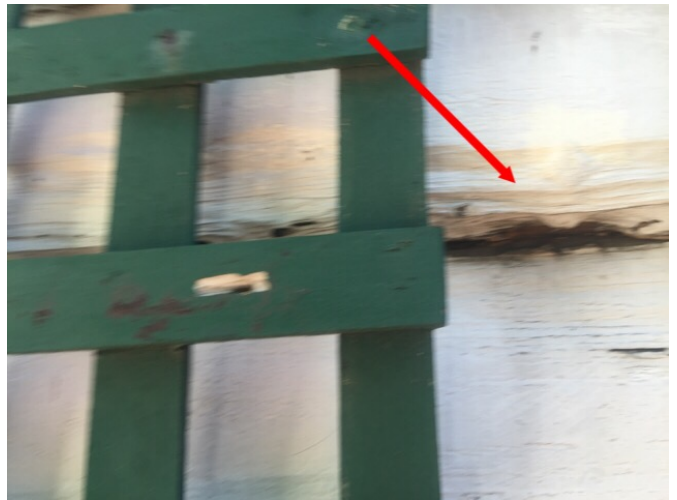
WEATHERBOARDS

Heavy Fungal Decay Was Observed

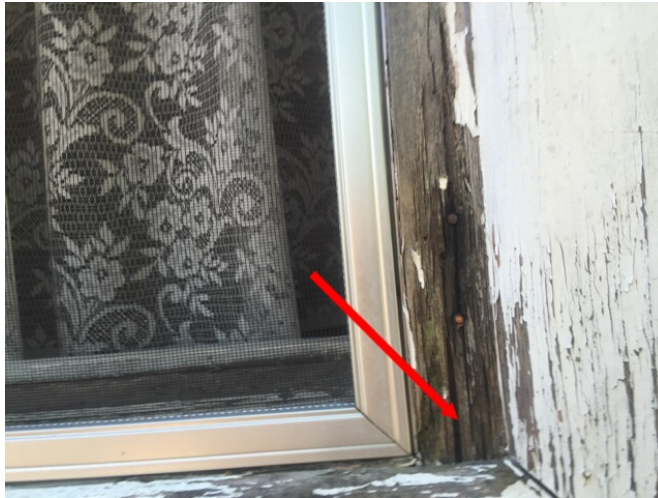
WINDOW FRAME(S)

Heavy Fungal Decay Was Observed

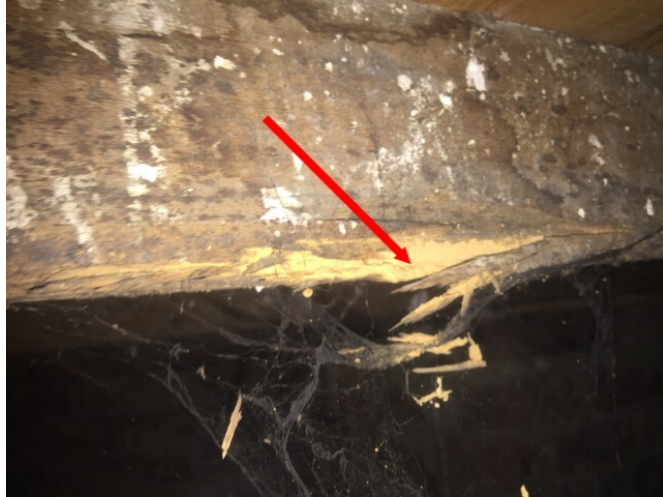
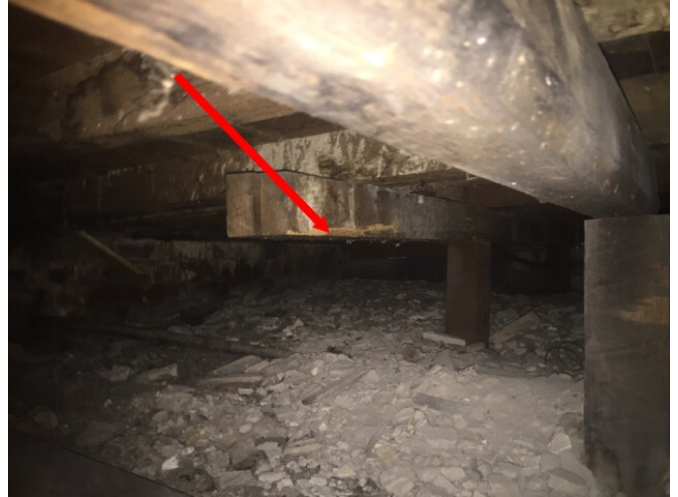
EVIDENCE OF LYCTID BORER WAS OBSERVED

Evidence of Lyctid borer damage was observed to the following area(s)

To a Bearer under the kitchen area

To a joist under the lounge room

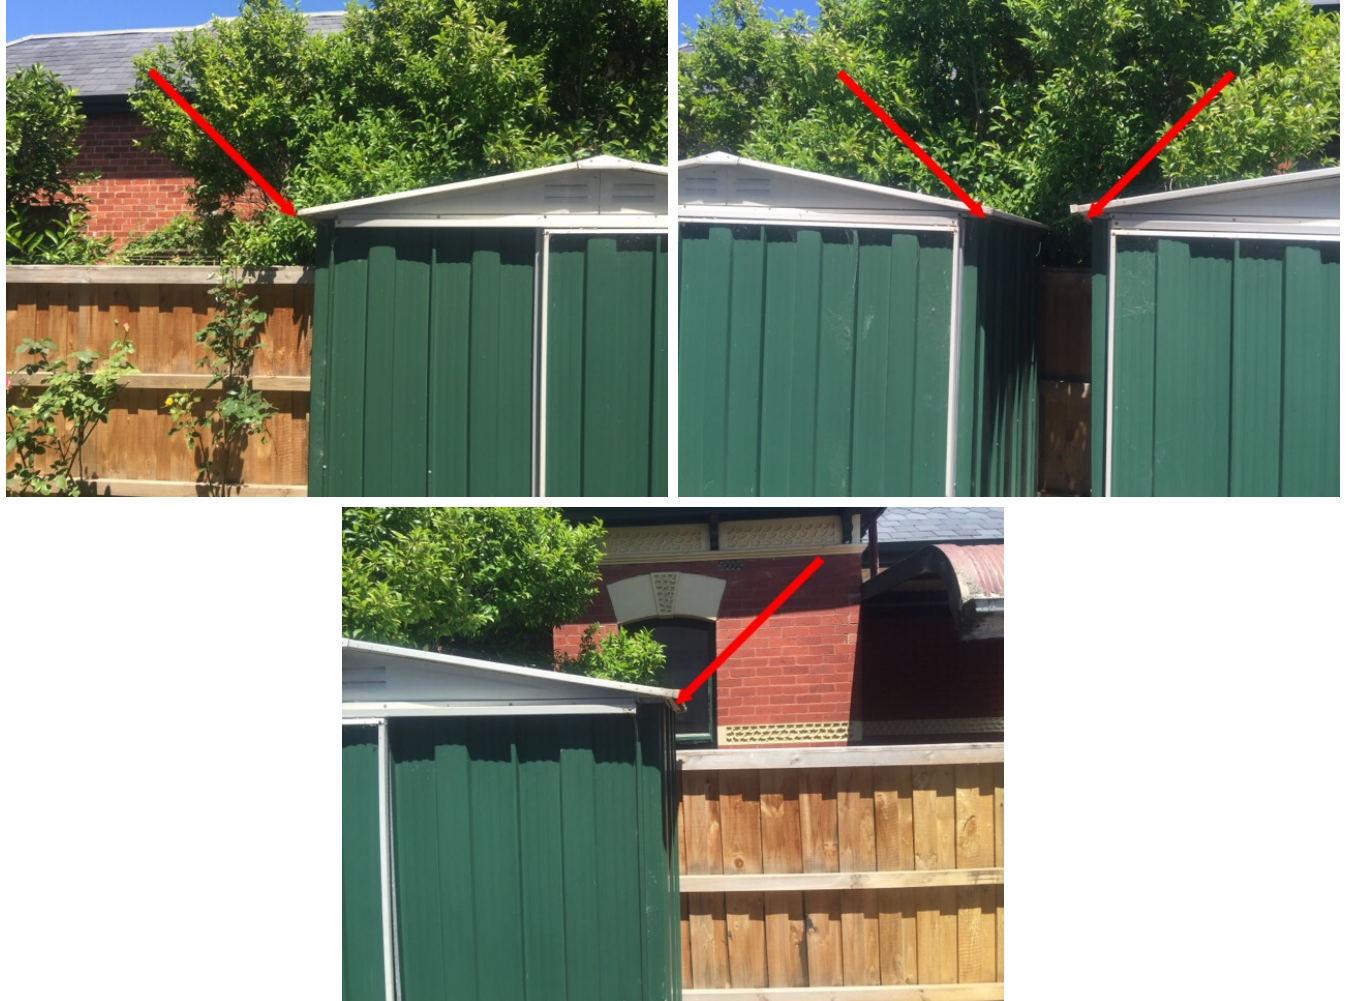
DOWNPIPE(S) AND GUTTERING MISSING

Missing downpipe(s) and guttering should be installed immediately. Recommend the client engages a licensed plumber to assess and rectify immediately.

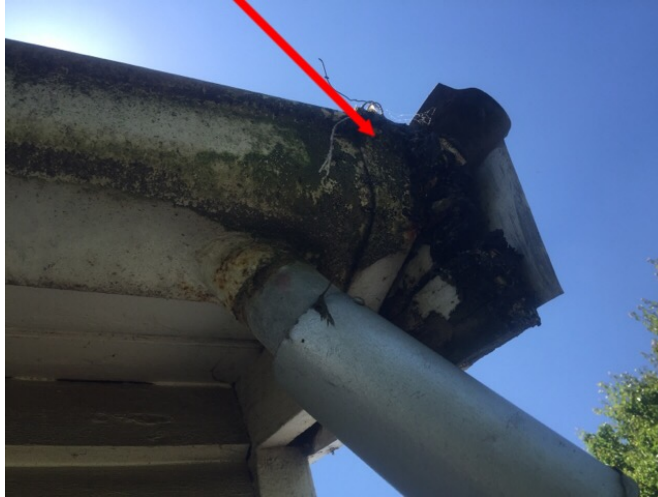
GUTTERING JOINT LEAKS

Leaking guttering joints need to be repaired. Recommend the client engages a licensed plumber for advice and recommendations.

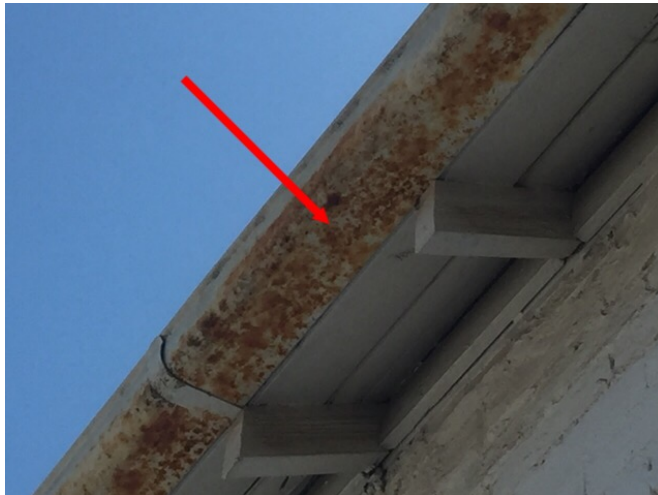
GUTTERING RUSTED OUT

Rusted out guttering should be replaced immediately. Recommend the client seeks advice of a licensed plumber to assess and rectify immediately.

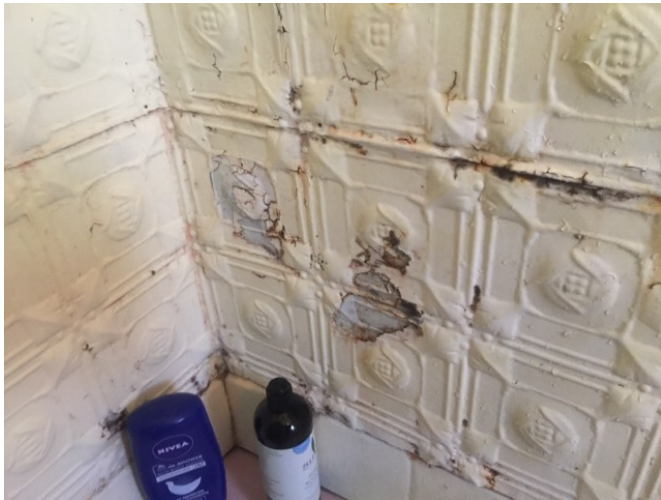
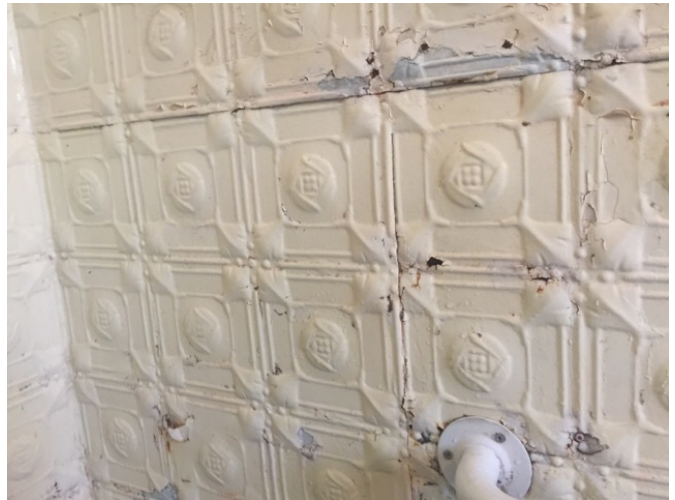
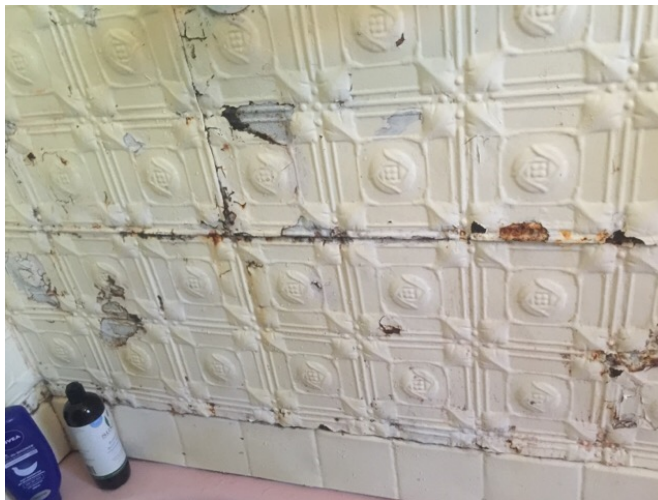
The tiles around the internal area of the shower have missing grout and/or silicon. Recommend that the client engages a qualify tiler to access and rectify.

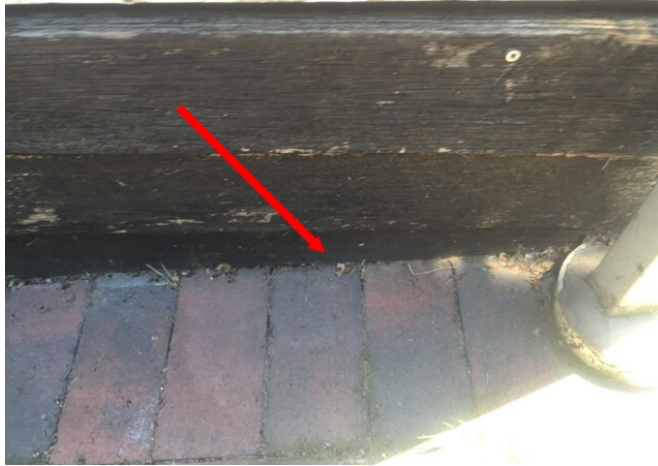
BASEBOARDS IN CONTACT WITH THE GROUND

There are baseboards in direct contact with the ground. We recommend that a gap of at least 75 mm is maintained between any baseboard and the ground. This is to help prevent termites from gaining direct concealed entry into these timbers and possibly the main building structure and also reduced the risk of fungal decay to these timbers as fungal decay is a condition conducive to termites.

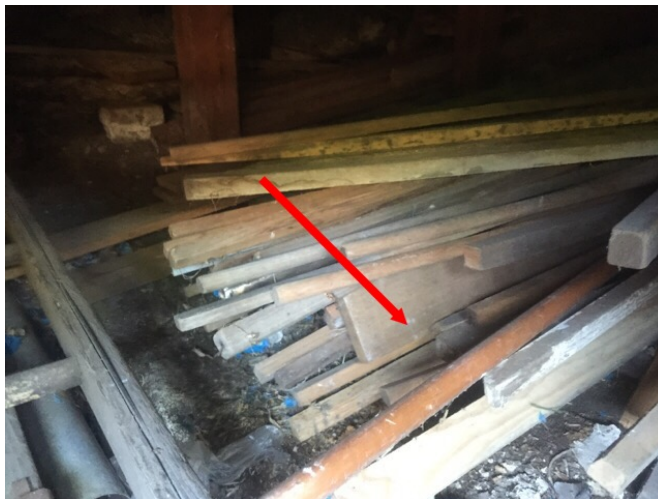
STORED TIMBER IN THE SUBFLOOR AREA

There is timber stored in the subfloor area. It is very important that the stored timber is removed immediately as it is a food source for termites and it can also conceal termite activity.

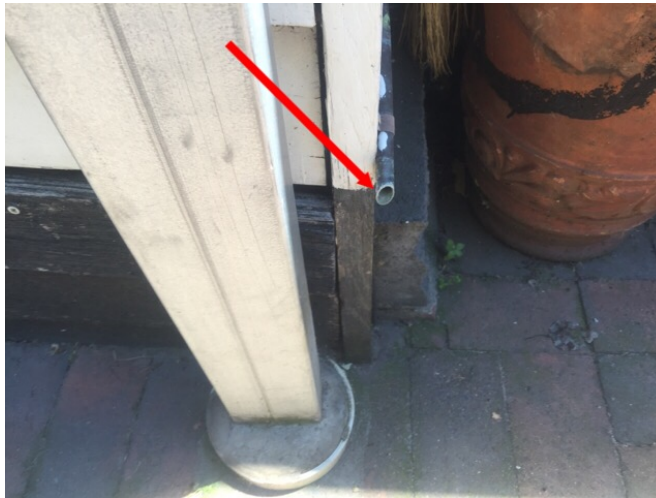
The hot water system overflow runs straight to ground. If possible the overflow pipe should be redirected into a drain, downpipe, or several metres away from the property external walls. The reason we asked for the overflow to be redirected is because sometimes the hot water systems can break down allowing water to run out of the overflow and onto the ground next to the buildings external wall(s). This moisture then builds up against the external wall(s) of the property which in turn can create conditions conducive to timber pests especially termites. If at any time you find the hot water system leaking you should call a licensed plumber immediately to assess and rectify
