Date of inspection: Monday, 17 March 2014 12:00 PM

Pre-purchase Inspection Report

Property address	8 Alfred Street COBURG VIC 3058
Report prepared for	Mitchell PRAHRAN VIC 3181
Client's contact details	mitchell@*****.com.au
Real estate agent's details	Name Leigh Chant Company Rendina RE Mobile 0418 100 082
Type of inspection report	Standard Inspection, Complete
Persons present	Agent's Representative, Pre-purchase Building Inspector, Pre-purchase Pest Inspector
Weather conditions	Fine
Inspector	Joe Noto, Bachelor Applied Science (Construction Mgt) (Economics) Registered Building Practitioner - Domestic Builder - Unlimited DB-U 28857

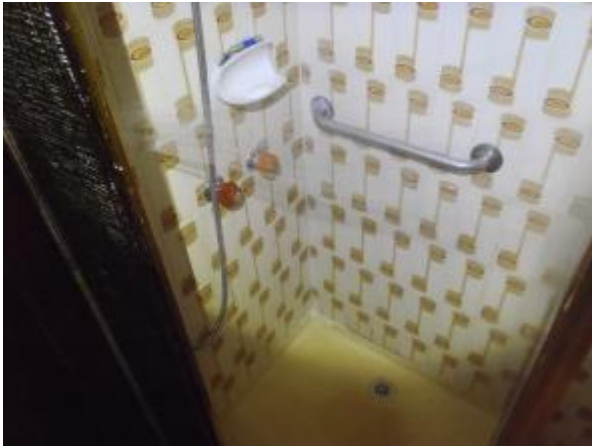
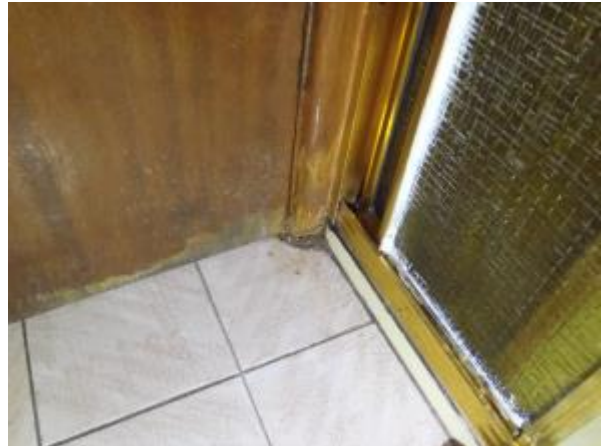
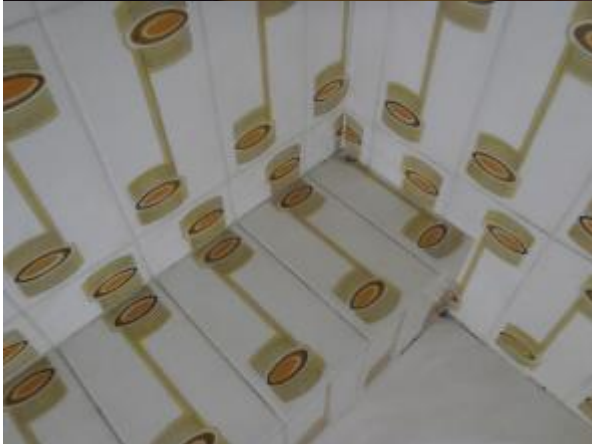
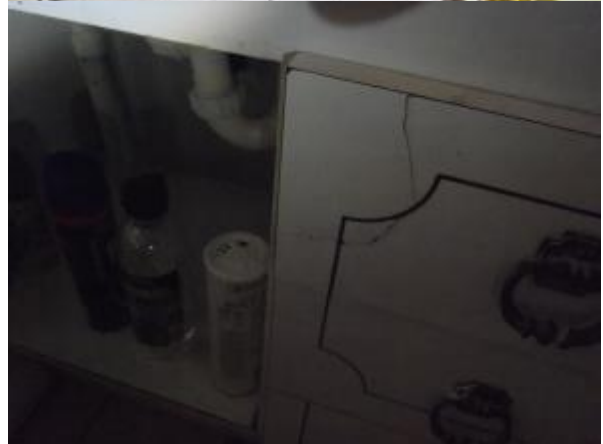
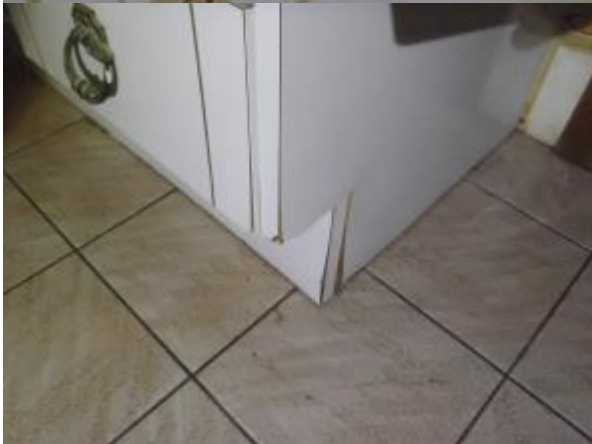
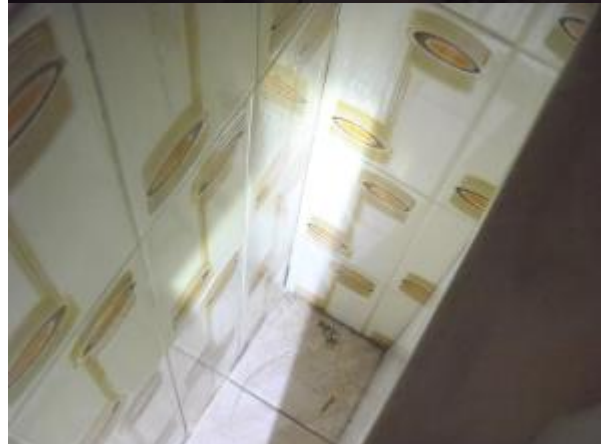
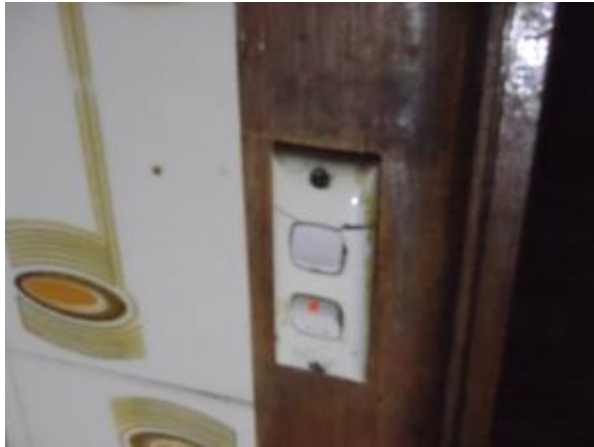
Major Defect

It is recommended the wall floor and ceiling structure is straightened, re-levelled and plumbed and a complete renovation of the bathroom is carried out.

Electrical & plumbing services upgrade will be required.

An asbestos audit is required to determine extent of asbestos to accessible and concealed areas prior to undertaking any demolition, removal or destructive works.

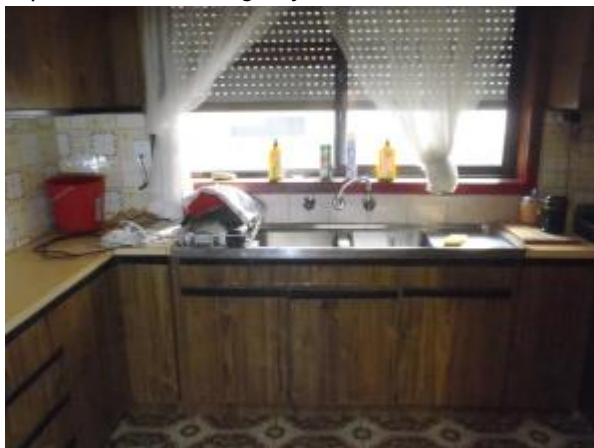
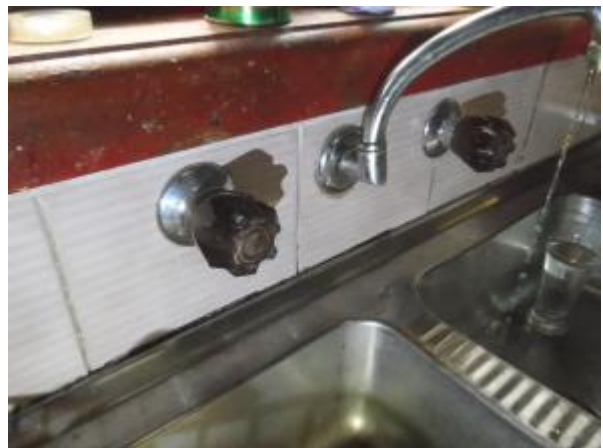
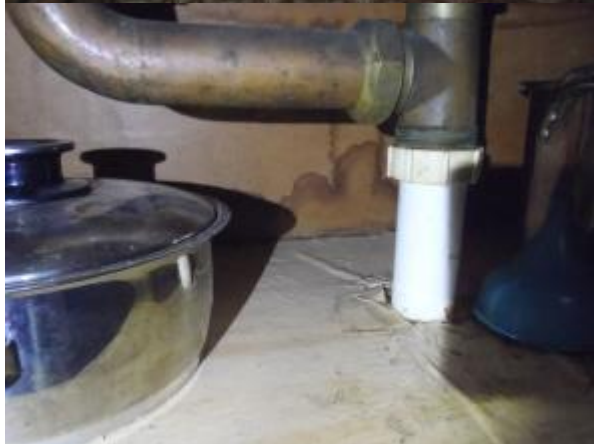
Interior - Kitchen

Various items

Minor Defect

It is recommended the wall floor and ceiling structure is straightened, re-levelled and plumbed and a complete renovation of the kitchen is carried out.

Electrical & plumbing services upgrade will be required.

An asbestos audit is required to determine extent of asbestos to accessible and concealed areas prior to undertaking any demolition, removal or destructive works.

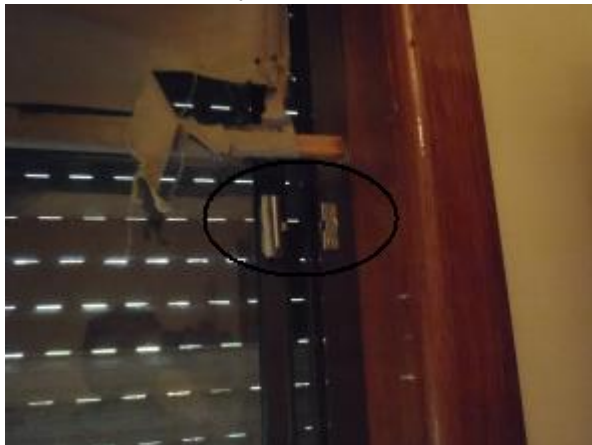
Aluminium windows Defective hardware Minor Defect Type: A, E

Hardware to be replaced to enable window to latch shut. One example depicted below.

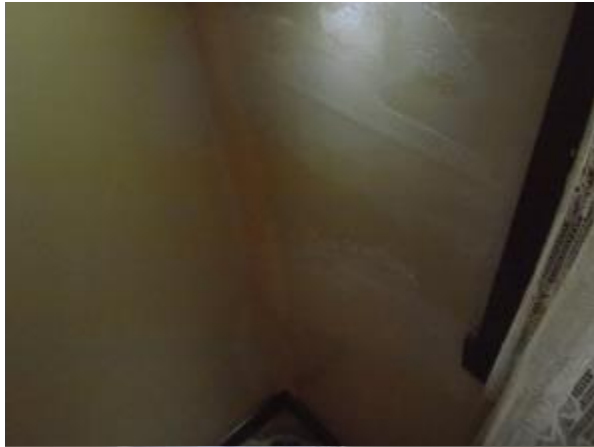
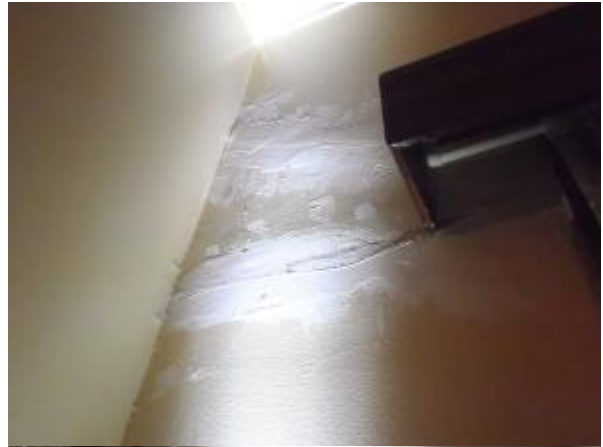
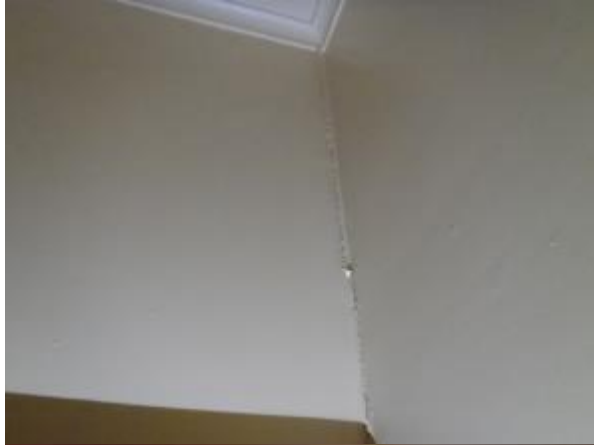
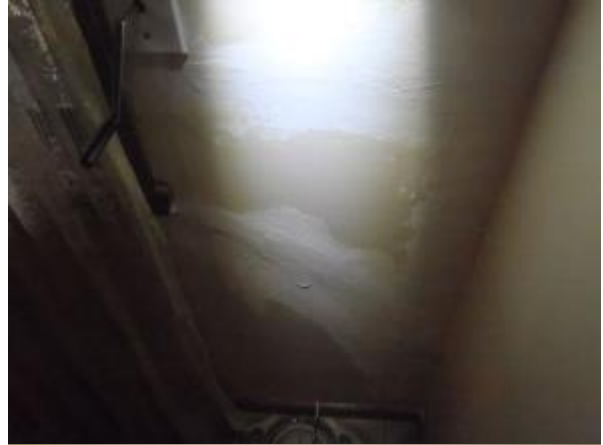
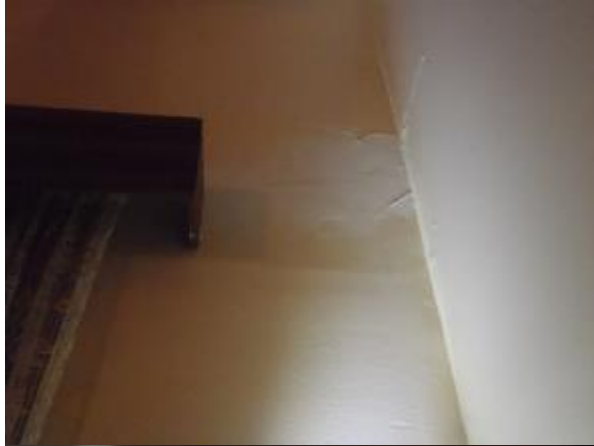
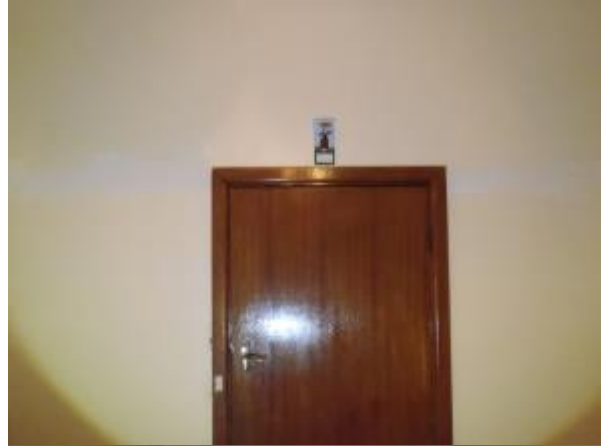
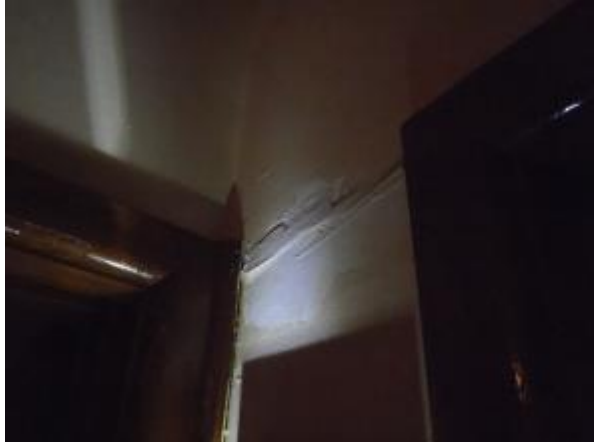
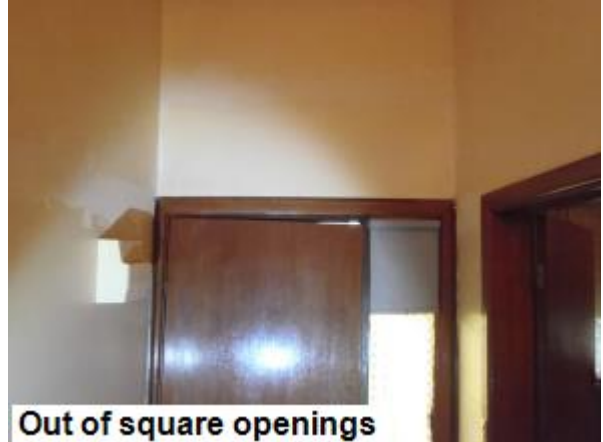
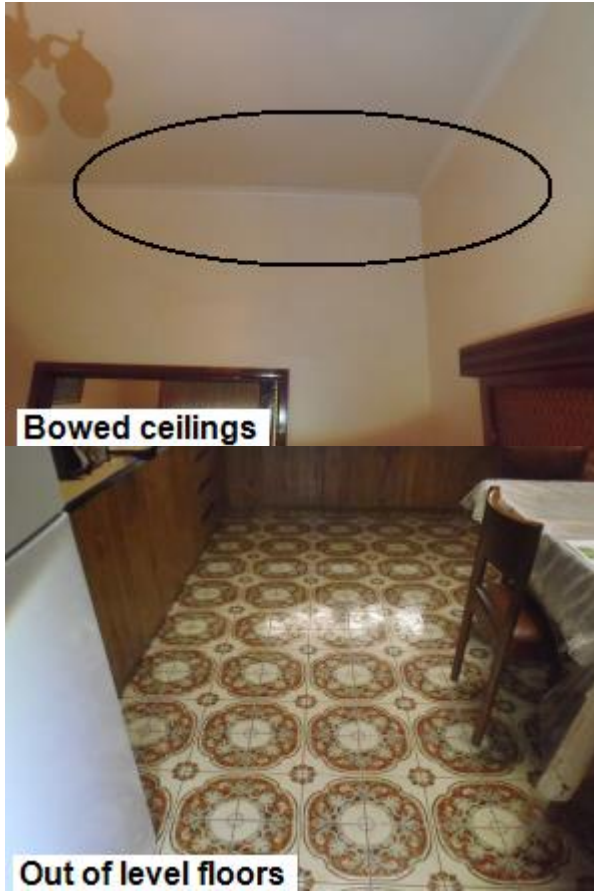
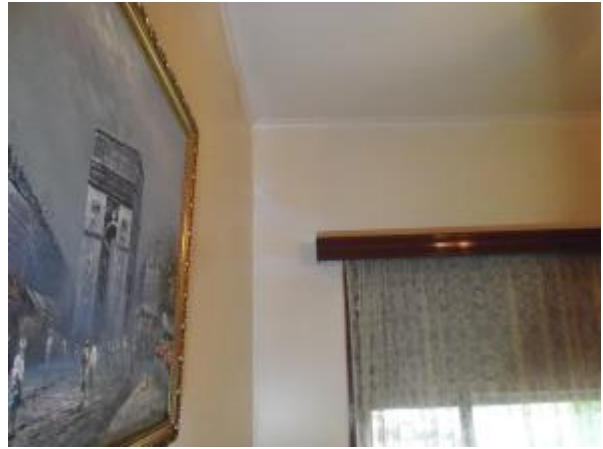
Movement defects Various items Further Investigation Type: A

Significant movement through the sub-floor structure has resulted in various movement defects to the internal areas of the home. It is highly recommended an invasive inspection of wall cavities is carried out to determine extent of defects to concealed areas.

- 1. Out of level floors*
- 2. Cracking to internal walls*
- 3. Out of level ceilings*
- 4. Out of square door openings*
- 5. Out of square window openings*

It is highly recommended the sub-floor structure is re-levelled. It cannot be determined that stump bases have been installed to any particular standard, it is therefore recommended re-stumping be carried out. At this point a qualified carpenter will be required to de-construct particular linings in order to straighten, re-level and plumb up certain areas of the frame including wall and ceiling framing.

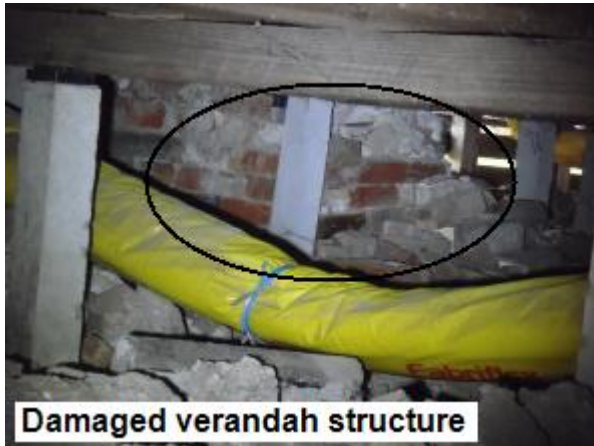
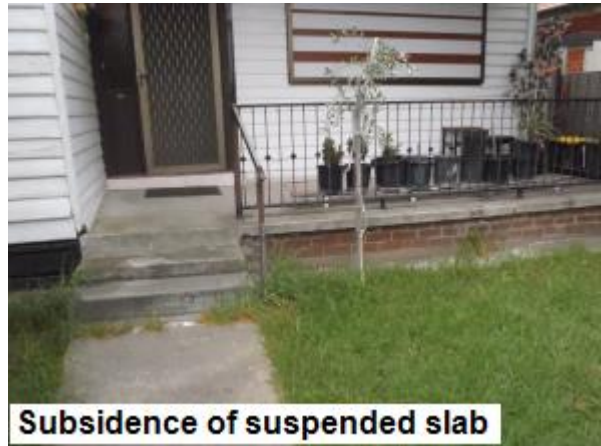
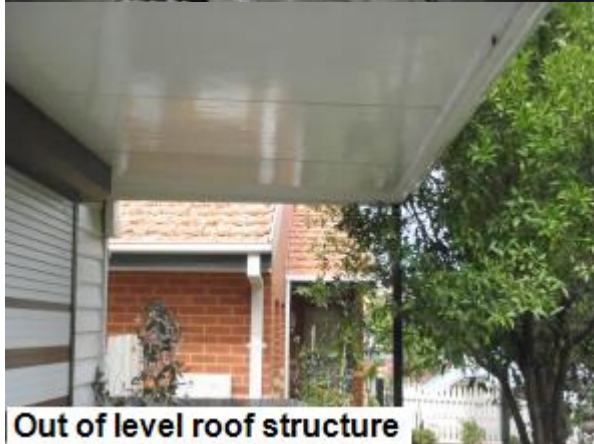
Exterior - Front Elevation

Patio/veranda Structural damage to front verandah Major Defect Type: A

Re-construction or removal and replacement to a timber deck is required. Residual defects include movement of the roof structure above the verandah.

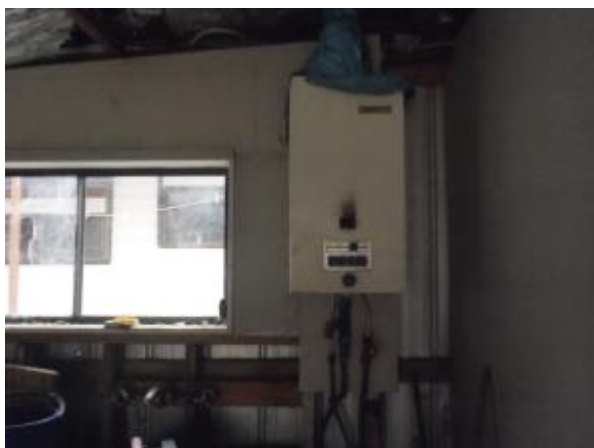
Plumbing Hot water service to be replaced Minor Defect Type: F

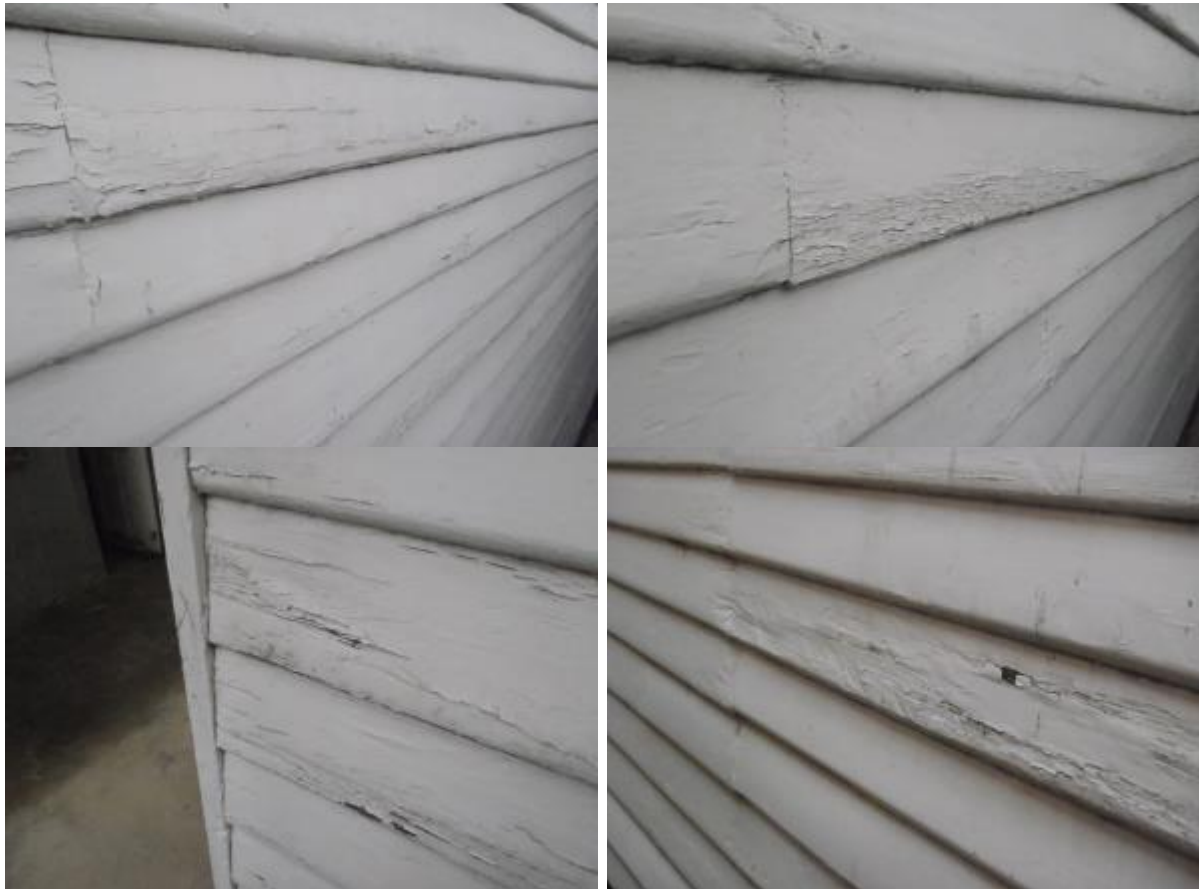
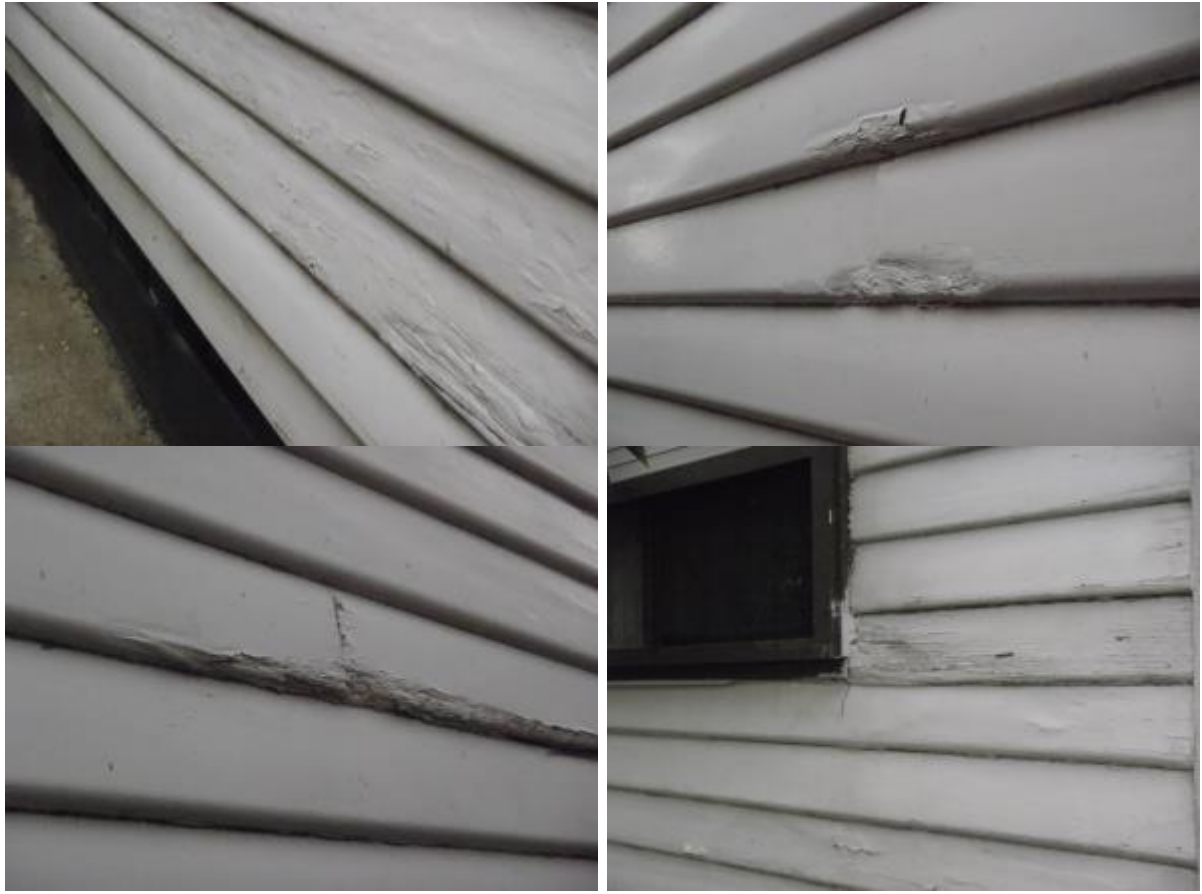
External timbers Rot & timbers susceptible to rot Minor Defect Type: C, D
Application of sealants, paints or flashings required to protect external timbers from moisture ingress to prevent further decay/rot to exposed timbers.
Replacement of various weatherboards is required.
All timber joints, gaps at junctions, un-painted surfaces etc required filling, sanding and painting.
All timber glazing beads to external window faces require sealant to prevent further decay.
All non-treated timber in contact with the ground should be replaced with treated timber to prevent rot and damage.

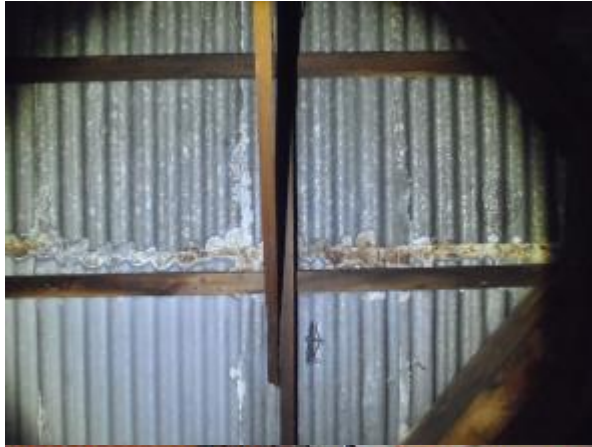
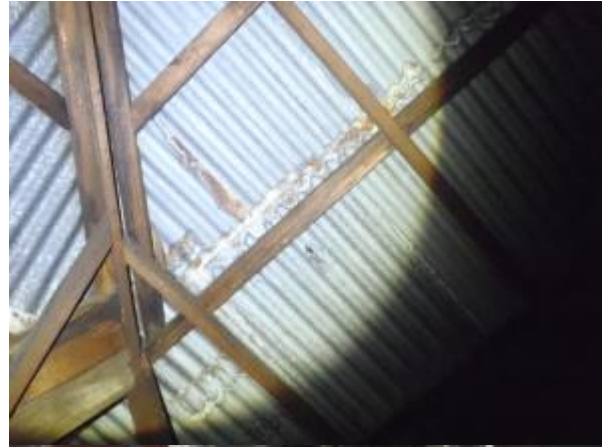
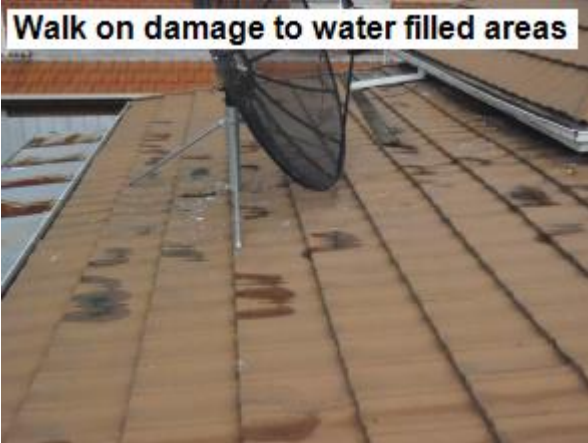
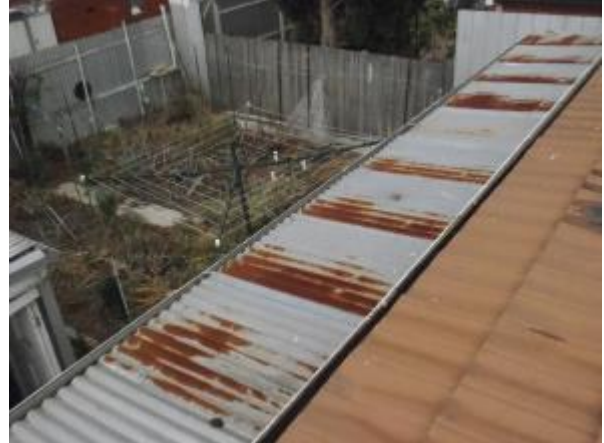
Roof iron

Walk on damage to metal tiles

Minor Defect

It is highly recommended the rusted corrugated iron roof sheets and metal tiles are removed. Replace with new roof covering.

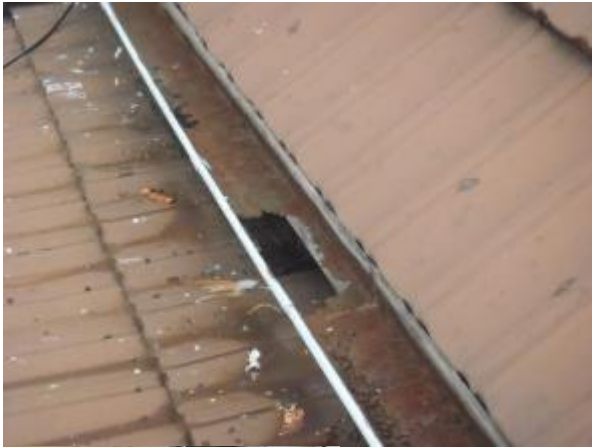
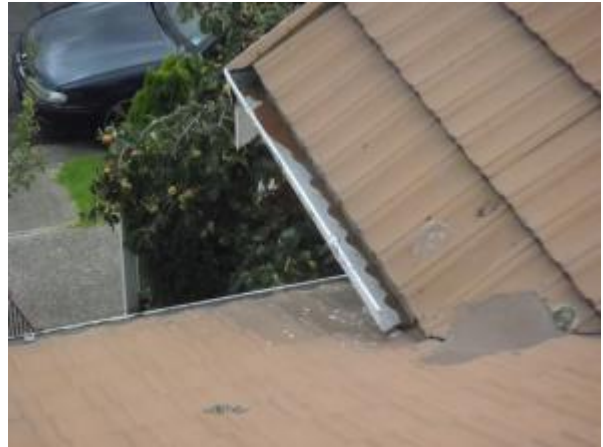
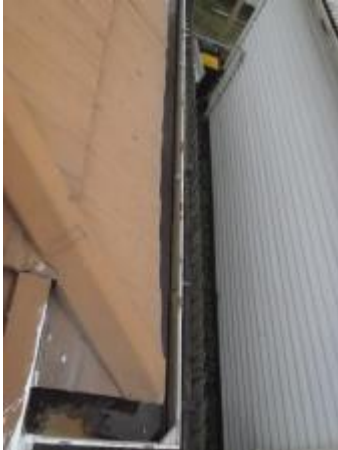
Guttering

Corrosion in gutters

Minor Defect

Replacement of corroded gutters is required.

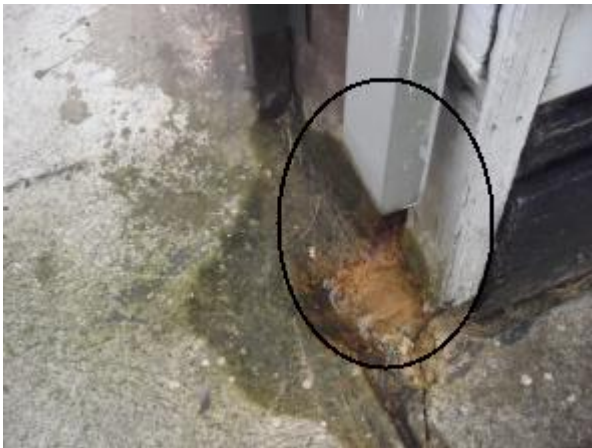
Down pipes

Not connected to storm water system

Minor Defect

A storm water point is required to be installed by a licensed plumber to pick up the down pipe to the North West elevation. This will prevent water flow into the sub-floor and residual defects such as decay of stumps and structural movement defects.

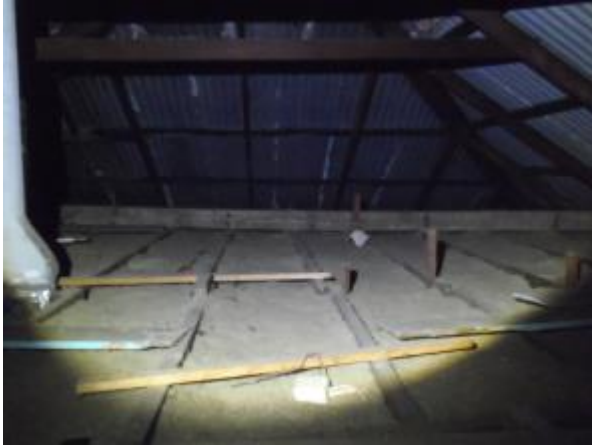
Roof framing

Minor Defect

Rectification of site drainage and items associated with the sub-floor structure is required to prevent further movement.

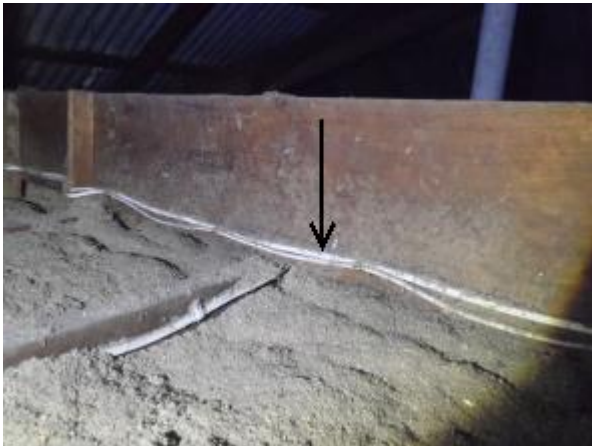
Roof wiring

Original wiring in use

Further Investigation Type: F

Safety inspection is required by a licensed electrician prior to making the purchasing decision.

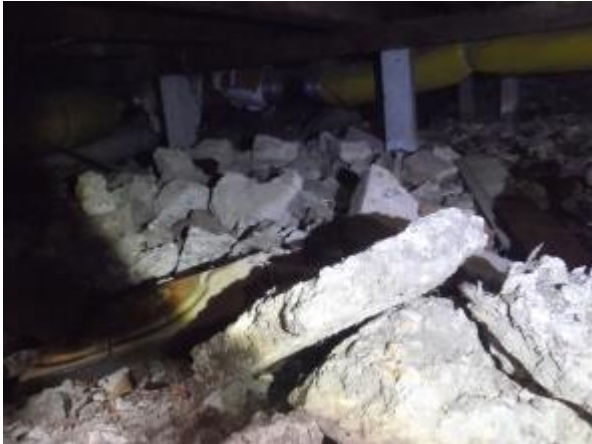
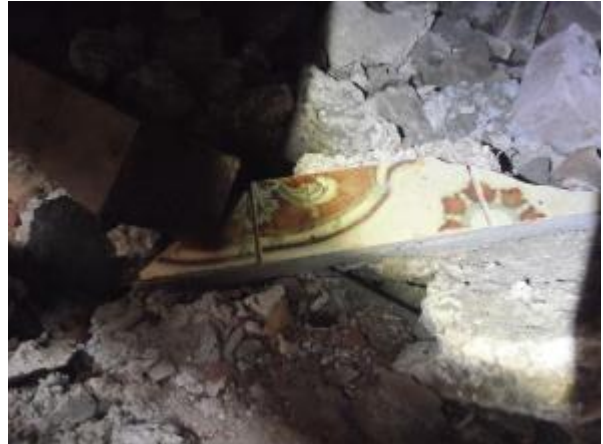
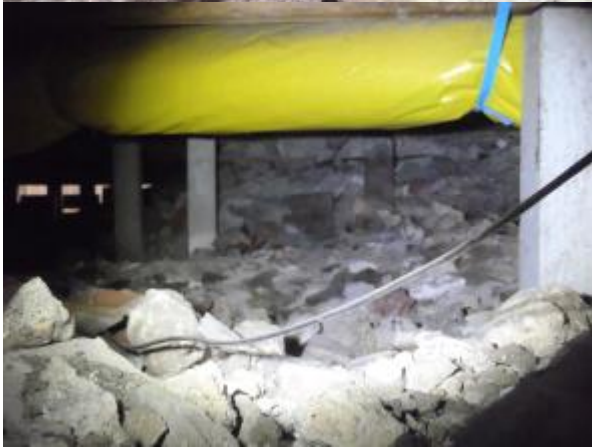
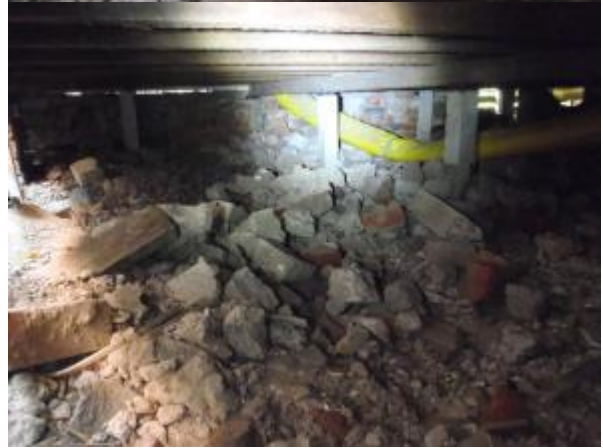
General state of the under floor space

Further Investigation Type: A, F

An asbestos audit is required prior to removal of rubble.

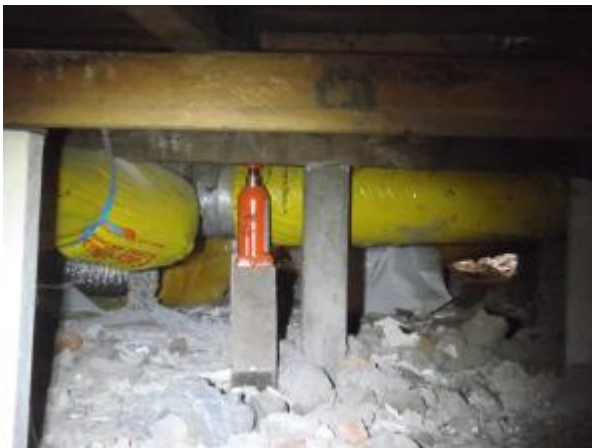
Jack left behind

Minor Defect

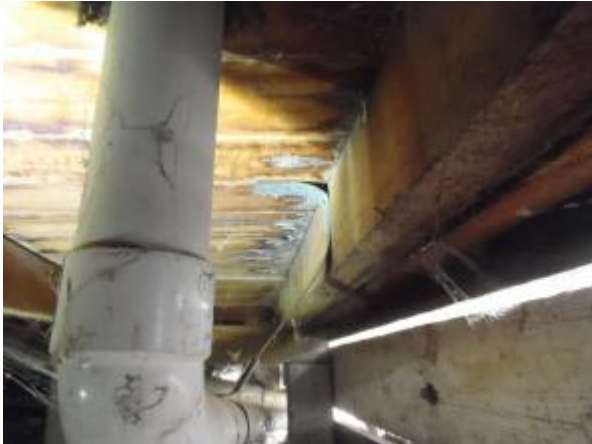
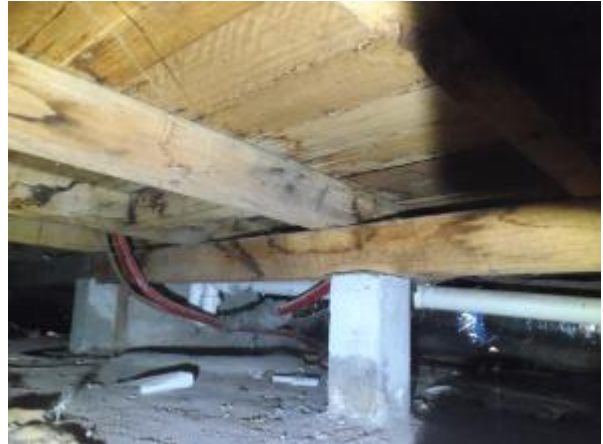
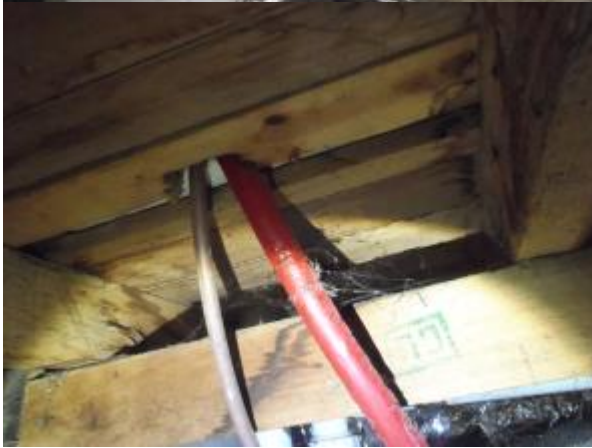
Under timber floor Water seepage through laundry/bathroom areas
Refer to "bathroom" of this report.

Minor Defect Type: C, D, F

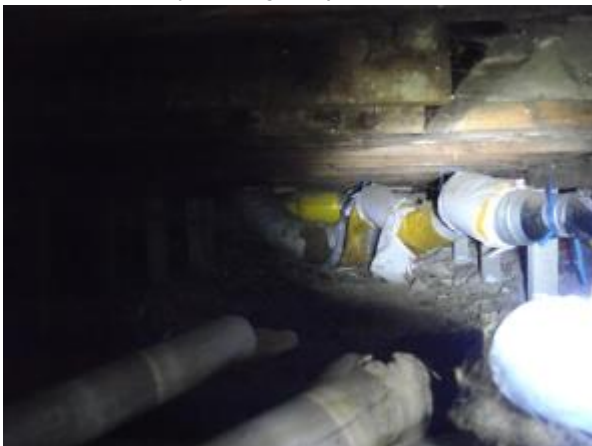
Under timber floor Damaged casing to heating ducts
Rats will likely damage exposed duct insulation.

Minor Defect Type: A

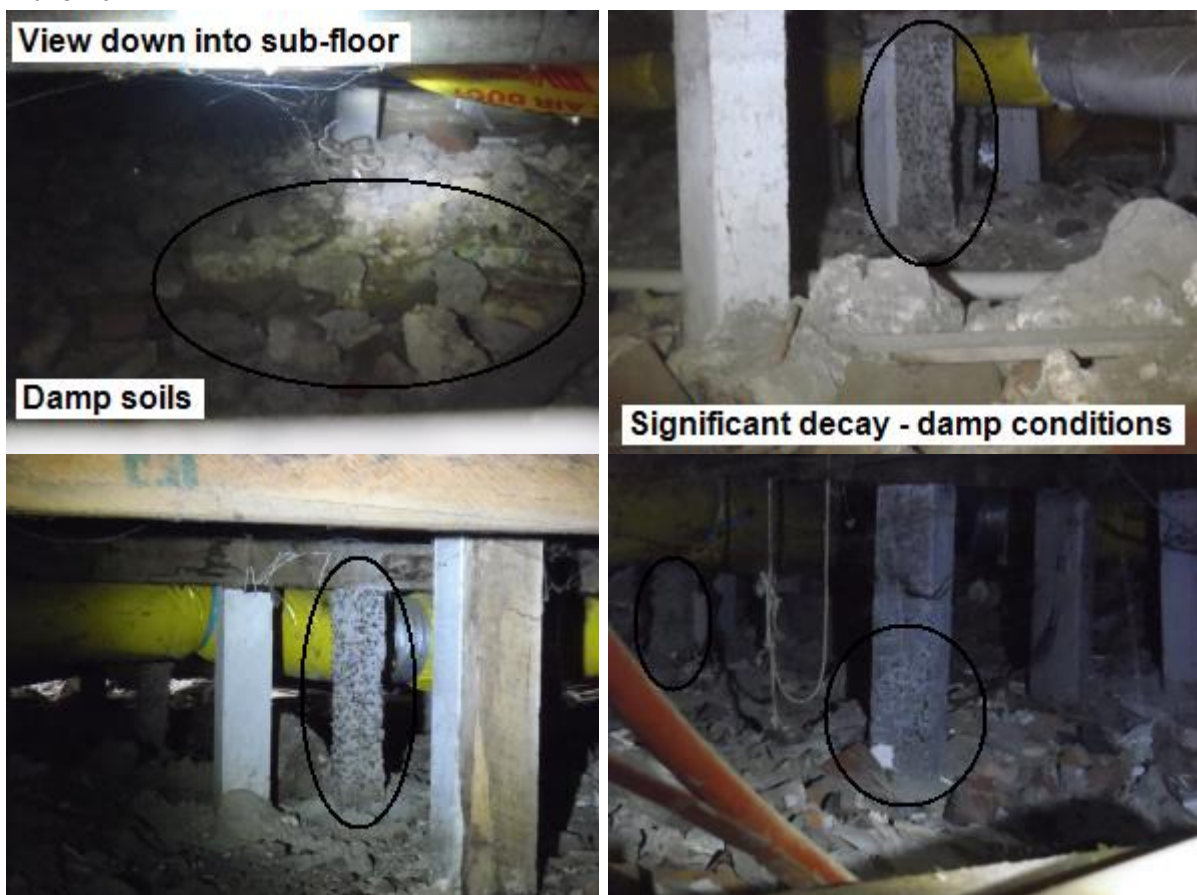
Surface water Ground slopes towards building & no provision for drainage Major Defect Type: F

The natural flow of the ground will lead water to its lowest point. In this case, much of the sub-floor ground level lies well below the external ground levels. Much of the sub-floor was dry although this is likely a result of the recent dry weather. There are various locations where soils are damp and other evidence that sub-floor soils have been damp where various original concrete stumps have been left behind that show significant decay.

It is highly recommended, concrete paths are removed to allow for installation of an agricultural drain that lies underground and below the level of the sub-floor soils. If the agricultural drain lies too low to be connected into the storm water system it is recommended it flows into a drainage pit with water pump that can push water up into the storm water system. Earth works & concrete paving can then be replaced.

The current storm water system requires inspection to determine any damage prior to carrying out this work.

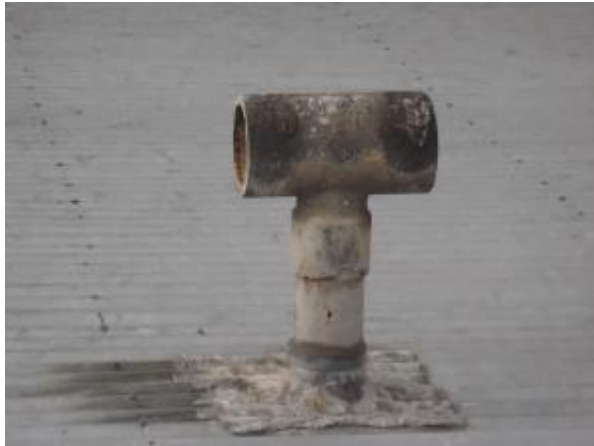
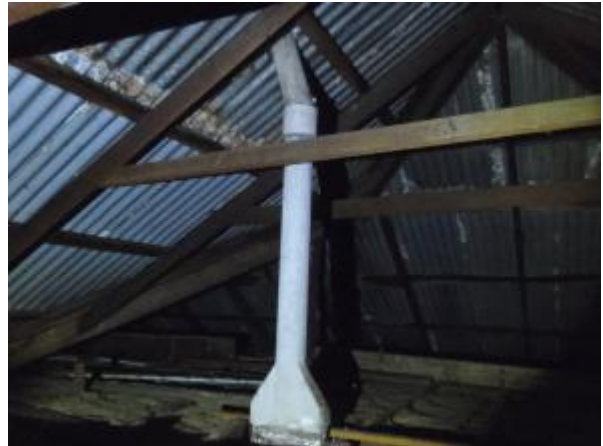
Various items Possible use of asbestos materials Further Investigation Type: F

1. *Internal & external flues.*
2. *Internal wall linings to bathroom's/Laundry.*
3. *Eaves linings.*
4. *Tile substrates.*
5. *etc.*

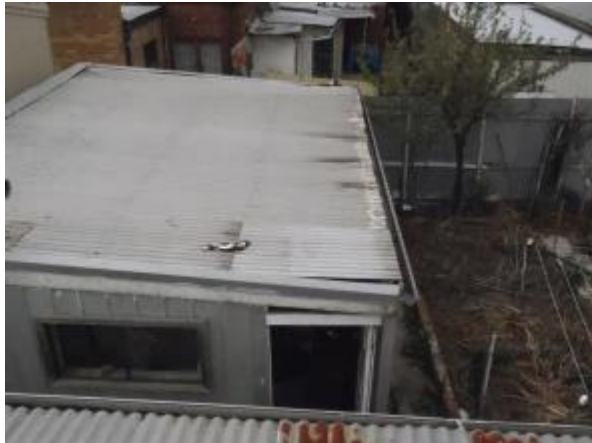
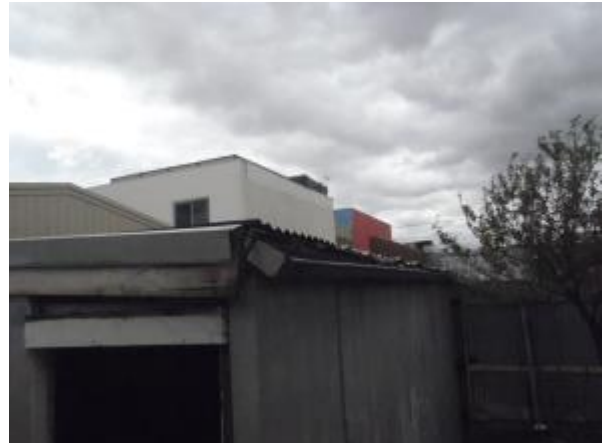
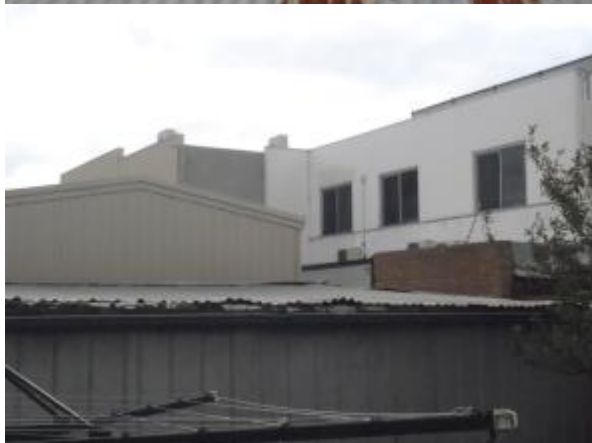
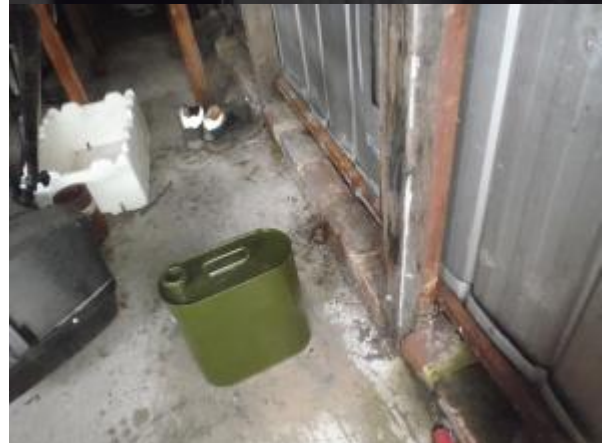
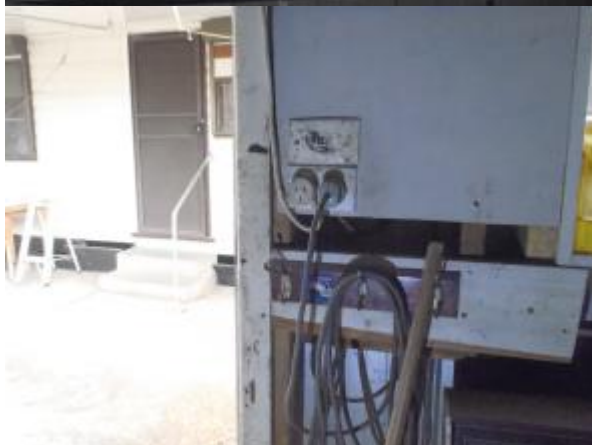
Garage

Minor Defect

1. Corrosion to structure.
2. Loose roof iron.
3. Roof leaks.
4. Corrosion to claddings.
5. Sub-standard electrical items.
6. etc..

Complete gut out and renovation required. Defective items to areas including the following were recorded;
