Pre-handover Inspection Report

Property address	10 Sample Avenue EYNESBURY VIC 3338
Report prepared for	Lucy Sample 34 Peppermint Grove HOPPERS CROSSING VIC 3029
Client's contact details	Mobile 5678 921 587 lucysample@gmail.com
Real estate agent's details	Name n/a Company n/a
Type of inspection report	Standard Inspection, Defect Only
Persons present	Client, Builder's representative
Weather conditions	Fine
Inspector	Joe Noto, Bachelor Applied Science (Construction Mgt) (Economics) Registered Building Practitioner - Domestic Builder - Unlimited DB-U 28857

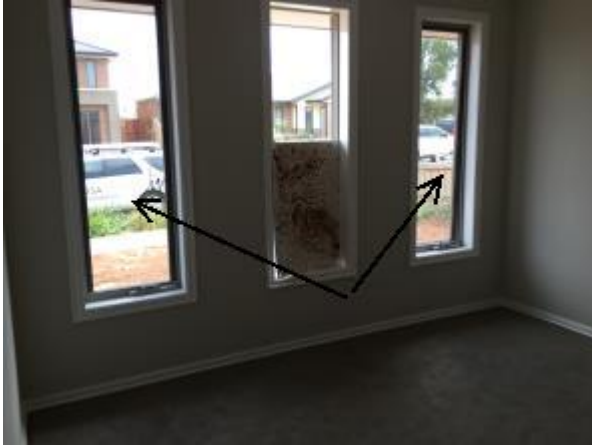
Interior - Bedroom 1

Binding windows

Minor Defect

Type: E

Adjustment required.

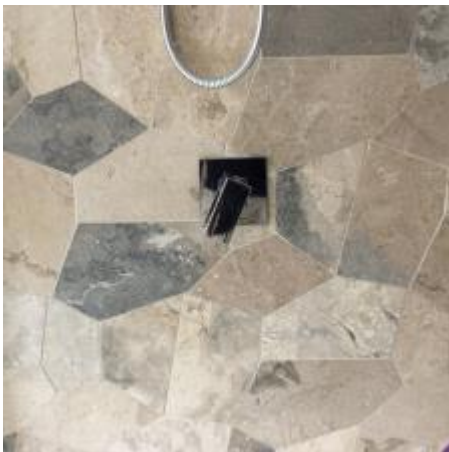
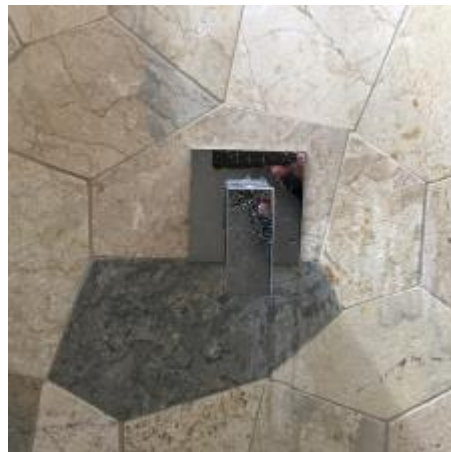
Ensuite

Square up cover plates to shower taps

Minor Defect

Type: F

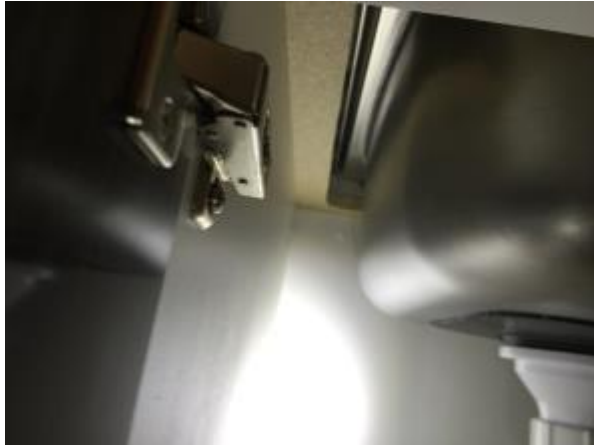
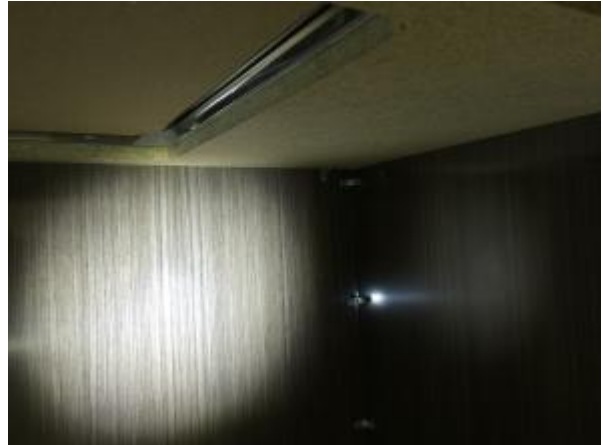
Interior - Kitchen

Missing under bench fixings

Minor Defect

Type: F

Fixings required as recommended by manufacturer.

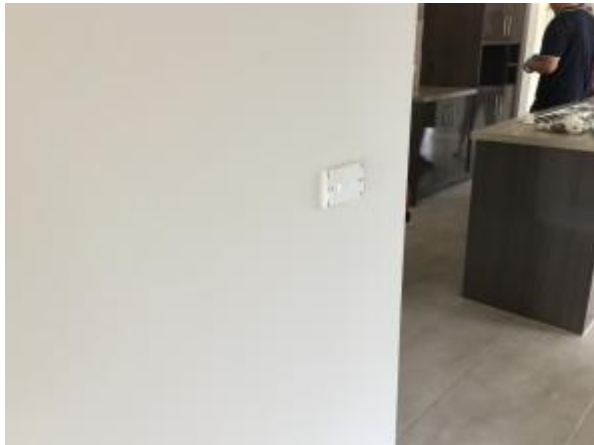
Interior - Passages

Install missing cover plate

Minor Defect

Type: F

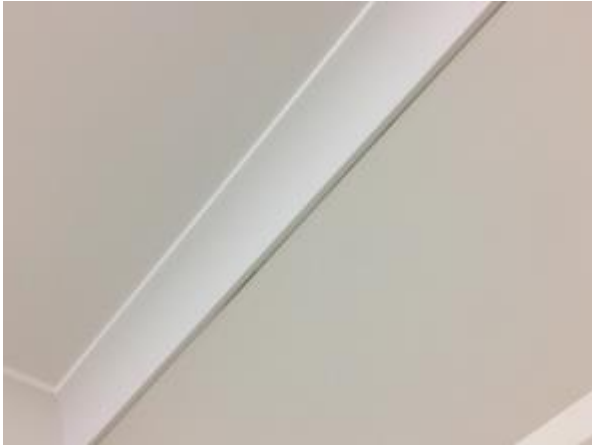
Interior - Pantry

Cornice corner separation/splitting

Minor Defect

Type: F

Patch and paint.

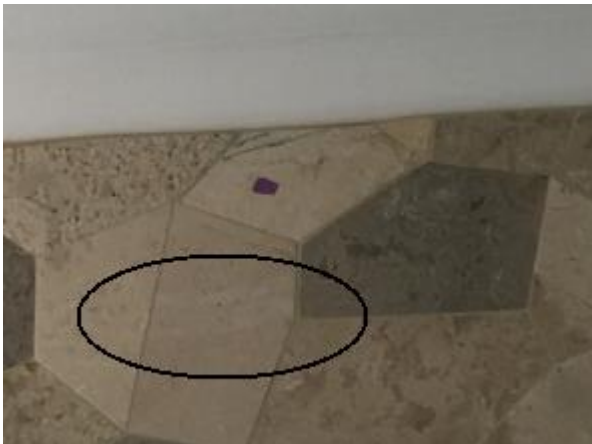
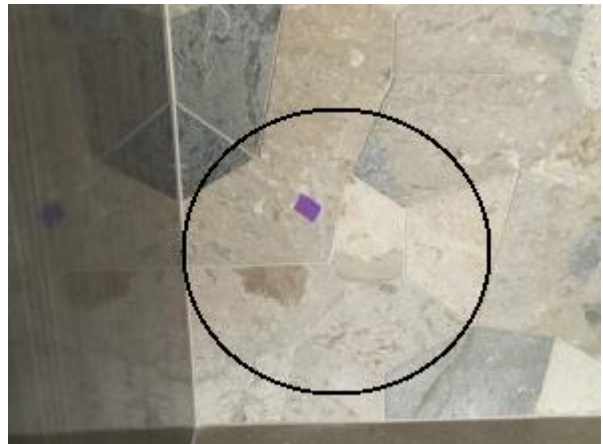
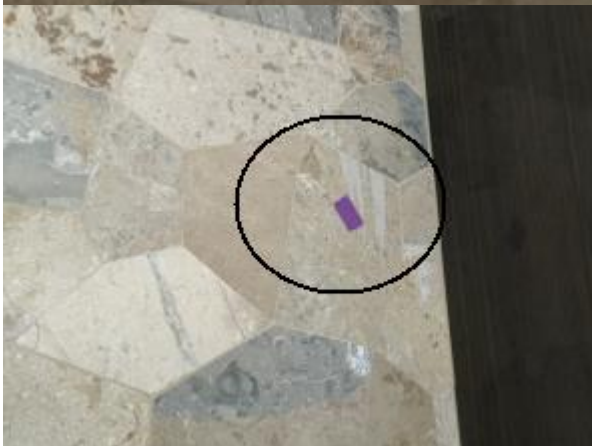
Interior - Various rooms

Damaged sections

Minor Defect

Type: A

It looks as though the grinder wheel has passed over the surface of the tile. Replacement of certain sections required. Defects occur to 2 areas to the kitchen splash back and one area to the ensuite.

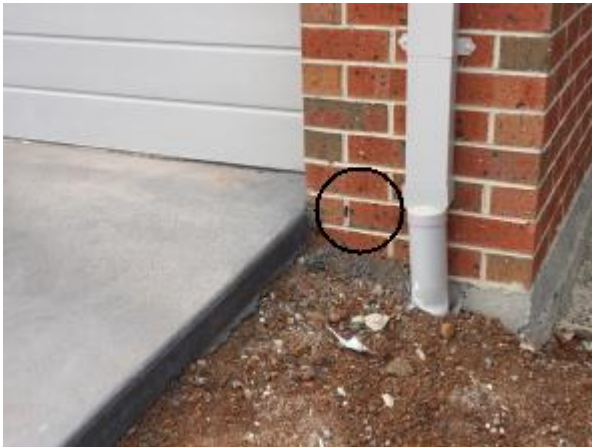
Exterior - Front Elevation

Re-pointing mortar blowout required

Minor Defect

Type: A, F

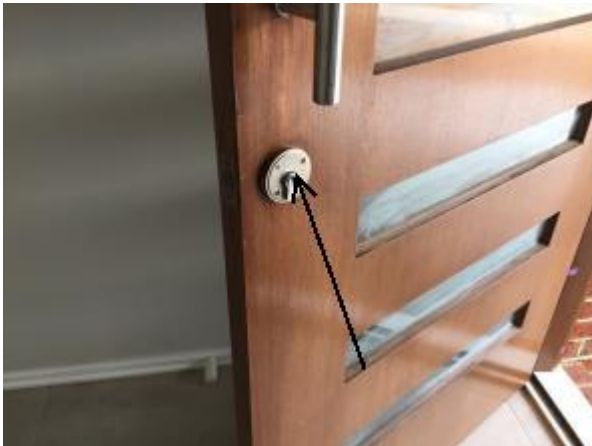
Missing cover plate

Minor Defect

Type: F

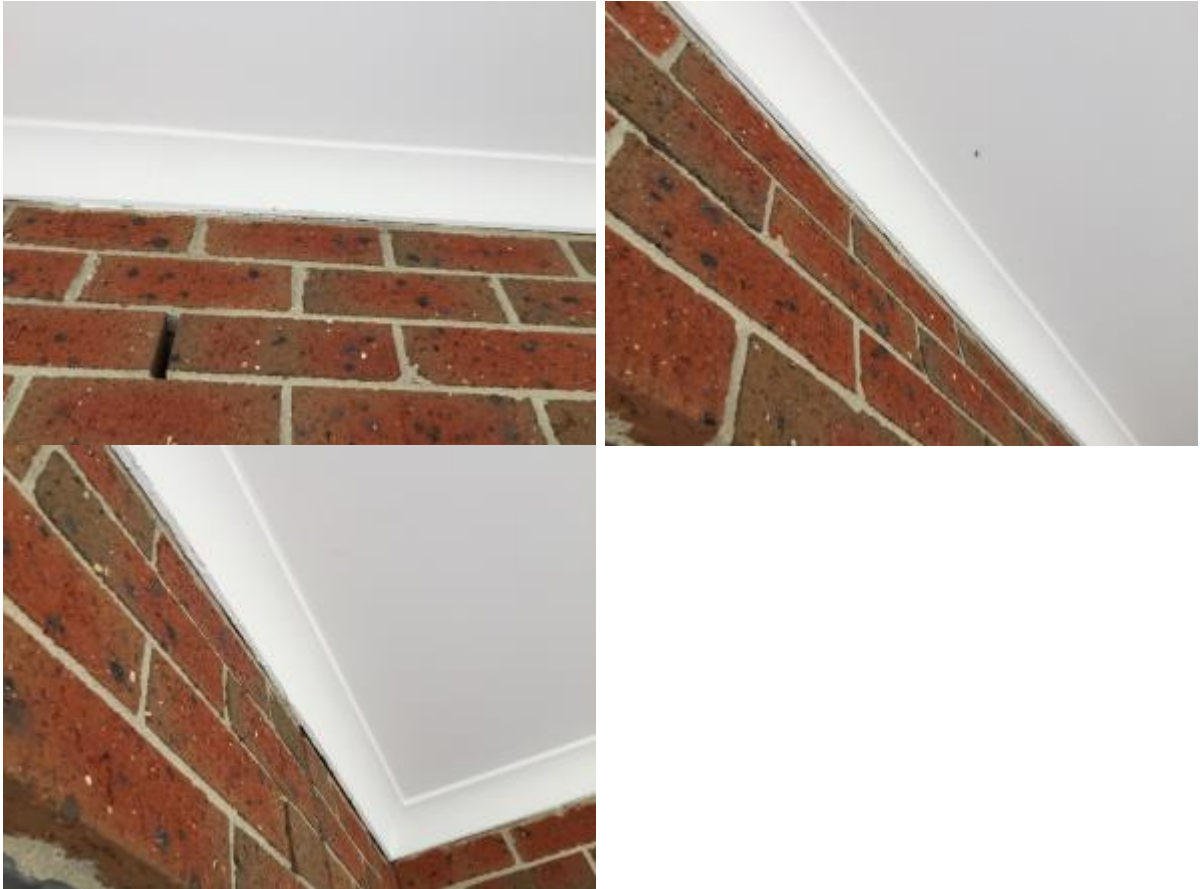
Exterior - Rear Elevation

Defective cornice

Minor Defect

Type: F, A

The underside of the cornice is to be sanded back and repainted.

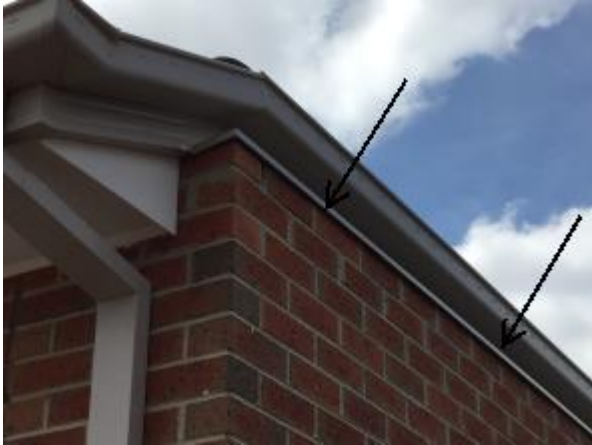
Exterior - East Elevation

Re-install capping to fall away from the home

Minor Defect

Type: F

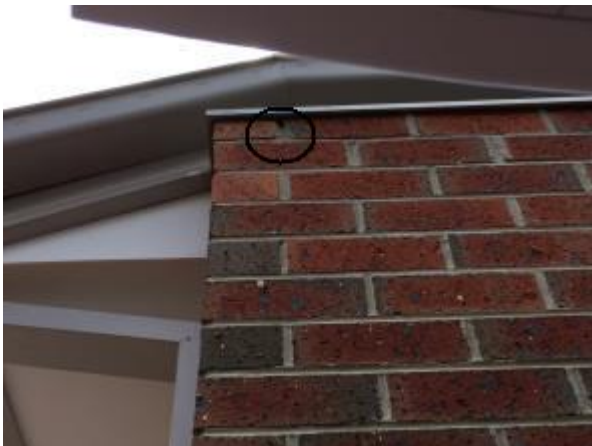
Re-pointing of mortar blowout required

Minor Defect

Type: F, A

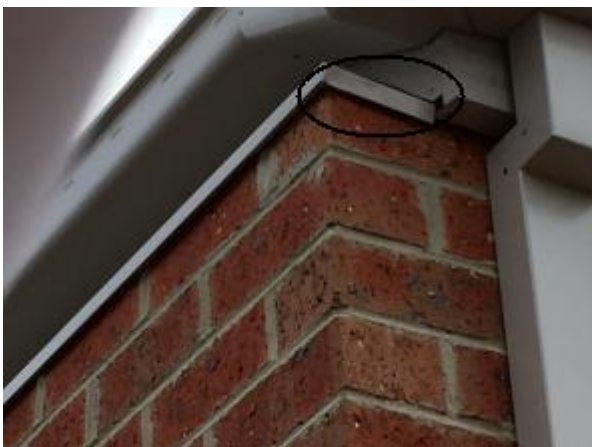
Replace dented capping

Minor Defect

Type: A

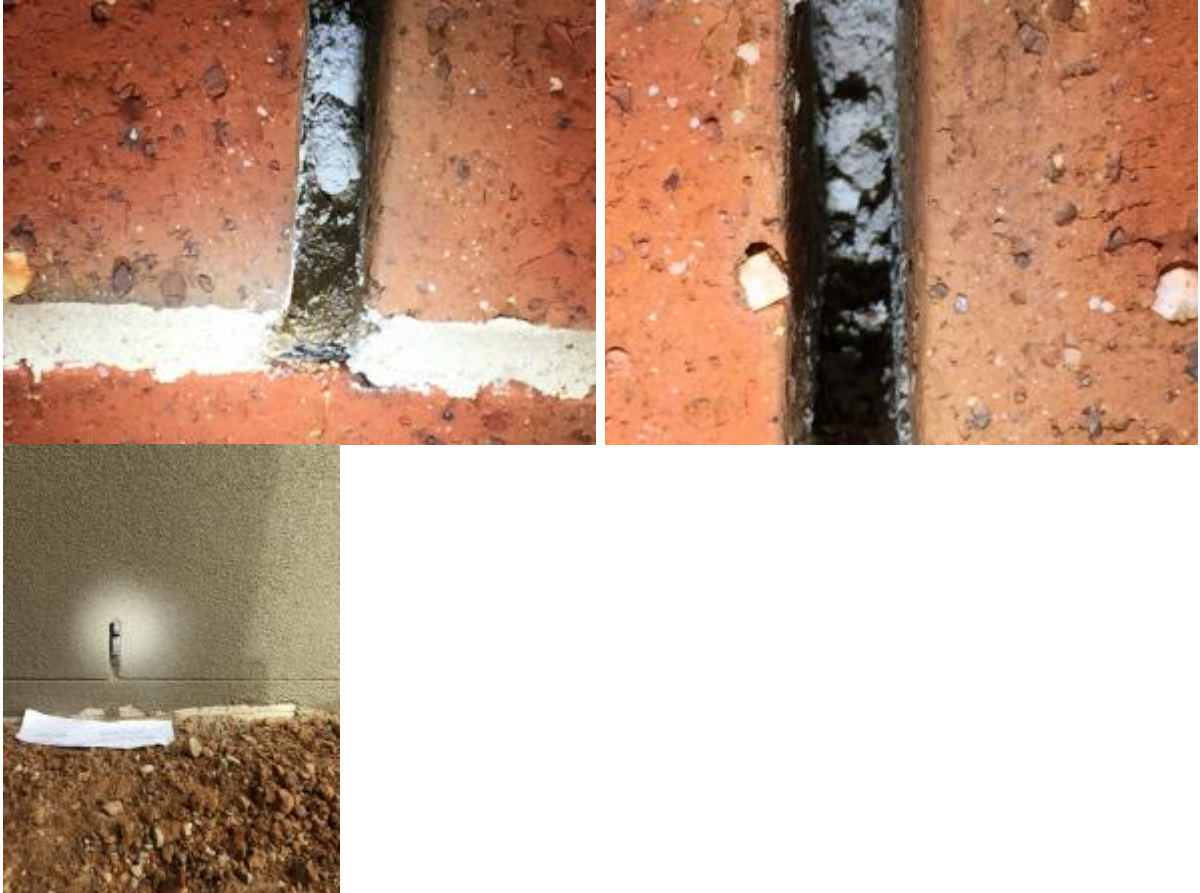
Exterior - Default Elevation

Obstructed weep holes

Minor Defect

Type: F

Remove excess mortar within weep holes and wall cavities to expose the moisture proof membrane. Some examples depicted below.

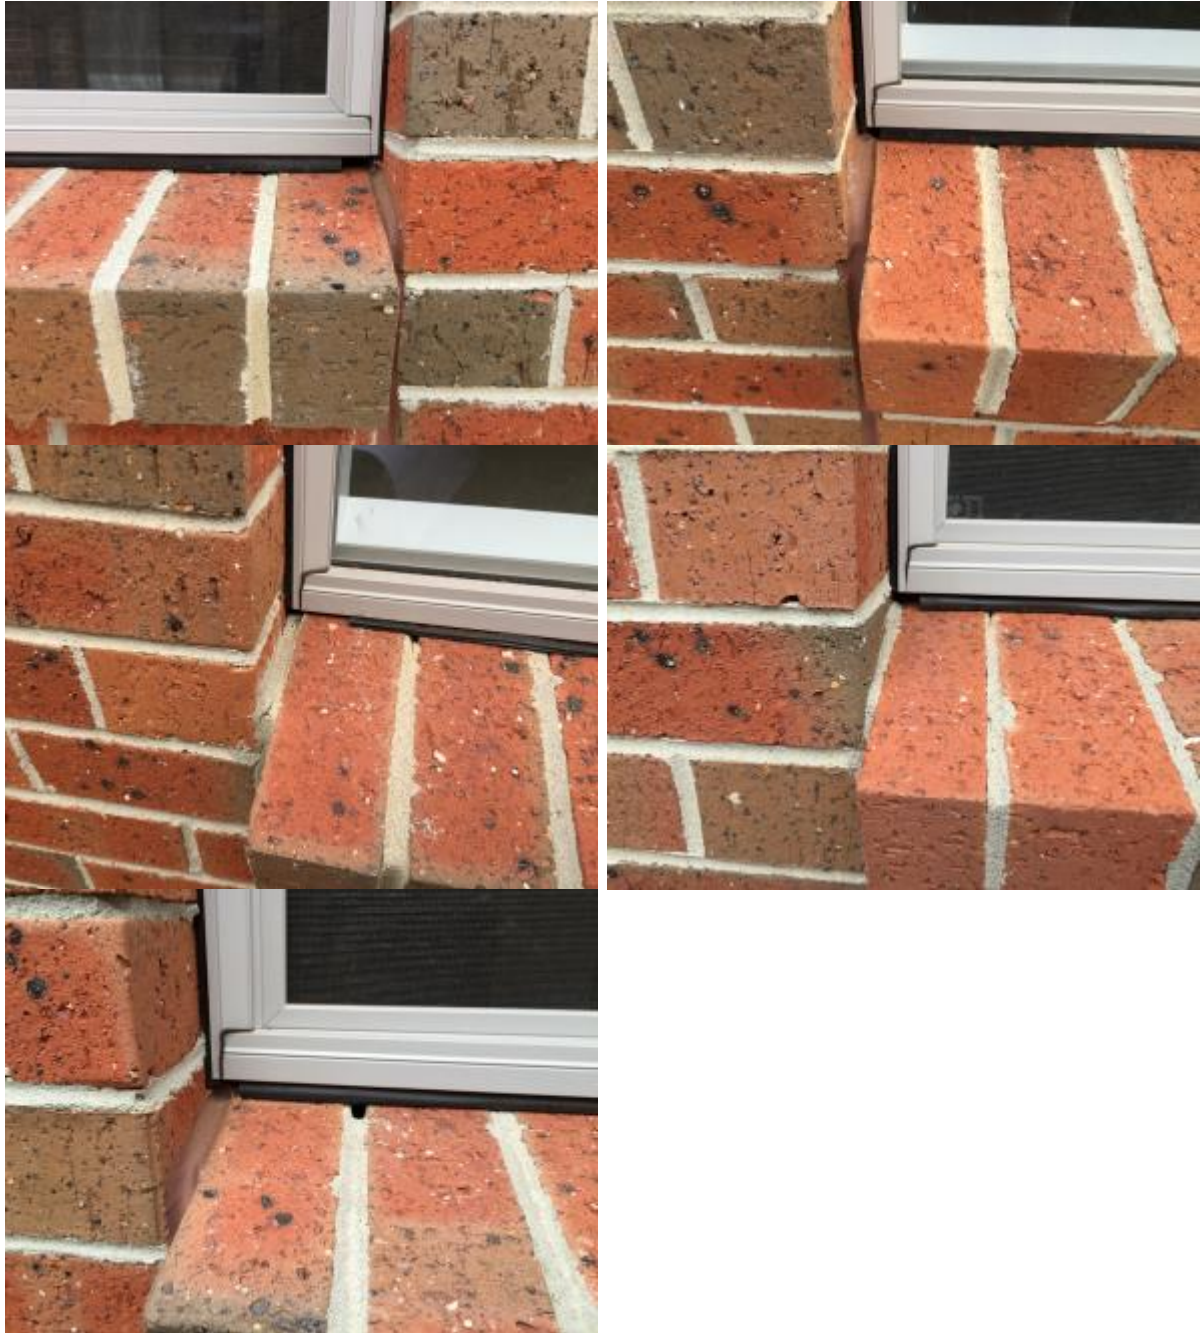
Weather seals run short to South and North elevation windows

Minor Defect

Type: F

Builder will apply to caulking compound the seal gaps.

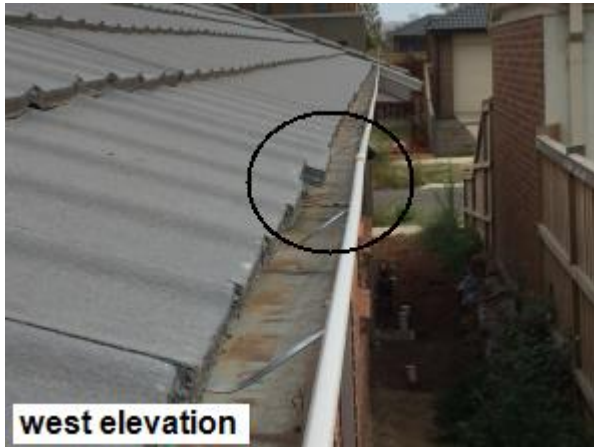
Roof - Roof Exterior

Roof tiles Some roof tiles need re-seating Minor Defect Type: F

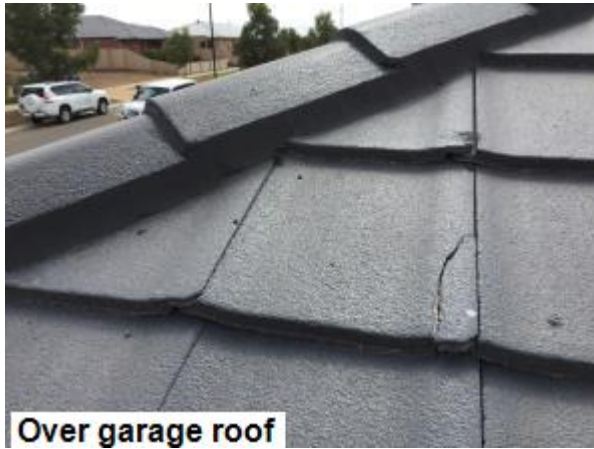
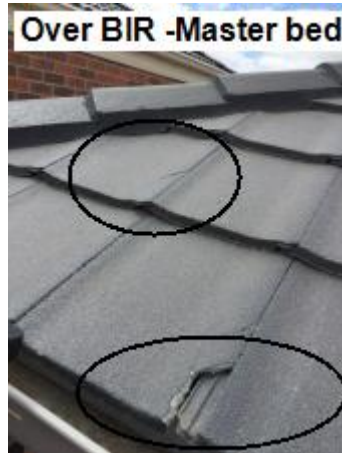
Roof tiles Replace cracked roof tiles Minor Defect Type: A

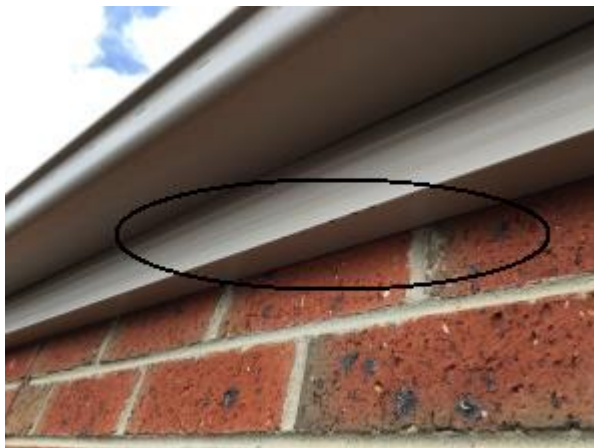
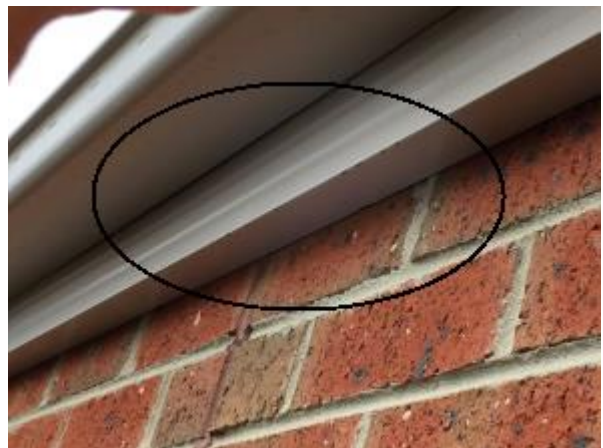
Fascias Damaged paint work to fascia Minor Defect Type: A

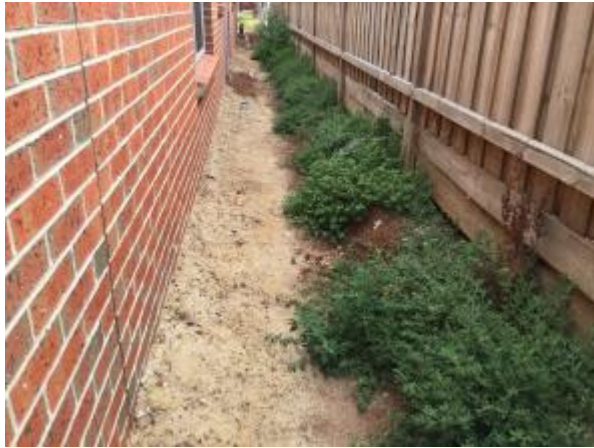
Site - Site Management

Surface water Ground slopes towards building & no provision for drainage Minor Defect Type: F

Also drainage where water flows toward the perimeter of the home may create significant structural movement defects over a period of time. It is highly recommended in agricultural drain be installed below the level of the slab to pick up any subterranean water coming from the neighbouring property stop is also recommended surface drainage points are installed and a perimeter concrete slab or with gradient toward these drainage points.
