Date of inspection: Tuesday, 16 February 2016 11:45 AM

Pre-purchase Inspection Report

Property address	13 Andrew Street NORTHCOTE VIC 3070	
Report prepared for	John Sample 709/5432 Church Street RICHMOND VIC 3121	
Client's contact details	Mobile	4932 987 654 joenoto@netscape.com.au
Real estate agent's details	Name	Ben
	Company	Hocking Stuart
	Mobile	0430 457 234
Type of inspection report	Standard Inspection, Defect Only	
Persons present	Client, Agent's Representative, Pre-purchase Building Inspector, Pre-purchase Pest Inspector	
Weather conditions	Fine	
Inspector	Joe Noto, Bachelor Applied Science (Construction Mgt) (Economics) Registered Building Practitioner - Domestic Builder - Unlimited DB-U 28857

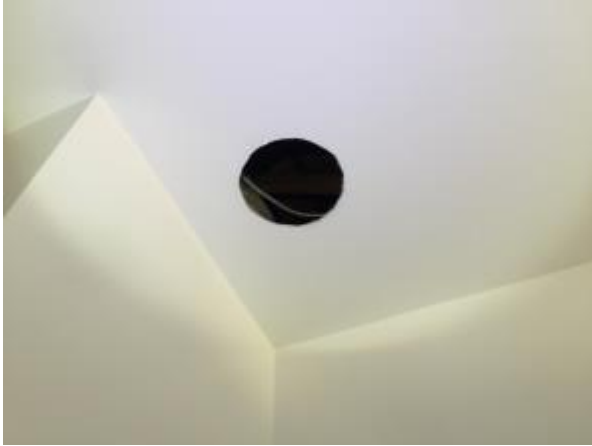
Missing exhaust fan and cover

Minor Defect

The installation of an exhaust fan is highly recommended.

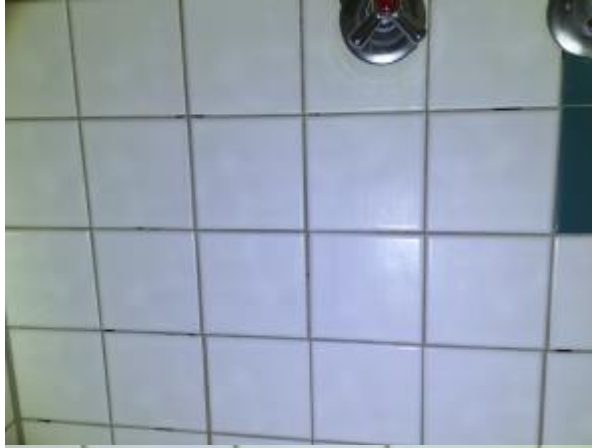
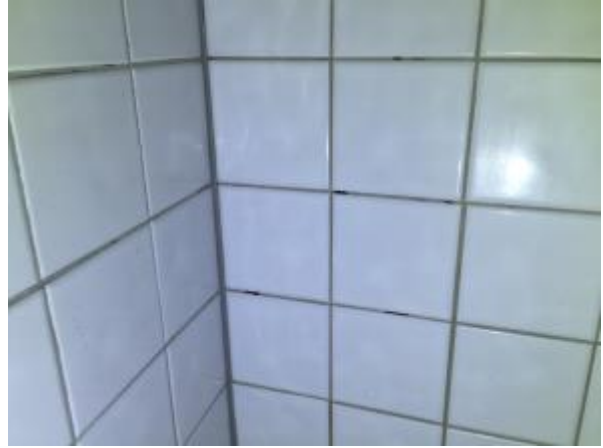
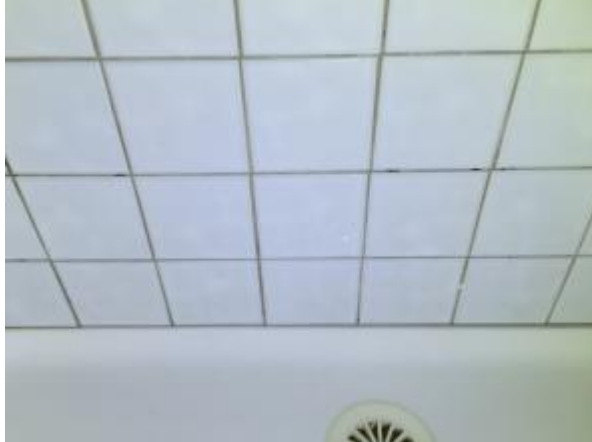
Shower tiles

Grouting gapped

Occurs to the shower to the laundry. It is highly likely a moisture proof membrane has not been applied to the shower walls & floor prior to tiling and over time water seepage into the wall cavity may have occurred - an invasive inspection of the sub-floor and wall cavity in the is required to determine extent of any potential damage.

Occurs to the shower to the laundry. It is highly likely a moisture proof membrane has not been applied to the shower walls & floor prior to tiling and over time water seepage into the wall cavity may have occurred - an invasive inspection of the sub-floor and wall cavity in the is required to determine extent of any potential damage. It is recommended tiles are re-grouted, silicone sealant applied to tile junctions and an epoxy resin applied to the surface to seal the grout.

It is recommended tiles are re-grouted, silicone sealant applied to tile junctions and an epoxy resin applied to the surface to seal the grout.

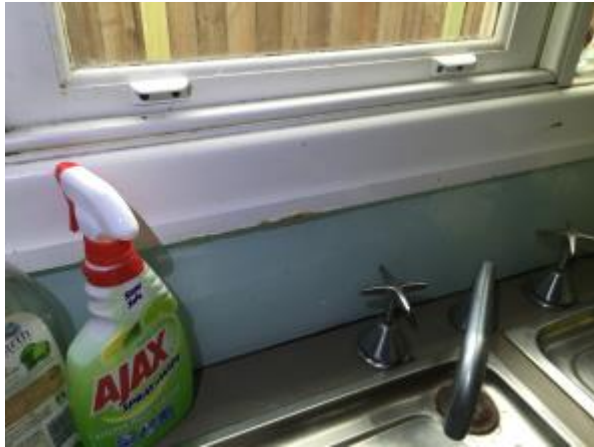
Windows Water damage to window architrave Minor Defect Type: C, D

Do not sand back architrave as it is likely have made from a hazardous material. Replacement is recommended.

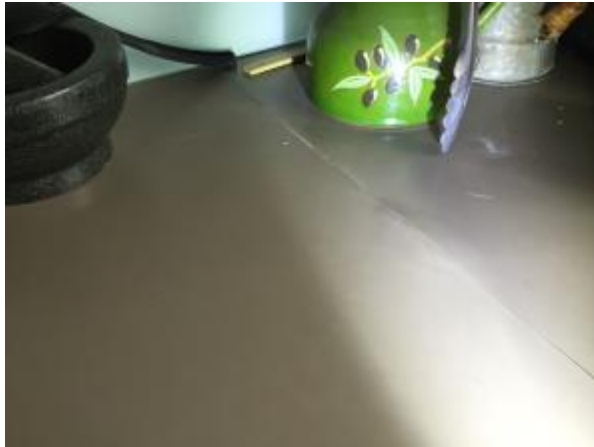
Bench top

Water damage

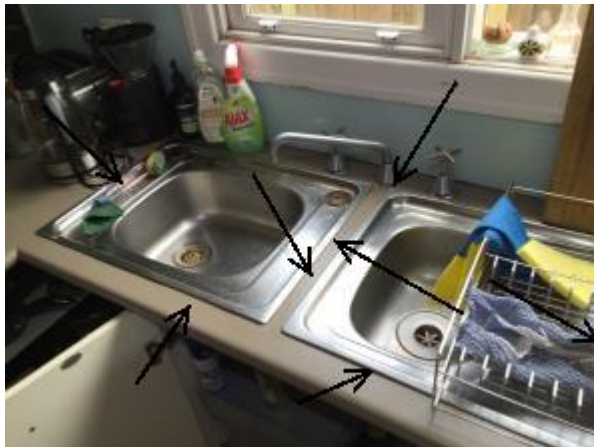
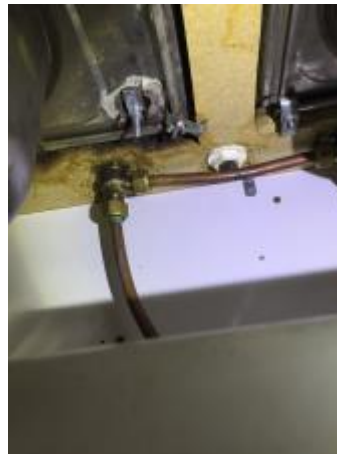
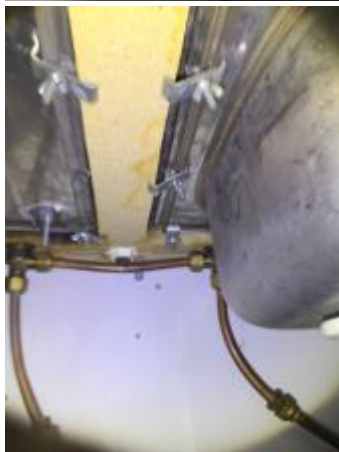
Bench top

Water leakage to the underside of
benchtop

Apply sealant to bench top / sink junction to prevent water flow into concealed areas. The benchtop is suitable until the renovation begins. The

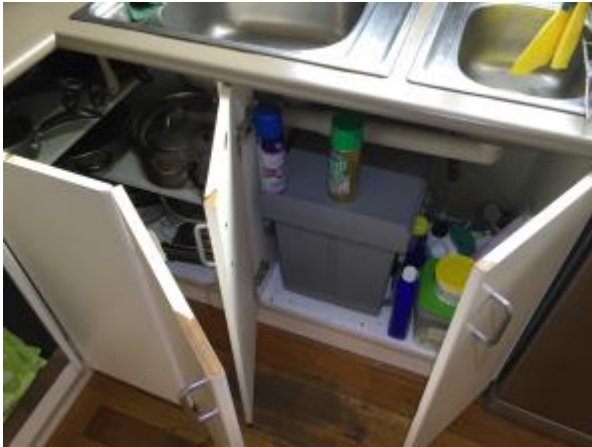
Cupboards

Water damage

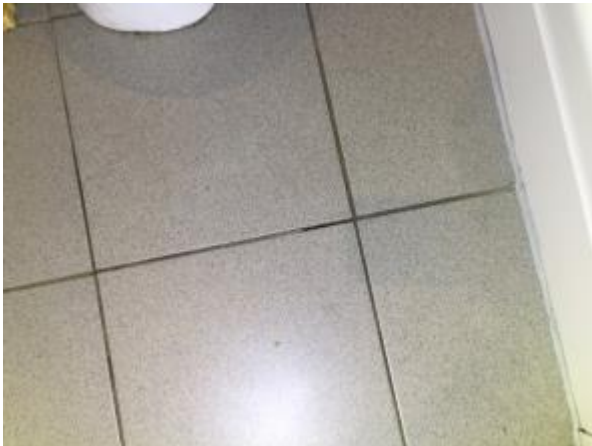
Floors

He may have occurred as a result of movement through the foundations or as a result of poor installation. Re-application of grout required.

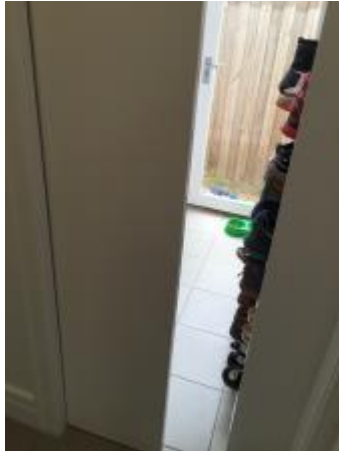
Missing the door hardware to sliding door

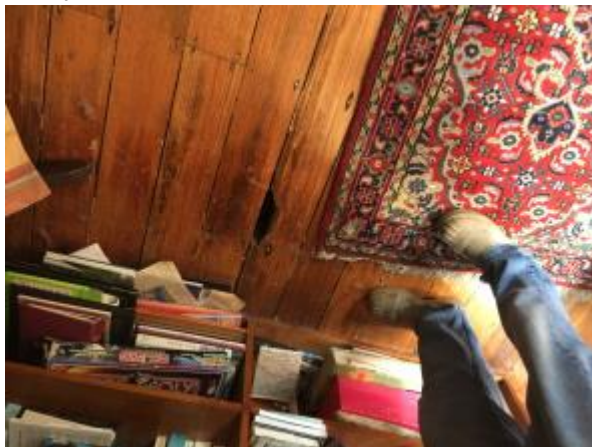
Floors

Damage

Replace floorboard.

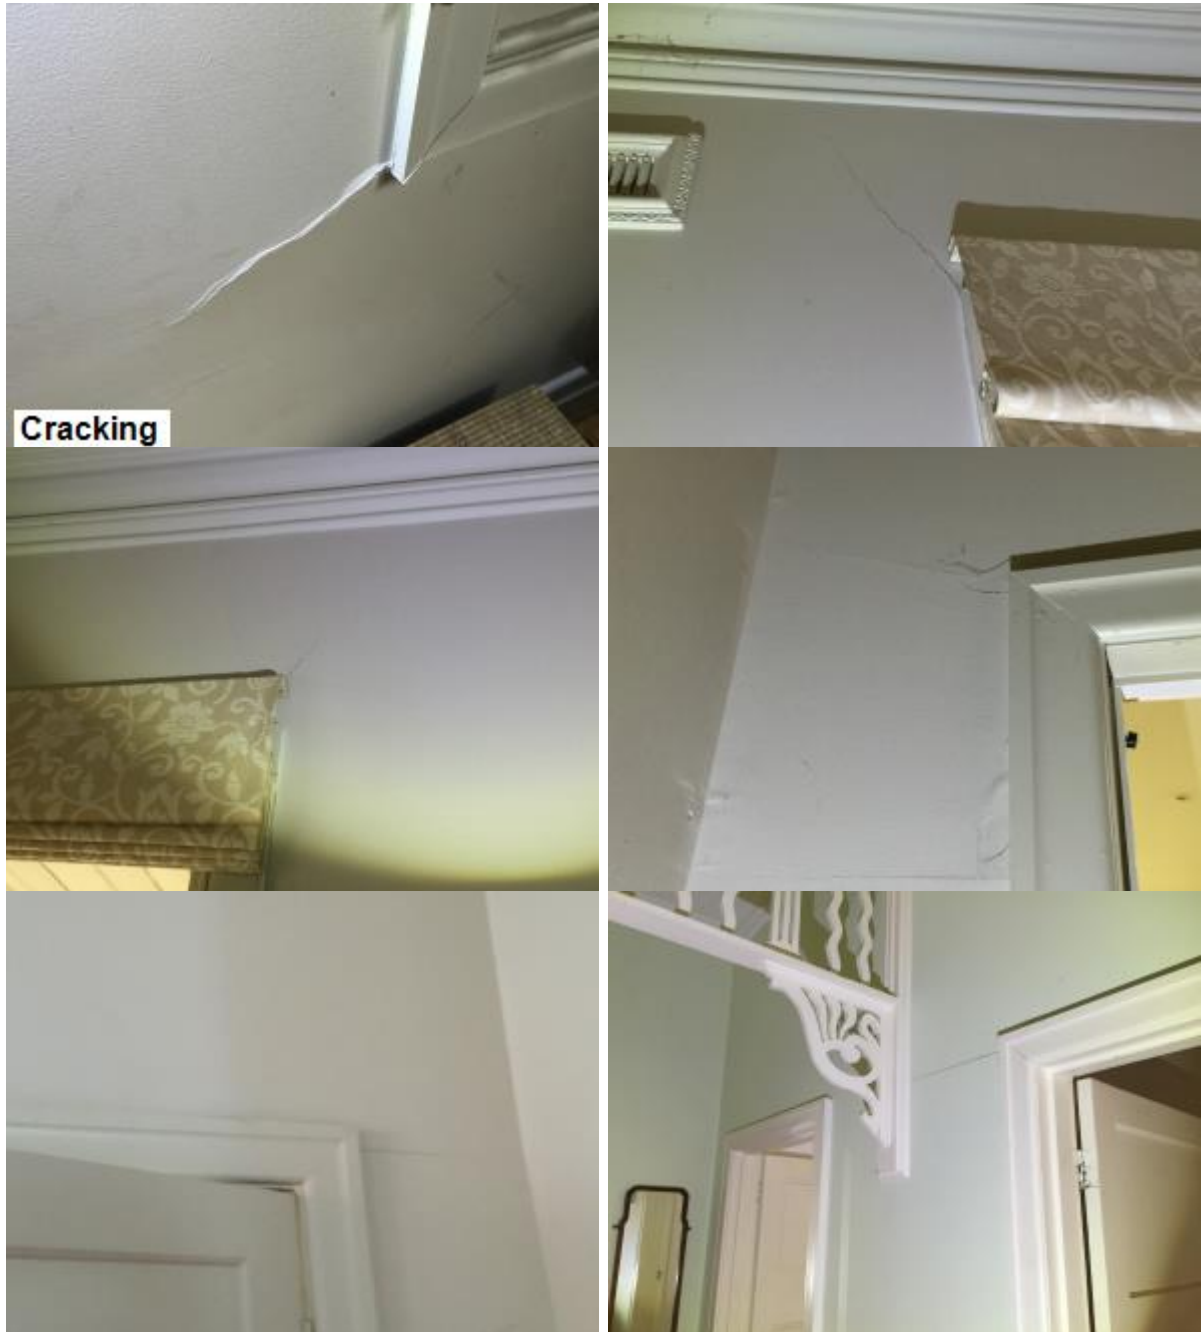
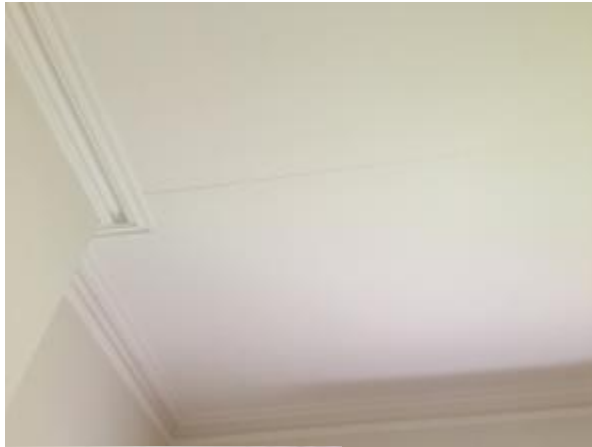
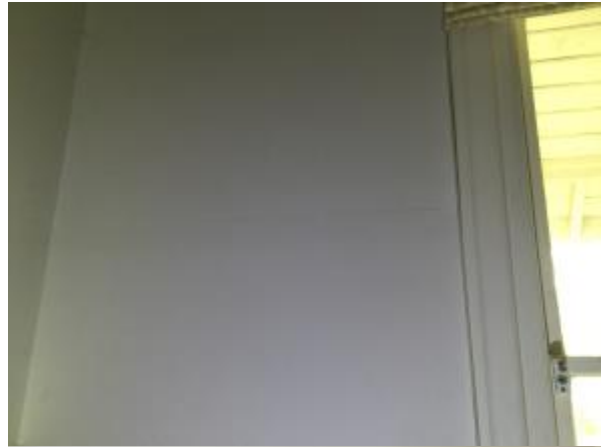
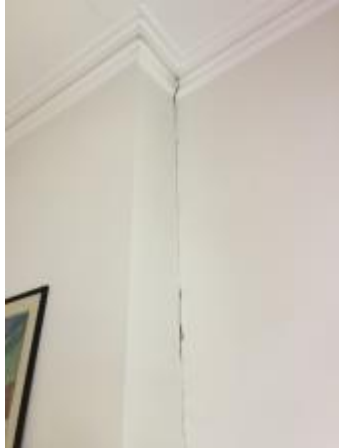
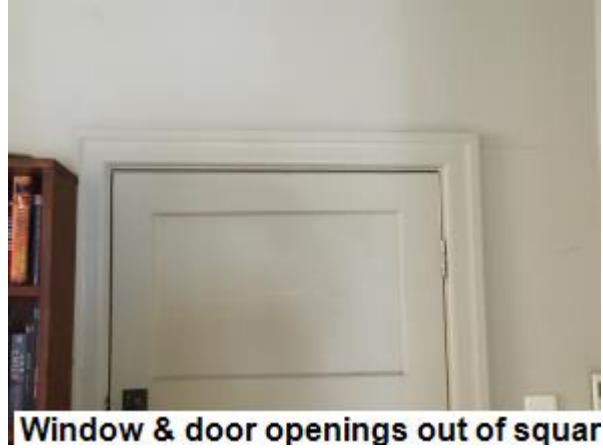
Internal movement defects

Various movement defects including the following have occurred as a result of foundation movement (ground movement) causing movement of the floor and therefore the wall and roof structures;

- 1. Cracking to various walls and ceilings - patching and painting required.*
- 2. Flooring significantly out of level - re-stumping has previously been carried out although re-levelling of the sub-floor structure was not.*
- 3. Window and door opening's out of square - adjustments of various windows and doors required to enable proper operation.*
- 4. Ceilings out of level - no action required other than to monitor over time.*

It is highly recommended an invasive inspection of the sub-floor is carried out prior to making the

Rectification of poor site drainage the poor ventilation to the sub-floor area is required prior to rectifying in the movement defects.

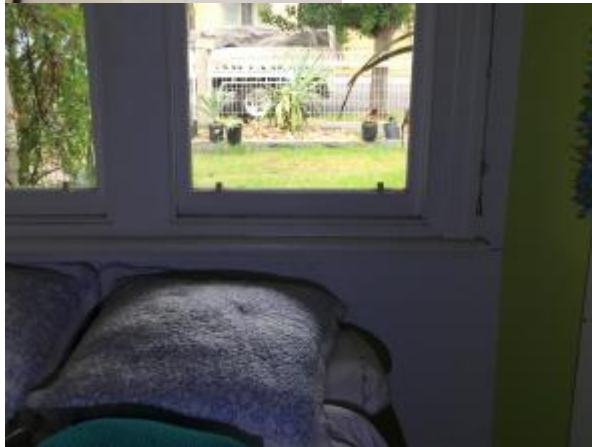
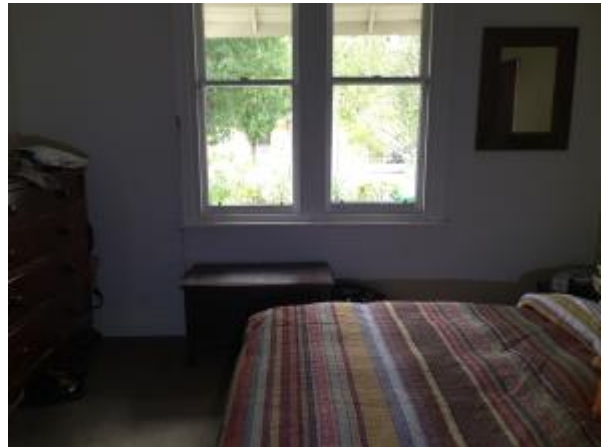
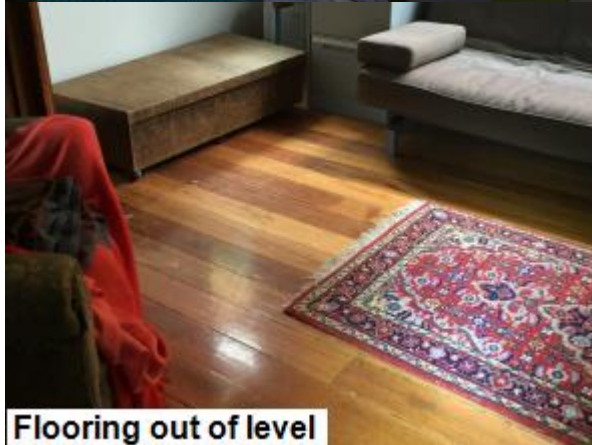
Window & door openings out of squar

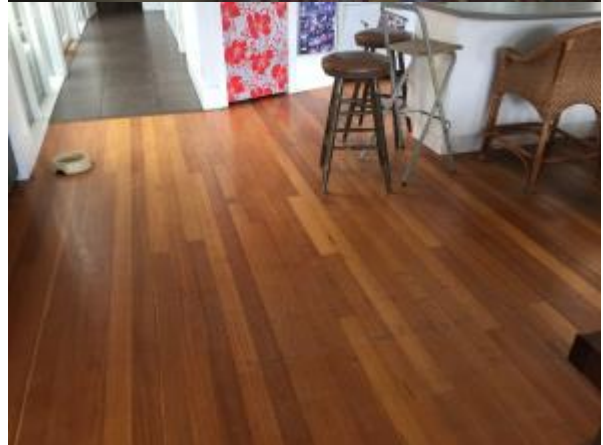
Flooring out of level

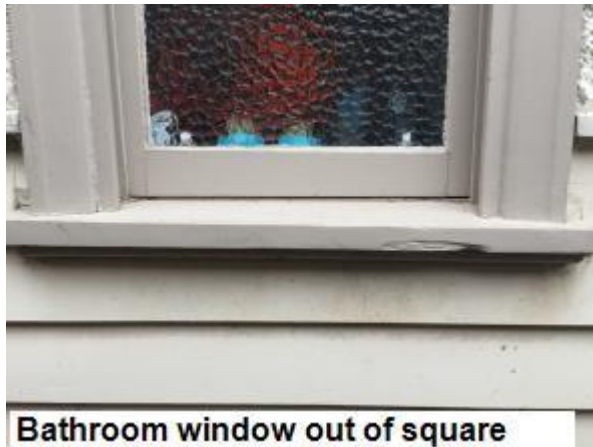
Bathroom window out of square

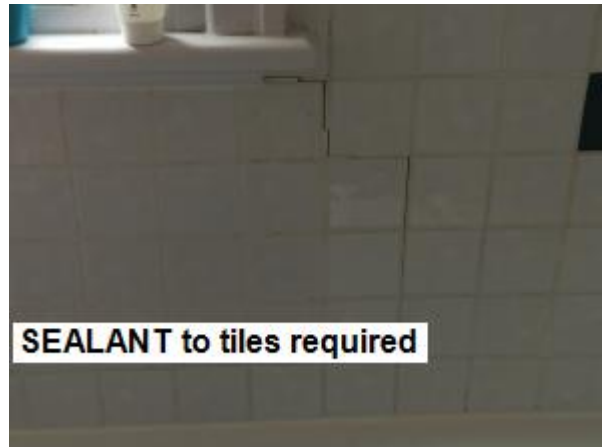
SEALANT to tiles required

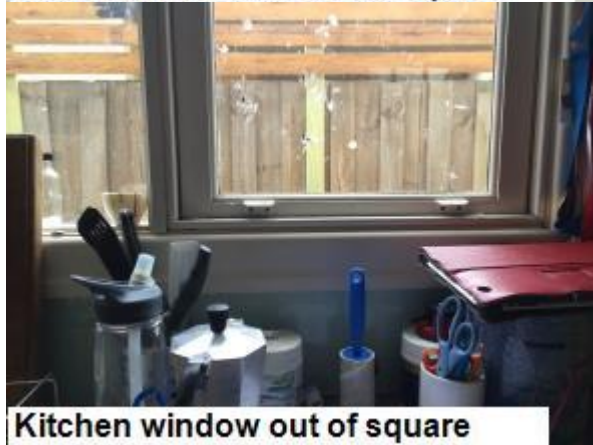
Kitchen window out of square

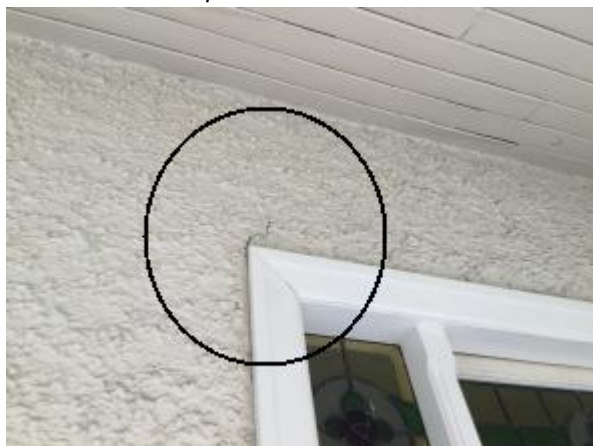
Minor cracking

Has occurred as a result of subsidence of the foundations. Further movement may occur as moisture content in foundations changes through changing weather conditions. Regular monitoring is required over time and should further significant movement occur, further inspection should be carried out.

An invasive inspection of the sub-floor is recommended to make further accurate determination.

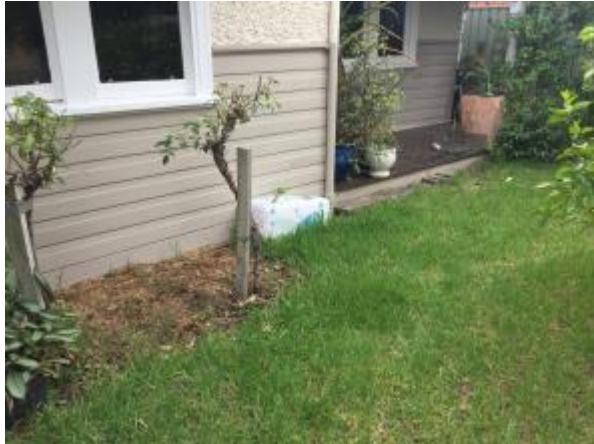
Under floor ventilation Insufficient under floor ventilation Minor Defect Type: F

It is recommended the bottom weather board is removed to enable better air flow through the sub-floor area. This will create dry conditions throughout the sub-floor.

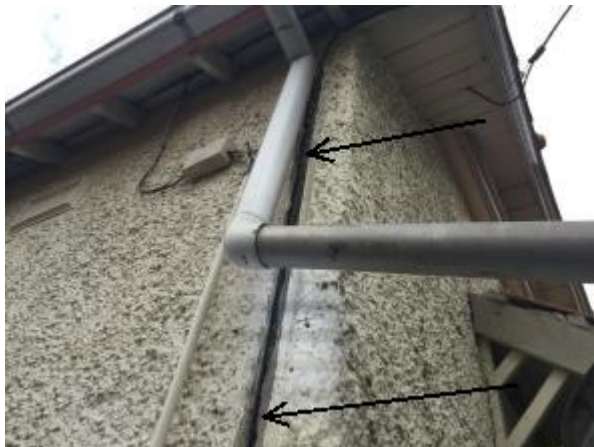
Walling Exposed wall cavity Minor Defect Type: F

Has occurred as the original down-pipe has been replaced. Application of stucco render required to prevent water flow into the wall cavity.

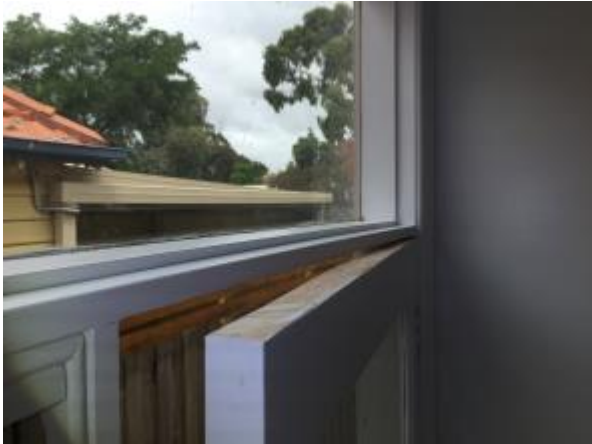
Painting of top and bottom edges of external timber doors is required to prevent decay

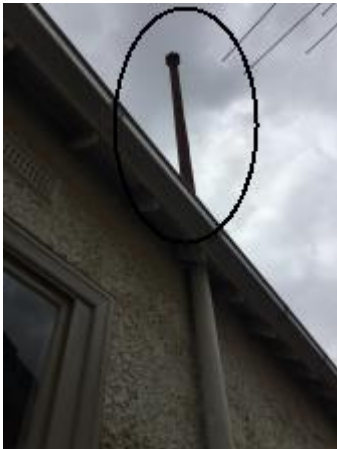
Surface corrosion to vent pipe above roof level

Re-painting required.

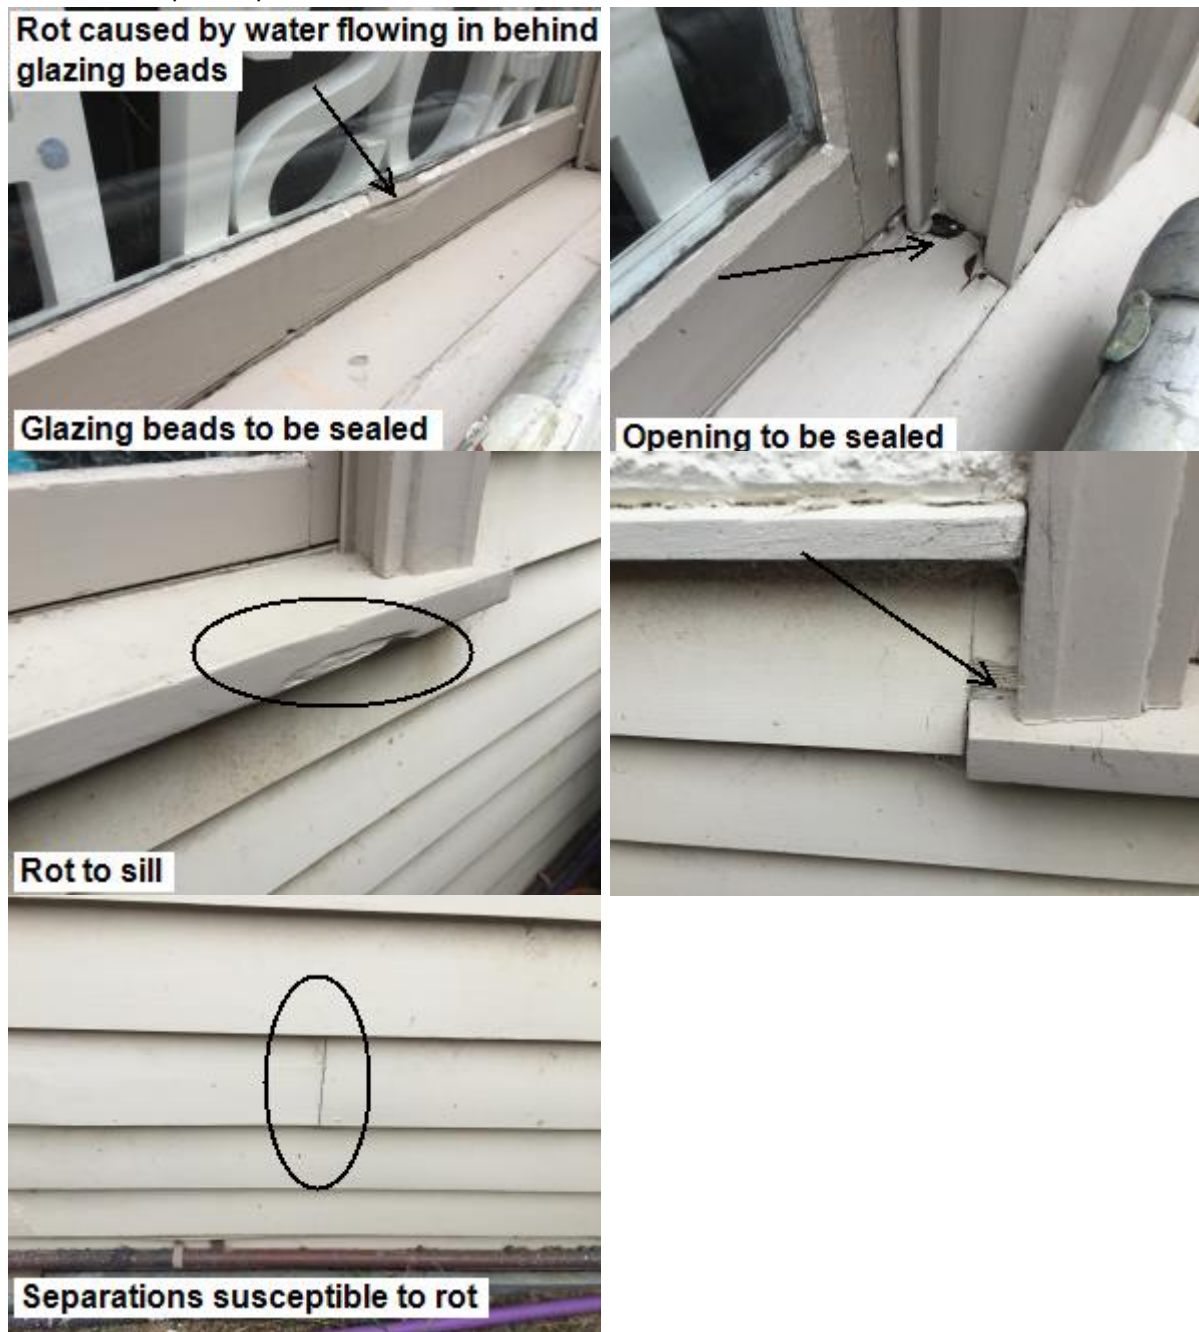
Rot & timbers susceptible to rot

Application of sealants, paints or flashings required to protect external timbers from moisture ingress to prevent further decay/rot to exposed timbers.

All timber glazing beads to external window faces require sealant to prevent further decay.

All non-treated timber in contact with the ground should be replaced with treated timber to prevent rot and damage.

Any rotted timber should be removed and patched / painted.

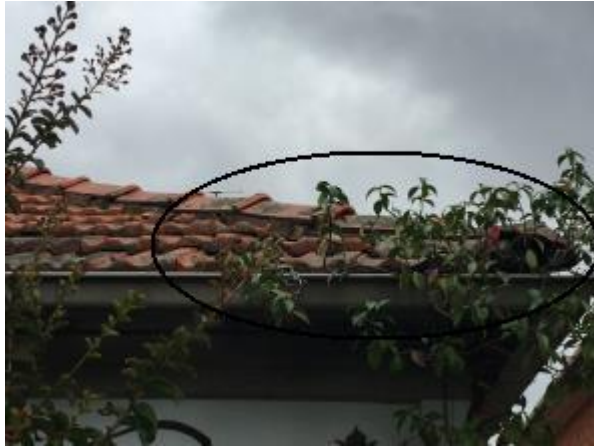
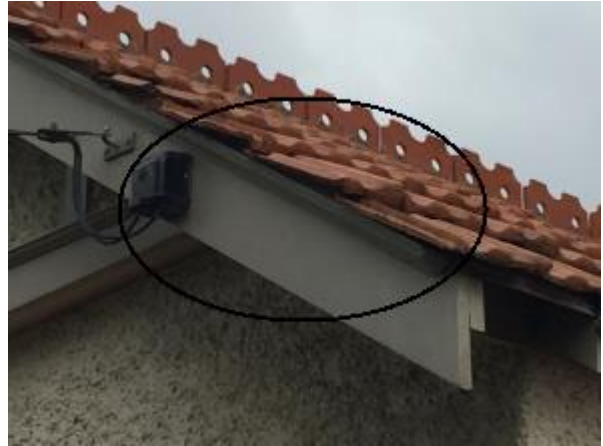
Roof tiles Capping mortar loose/missing Minor Defect Type: A
Re-pointing required to prevent further dilapidation and possible leakage.

Re-pointing required to prevent further dilapidation and possible leakage.

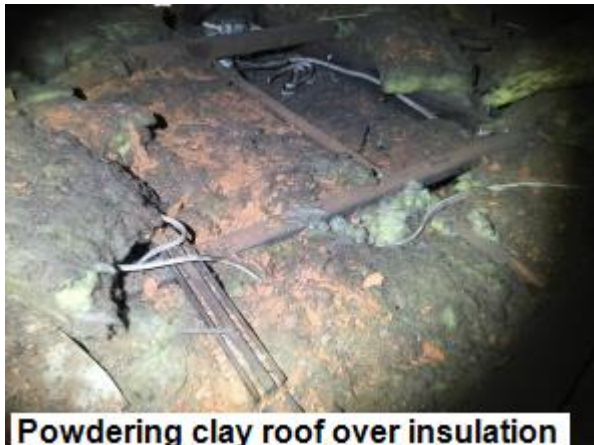
Roof tiles Cracked and decaying roof tiles Minor Defect Type: A, D, C
Complete replacement of roof tiles to the original home is required.

Complete replacement of roof tiles to the original home is required.

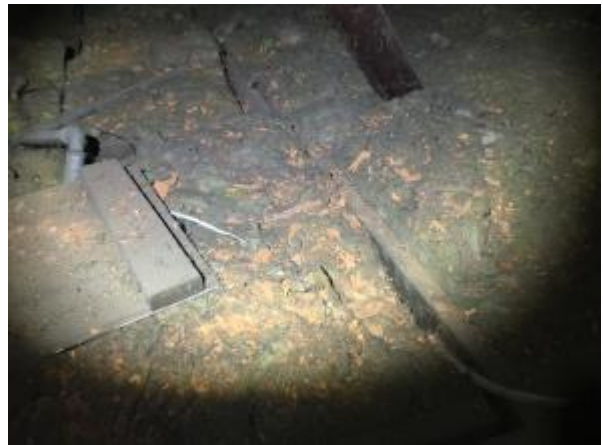
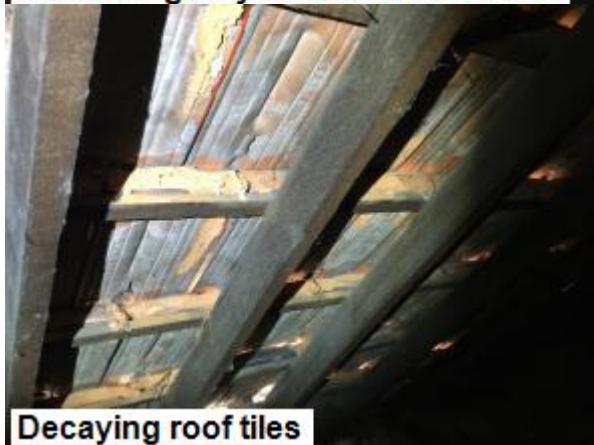
Powdering clay roof over insulation

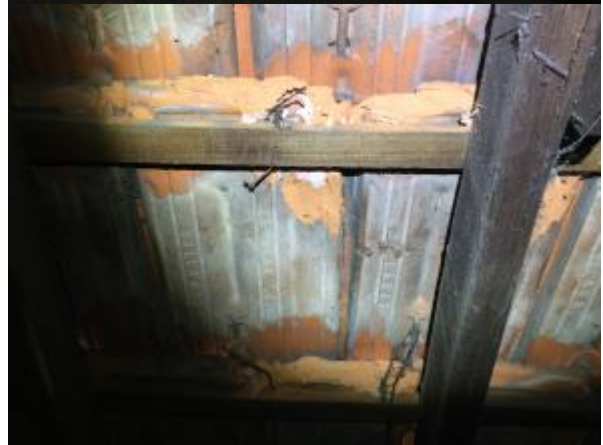
Decaying roof tiles

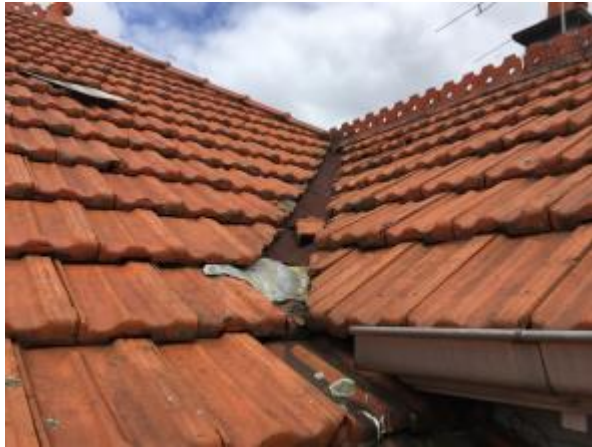
Corrosion in valleys

Application of metal paint required to prevent further corrosion or replace as part of the renovation.

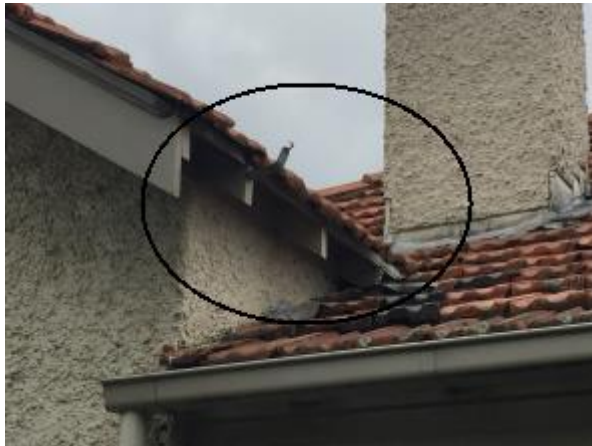
Missing gutter to the front elevation

Guter to be installed.

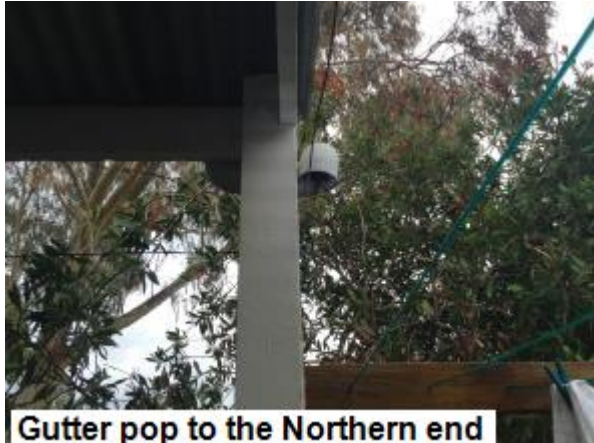
Not connected to storm water system Minor Defect

A storm water point has been installed to pick up the gutter pop to the Northern end of the rear veranda but a down-pipe and other miscellaneous works such as cutting of deck timbers has not yet been carried out. Installation of a down-pipe to the storm water point is required by a licensed plumber. This will prevent water flow into the sub-floor and residual defects such as decay of stumps and structural movement defects over time.

Gutter pop to the Northern end

The gutter point to the opposite end can be capped and the gutter re-installed to fall toward the Northern end.

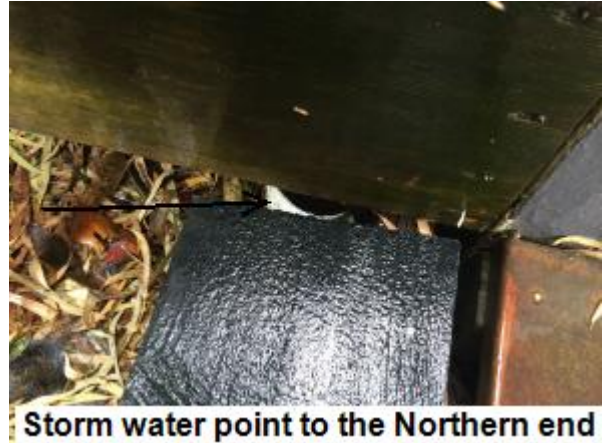
Storm water point to the Northern end

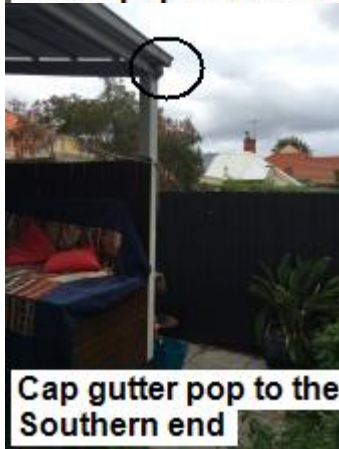
Cap gutter pop to the Southern end

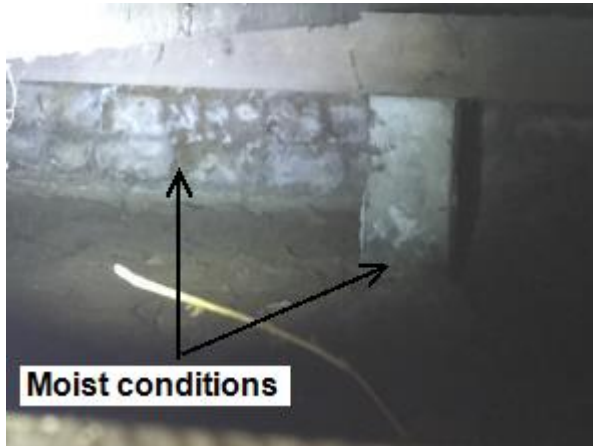
Damp Conditions to sub-floor area

Rising damp to masonry walls and efflorescence to concrete stumps has been recorded. Installation of a concrete slab and drainage points to the South elevation path may prevent water flow into the sub-floor to minimise moist conditions however, an invasive inspection of the sub-floor areas is required to ensure all area's where water seepage may occur are inspected and reported on. For instance, access under the timber deck to the North elevation may reveal water flow toward the sub-floor from the neighbouring property.

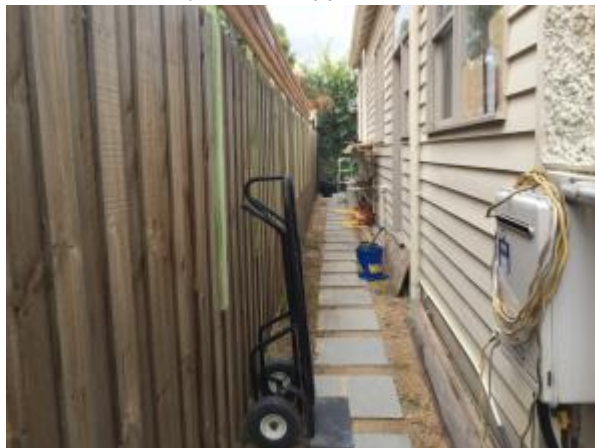
Surface water No grade away from perimeter path edges or provision for drainage Minor Defect Type: F

Poor site drainage occurs to the South elevation where the land slopes and water flows toward the home. Sub-floor structures are significantly affected by poor drainage where structural movement defects to internal and external area's of the home may occur as a result. These defects commonly include cracking to internal linings, separation of architraves, binding doors, movement of floors out of level and more significant structural defects may occur over time or may have occurred to concealed/inaccessible areas - access to the sub-floor area in particular is recommended to determine extent of any defects.

In this case, it is recommended that surface drains are installed and connected to the storm water system. A concrete paving slab is to be poured to fall water toward the drainage points and into the storm water system as opposed to the sub-floor cavity.

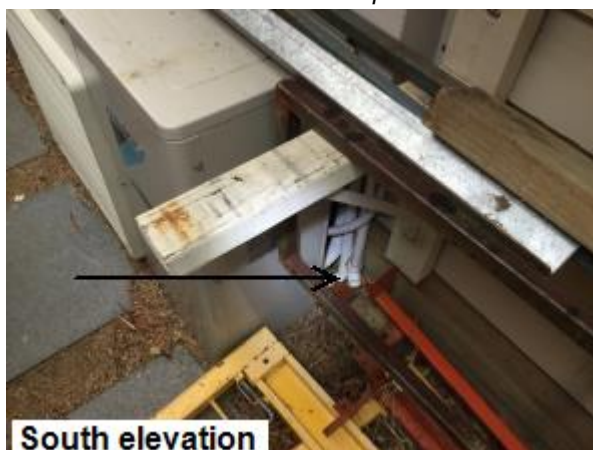
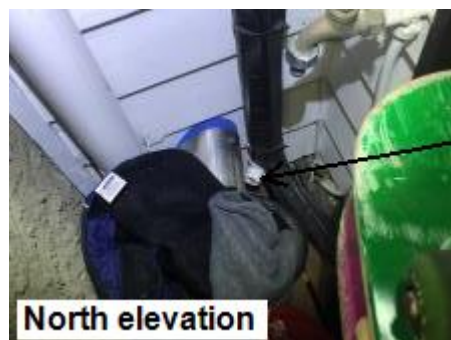
Surface water Airconditioning over-flows fall water direct to the ground & into the sub-floor Minor Defect Type: F

It is recommended over-flows are extended to fall water into the storm water system as opposed to the sub-floor area where damp conditions and structural movement defects can occur as a result.

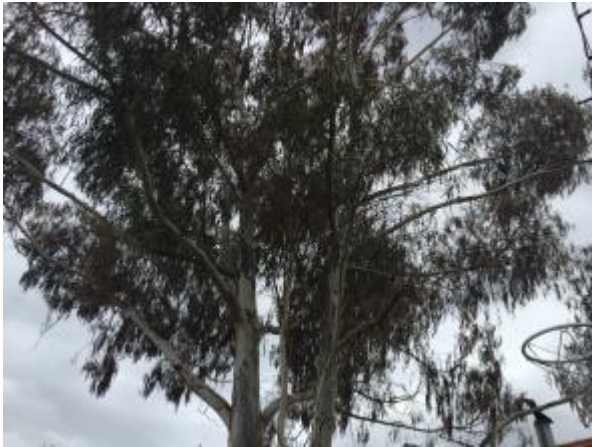
Dry leaves to gum tree at backyard

Arborist to determine health of tree.

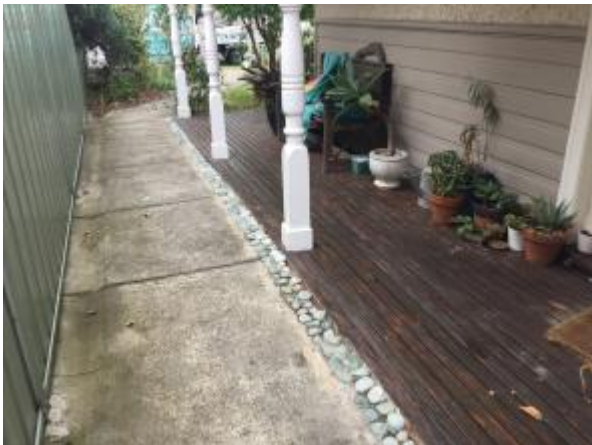
Pathways

An invasive inspection of the sub-floor is recommended to accurately determine cause for movement.

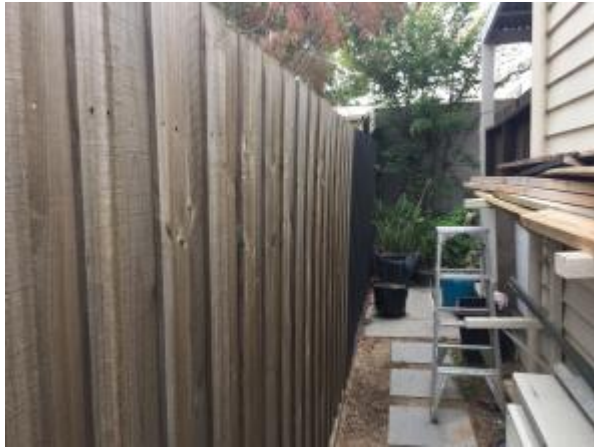
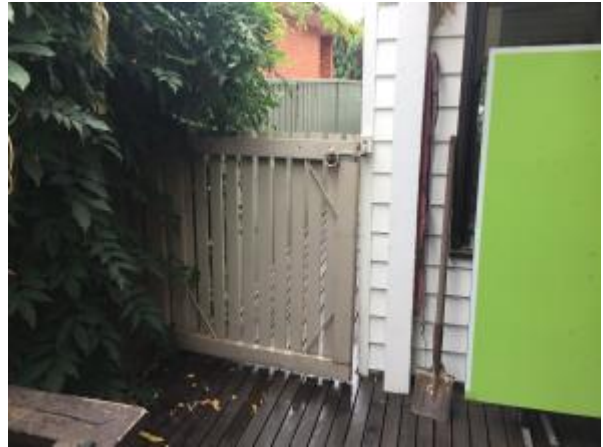
Fencing not in good alignment

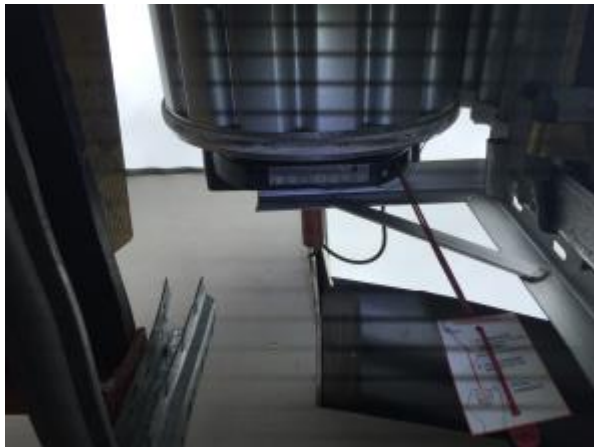
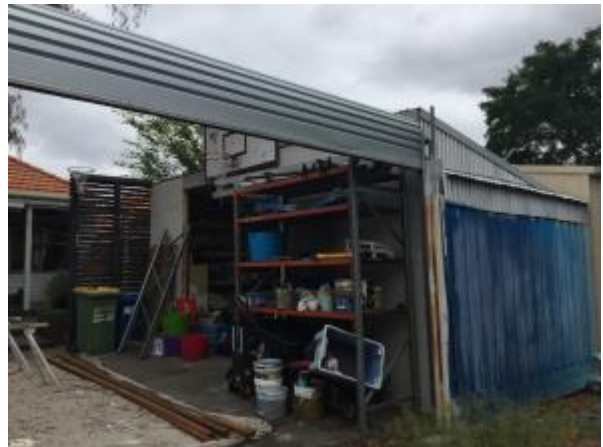
Electric roller door manual pad does not operate

The roller door worked with the use of the remote. Contact the roller door manufacturer for further advice.

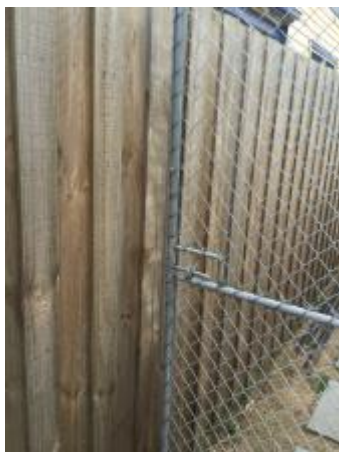
Missing lock/latch to side gate

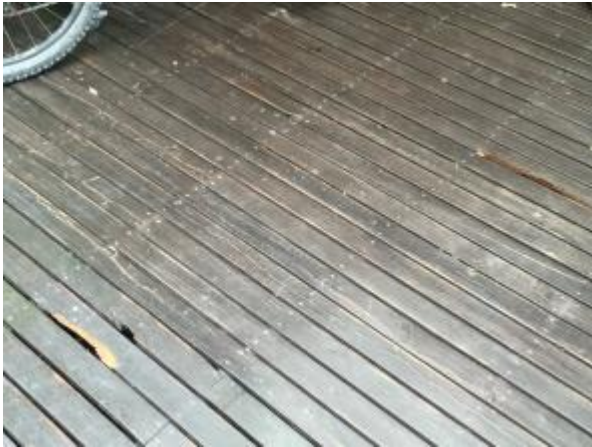
Damaged decking timbers

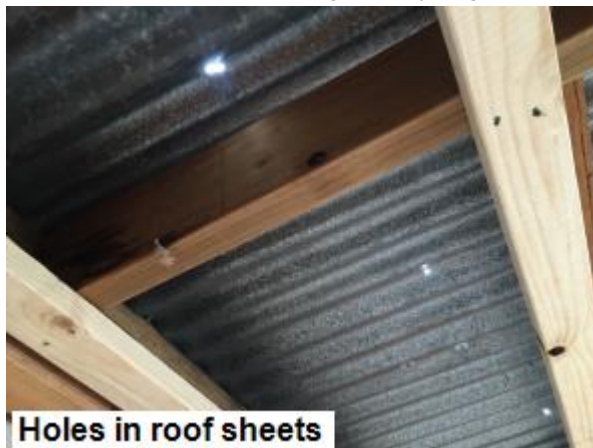
Holes in roof sheets

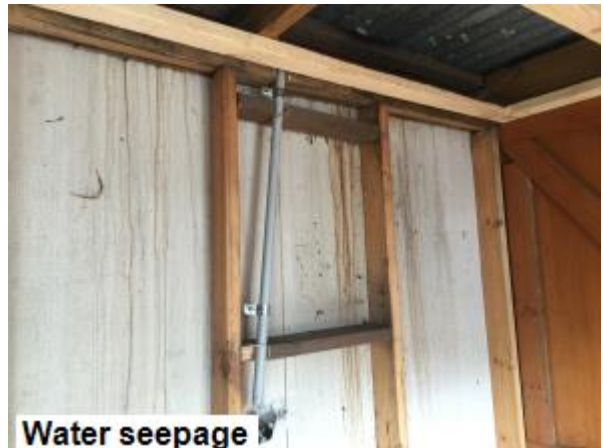
Water seepage

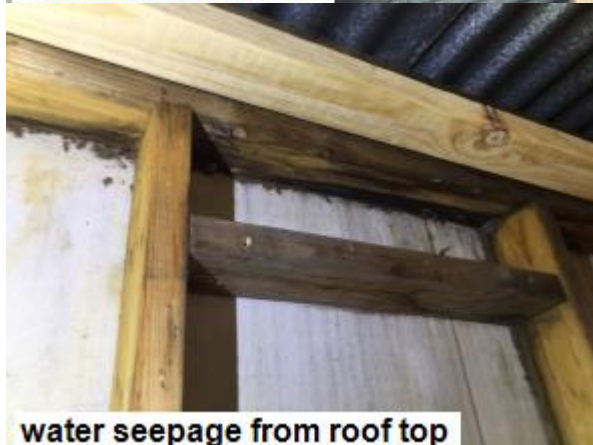
water seepage from roof top

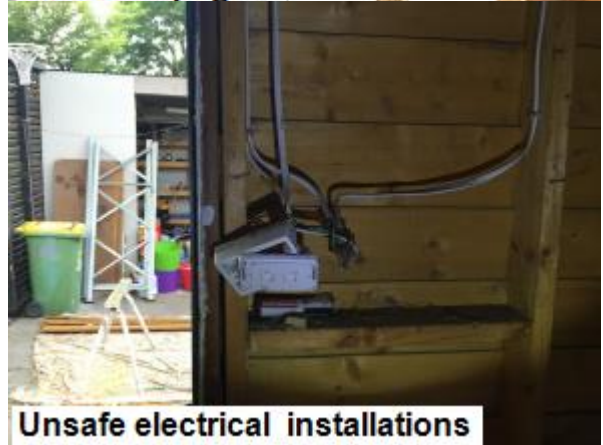
Unsafe electrical installations

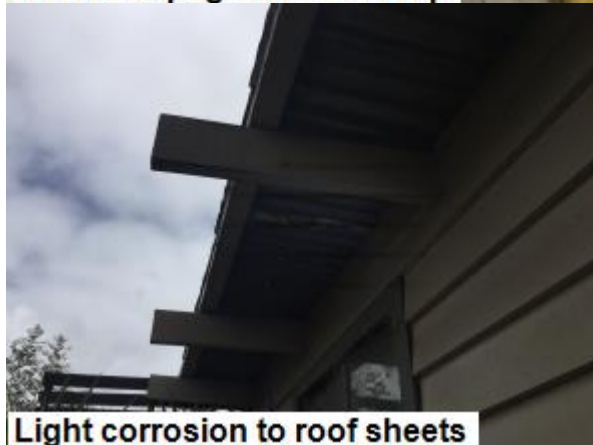
Light corrosion to roof sheets

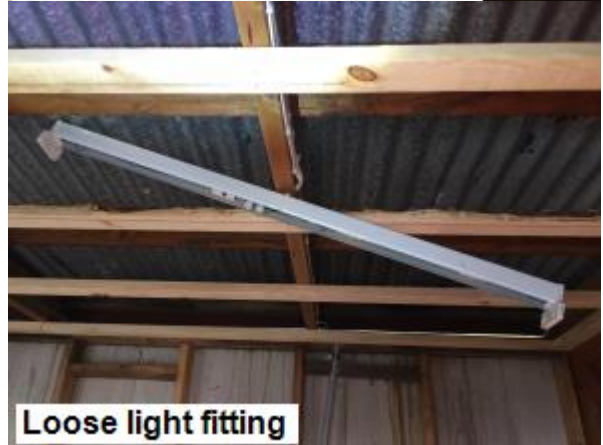
Loose light fitting
