Date of inspection: Thursday, 18 February 2016 12:00 PM

Pre-purchase Inspection Report

Property address	252 Woodland Street STRATHMORE VIC 3041
Report prepared for	Sample Jessup 42 Sample Street KENSINGTON VIC 3031
Client's contact details	Mobile 3456 740 916 sarh.sample@optusnet.com.au
Real estate agent's details	Name Lara Company Brad Teal Mobile 0433 211 268
Type of inspection report	Standard Inspection, Defect Only
Persons present	Vendor, Pre-purchase Building Inspector, Pre-purchase Pest Inspector
Weather conditions	Fine
Inspector	Joe Noto, Bachelor Applied Science (Construction Mgt) (Economics) Registered Building Practitioner - Domestic Builder - Unlimited DB-U 28857

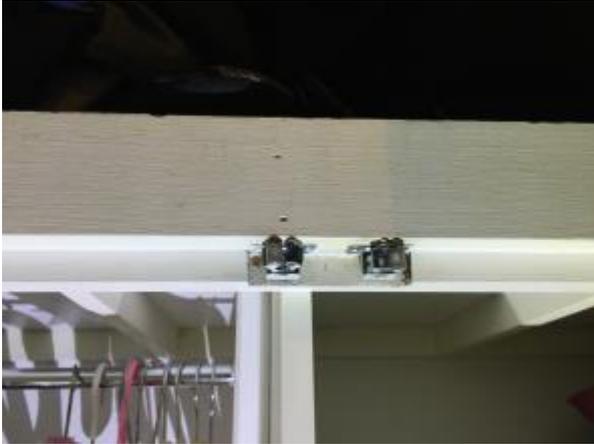
Built in robe/cupboard Defective door hardware

Minor Defect

Type: A

Replacement of various door catches required.

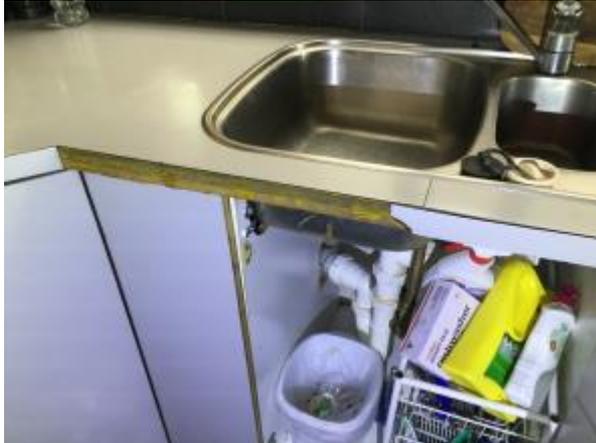
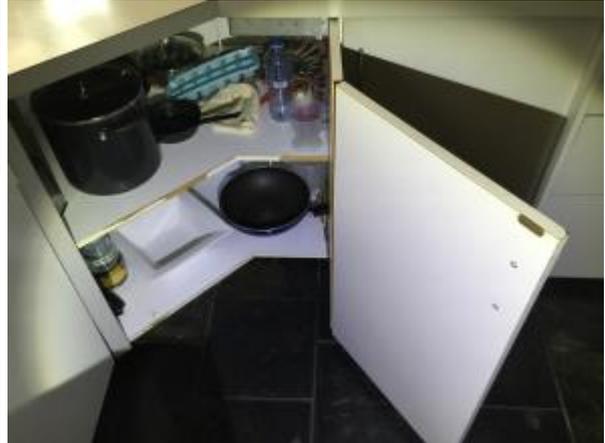
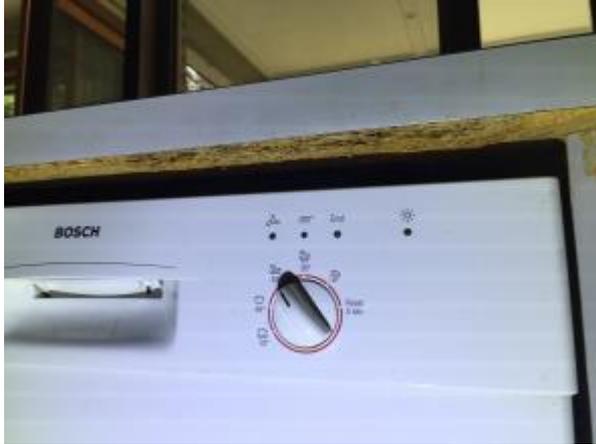
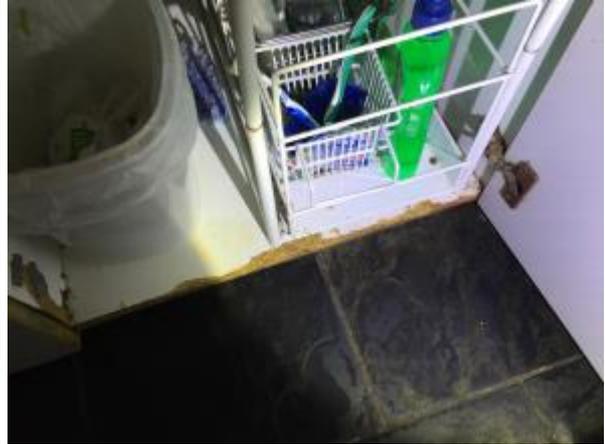
Cupboards

Water damage to cupboard doors and Minor Defect shelving

Type: D, C

Further contact with moisture will result in decay.

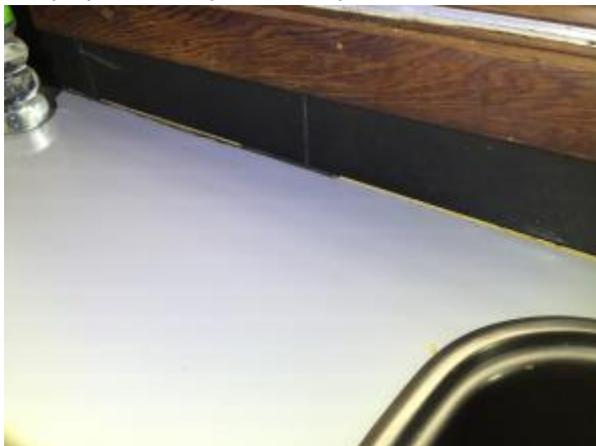
Cupboards

Lateral movement of the kitchen bench and cupboards away from the rear wall

Minor Defect

Type: A

It is recommended the covenant is fixed to the wall to prevent further movement over time particularly whilst tenants are occupying the property. To a consumer can then be applied to the bench top/splashback junction to prevent water flow into concealed areas.

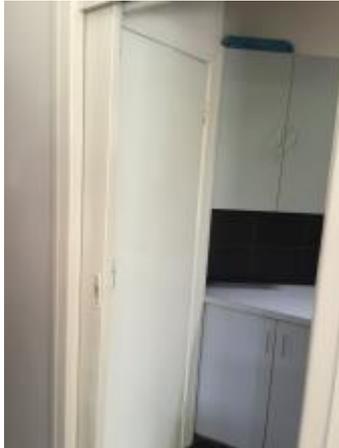
Doors and frames Loose or badly fitting doors Minor Defect Type: E
Adjustment of sliding door required.

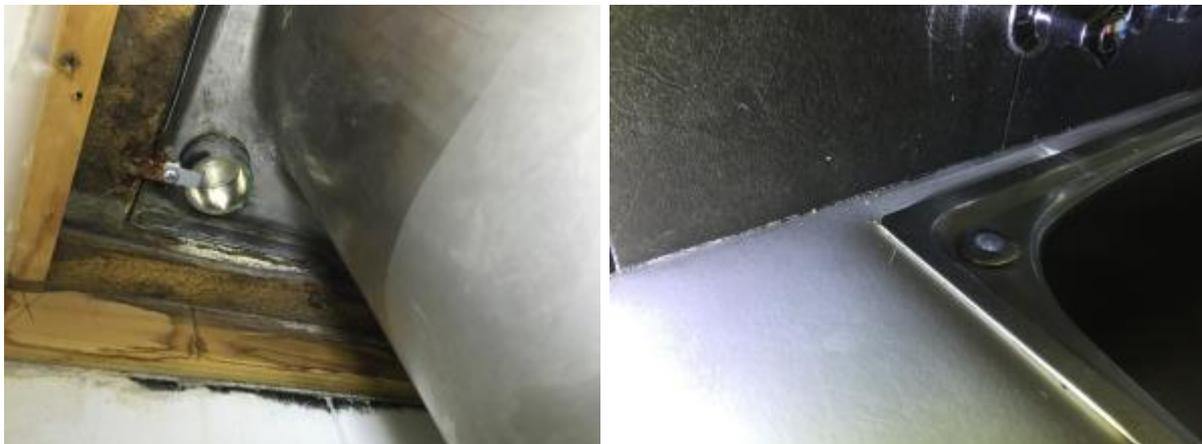
Bench top Water damage Minor Defect Type: D
Sealant around the perimeter of the sink is required to prevent further water penetration. Light rot has occurred although benchtop does not require replacement as a time of the inspection.

Sealant around the perimeter of the sink is required to prevent further water penetration. Light rot has occurred although benchtop does not require replacement as a time of the inspection.

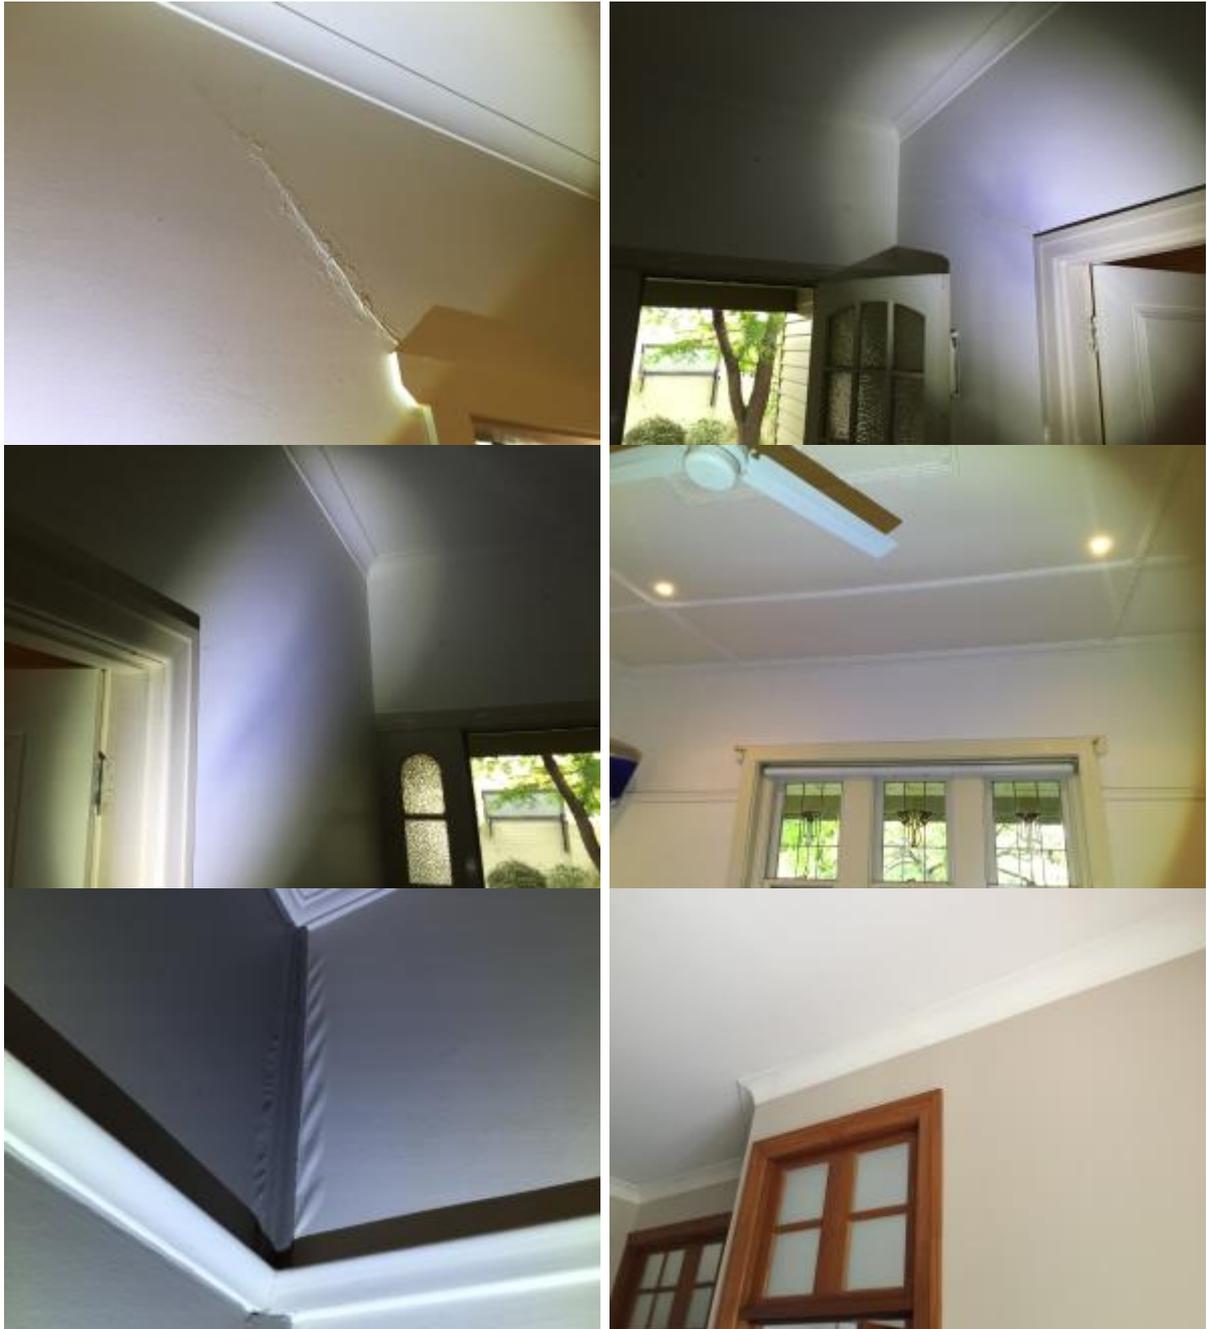
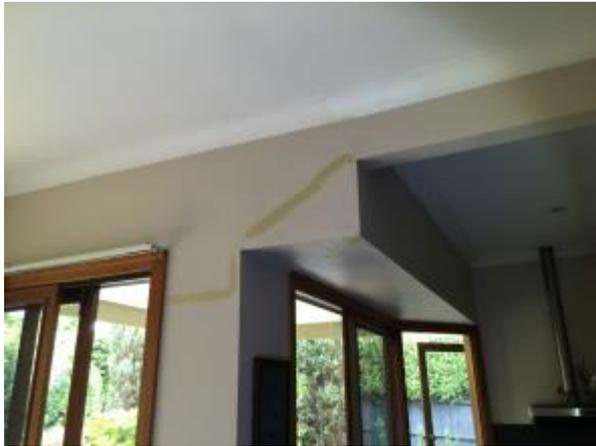
Structural movement defects Various items Minor Defect Type: A

Various movement defects including the following items have been recorded;

These defects have occurred as a result of movement through the foundations most likely as a result of natural movement over time and poor site drainage leading to residual defects such as decay &

- 1. Cracking to walls & ceilings - plasterer to patch cracks in a professional manner ready for paint.*
- 2. Movement of window & door opening's out of square - carpenter to adjust various windows and doors to enable adequate operation.*
- 3. Movement of floors out of level - caused by structural movement of the foundations transferring through stumps and therefore sub-floor structures. Re-stumping and re-levelling and is required*
- 4. Movement of various ceilings out of level / bowed ceilings. No action is required other than to monitor over time.*

Rectification of the above mentioned items should only be carried out once site drainage issues have been rectified / an invasive inspection of the sub-floor area has been carried out.

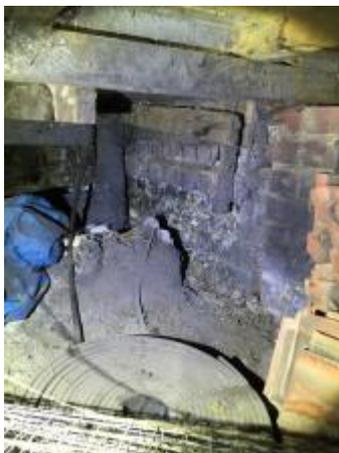
Walling Damp penetration to front wall under entry area Further Investigation Type: C, D

Access under the veranda floor is required to determine current conditions and therefore rectification methods.

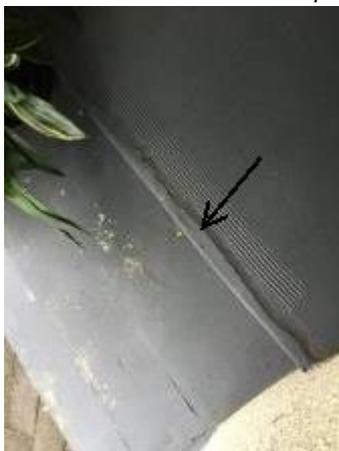
Concrete steps Cracking to concrete steps Minor Defect Type: A

Monitor over time and replace becomes required.

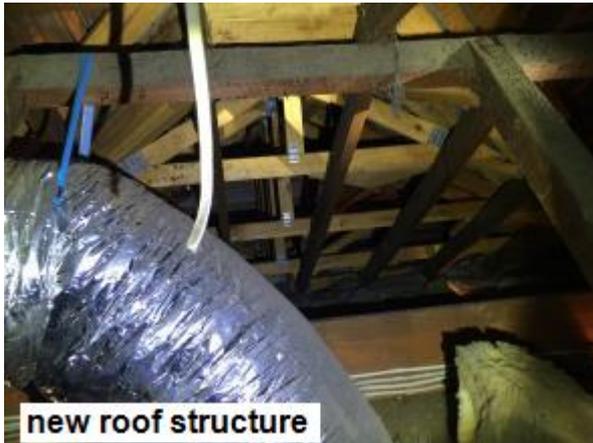
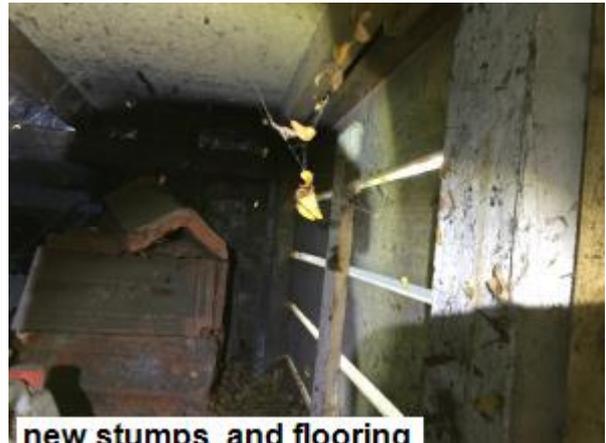
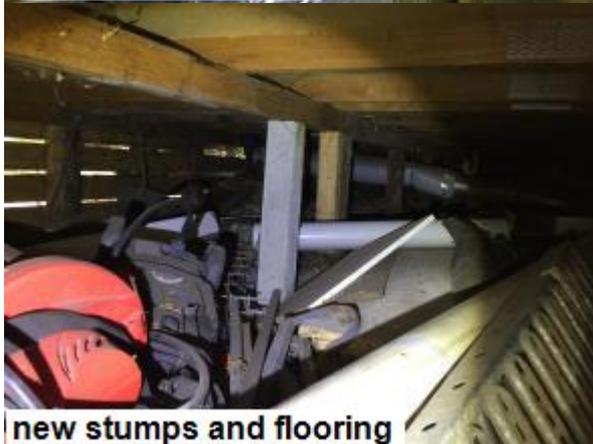
New structure to the front bedroom

Minor Defect

Type: F

New stumps, structural flooring timbers and roof structure have been installed to bedroom one possibly as a result of previous movement. Queries of the vendors are to be made.

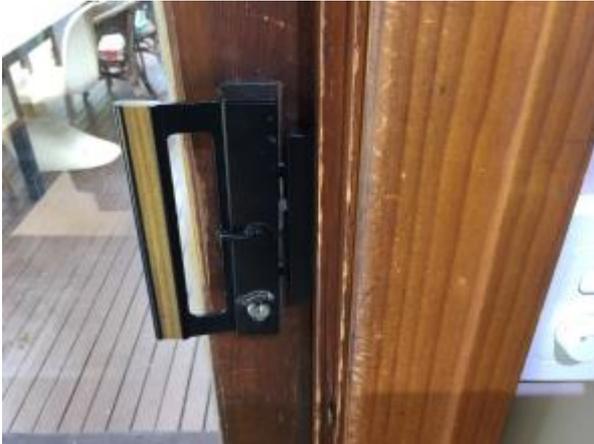
Doors Poor operation of door lock Minor Defect Type: E
Adjustment required.

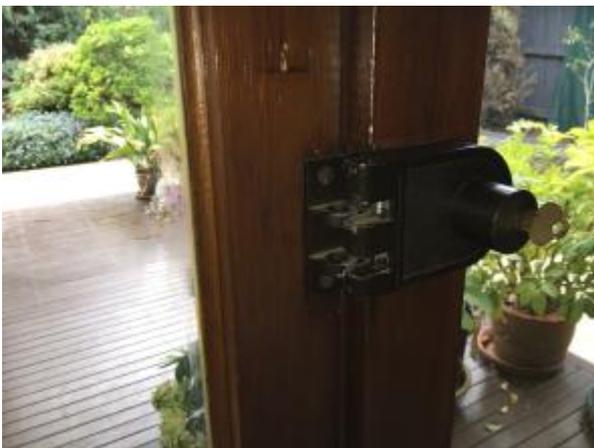
Doors Door opening out of square causing Minor Defect Type: A
all leaves to have moved out of
alignment

Movement has likely been caught as a result of poor site radix to the rear elevation. Refer to the site section of this report for further information. A qualified carpenter will be required to rectify. Currently the door cannot close.

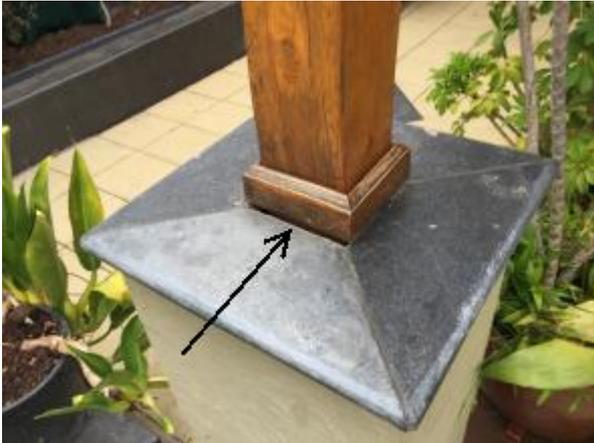
Patio/veranda

Water entry likely to alfresco area
column

Minor Defect

Type: F

Application of silicon sealant required to prevent water flow into concealed area.

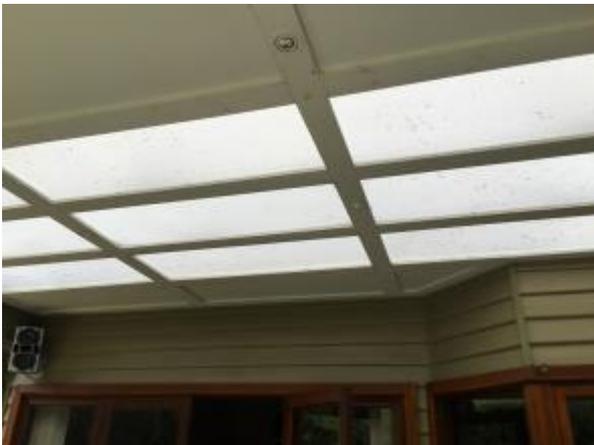
Patio/veranda

Damaged skylight panel

Minor Defect

Type: A

Replacement is not essential.

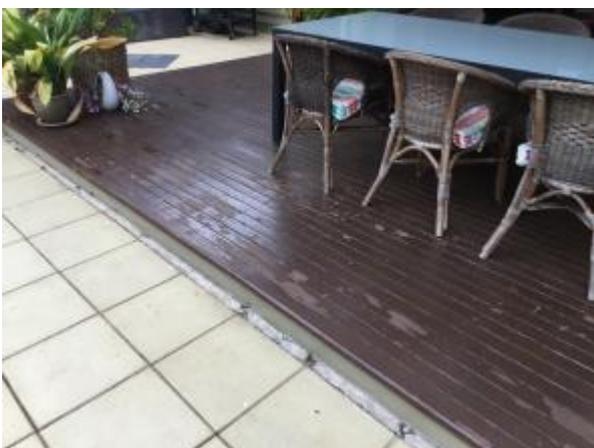
Patio/veranda

Decking timbers to be repainted to
prevent decay over time

Minor Defect

Type: E

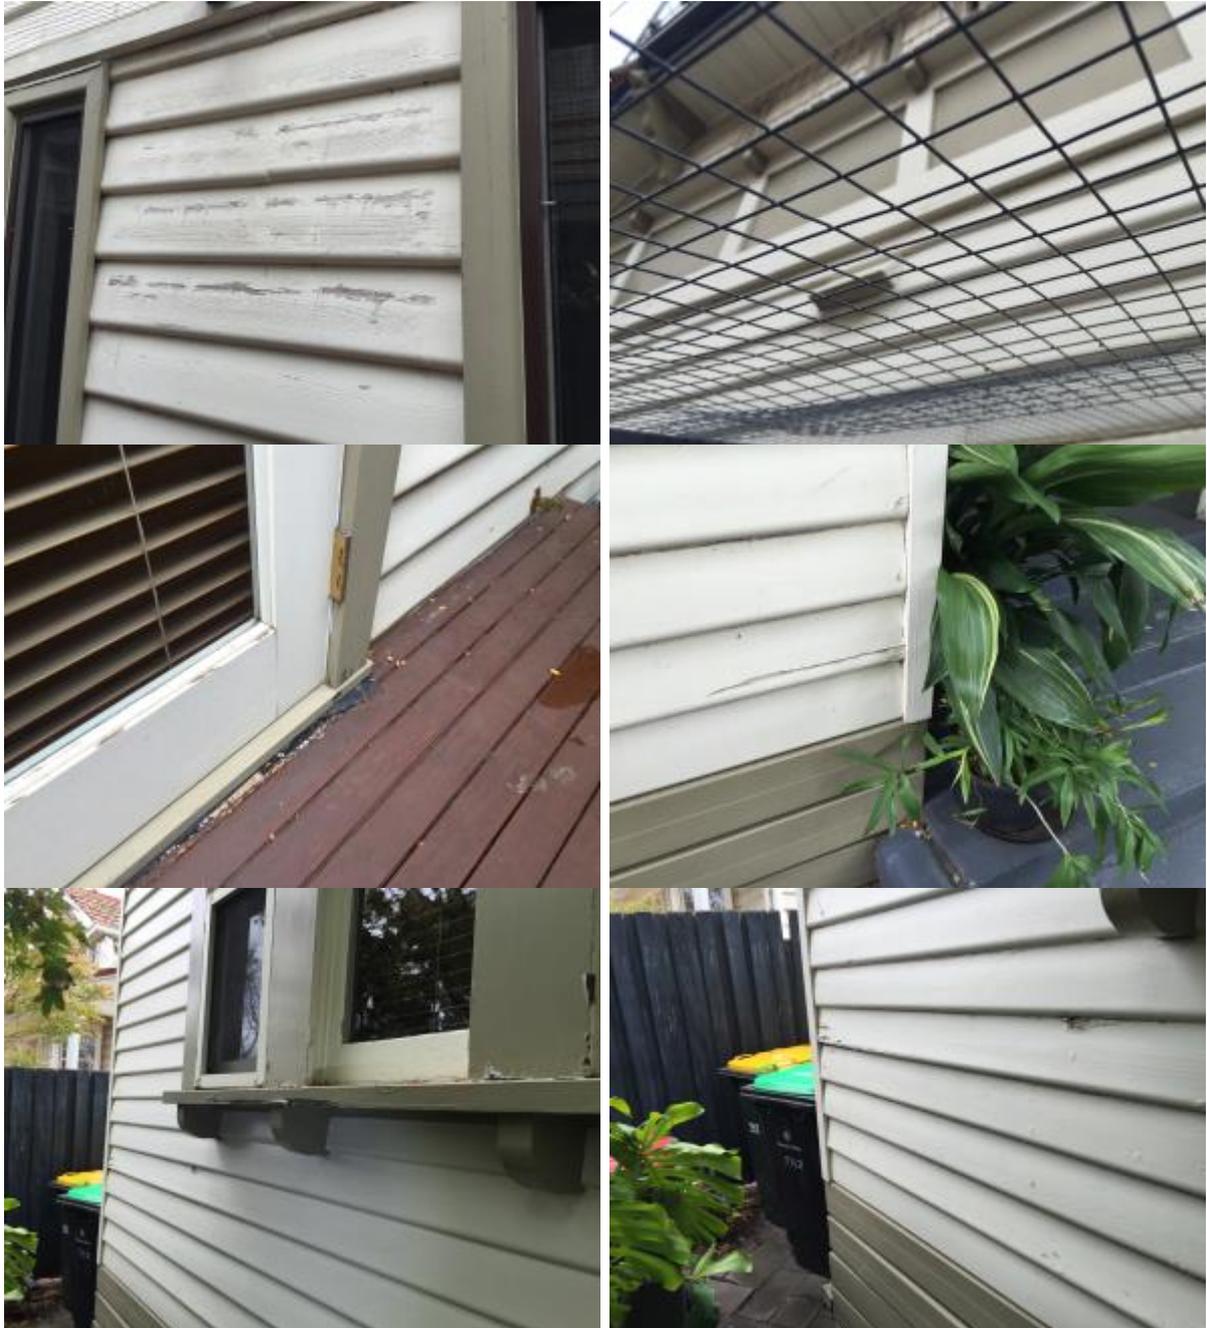
External timbers Rot and timbers susceptible to rot Minor Defect Type: C, D

Application of sealants, paints or flashings required to protect external timbers from moisture ingress to prevent further decay/rot to exposed timbers.

All timber glazing beads to external window faces require sealant to prevent further decay.

All non-treated timber in contact with the ground should be replaced with treated timber to prevent rot and damage.

Rotten sections are to be removed, filled and painted.

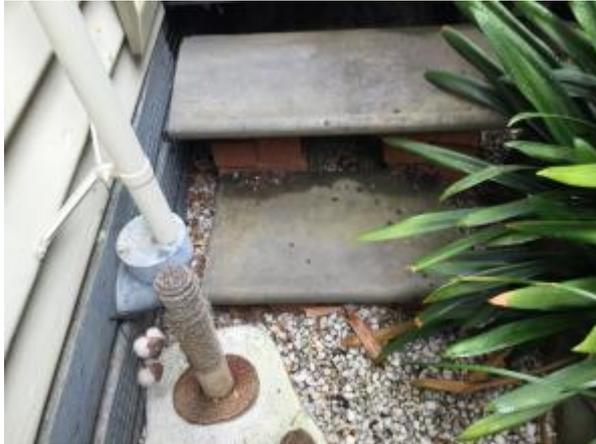
Steps Steps installed on loose bricks

Safety Hazard

Type: F

Replacement steps required.

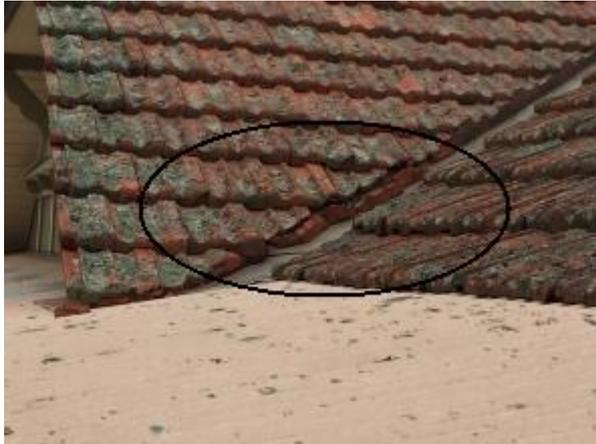
Roof tiles Capping mortar loose/missing Minor Defect Type: A
Re-Pointing of mortar required to Valley gutter tiles.

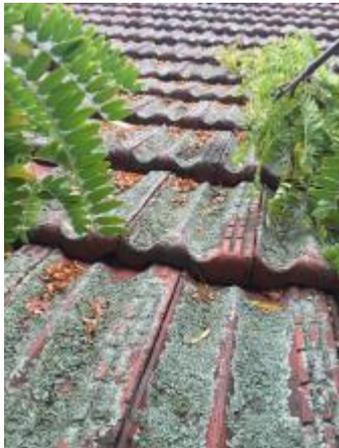
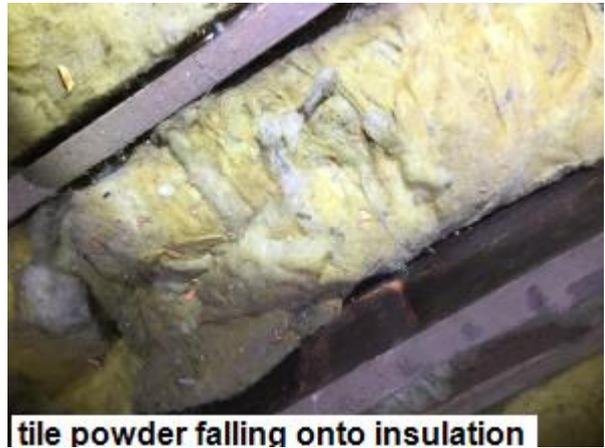
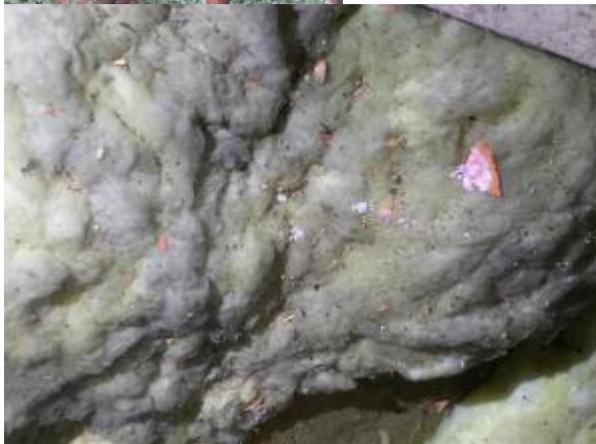
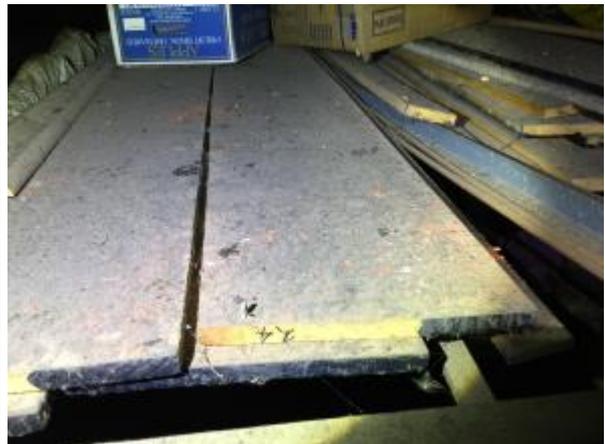
Roof tiles Moss and lichen growth on roof tiles Minor Defect Type: D, C

Moss and lichen growth is to be removed to prevent continuing decay of the tiles. At this stage only light decay has occurred. Tiles should last for at least the next 10 years. Examples below show where decay is begun to the underside of roof tiles.

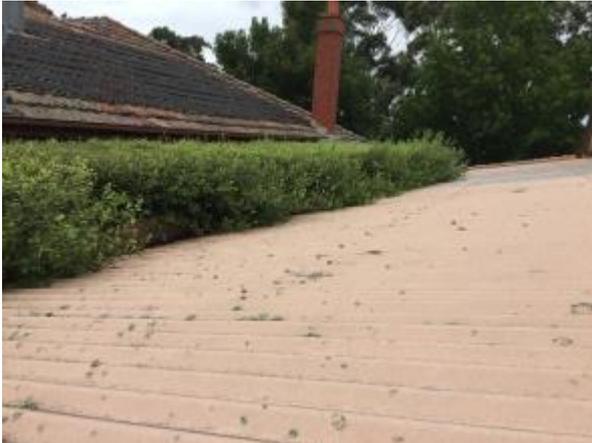
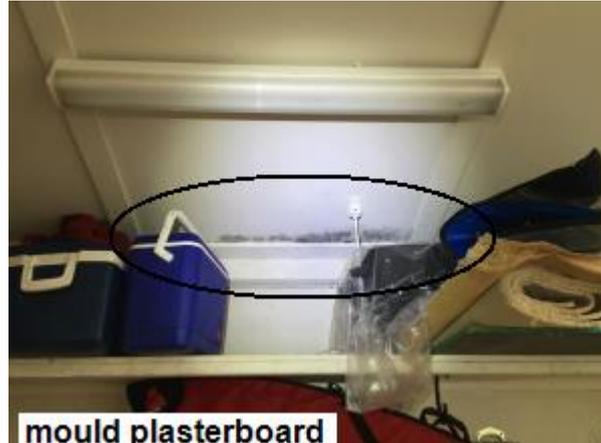
Roof iron

Tree debris over roof

Minor Defect

Type: F

Tree debris over roof is causing leakage and mould growth to the garage ceiling. The box cutter is also full of debris and requires cleaning out. It is likely that to remove moulded plasterboard, replacement of the plasterboard required.

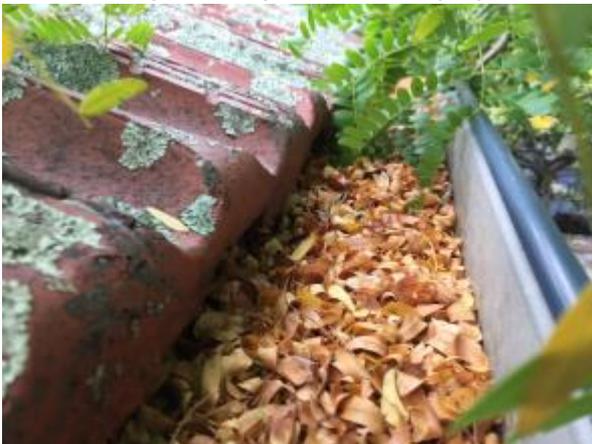
Guttering

Gutters blocked with leaves, silt, moss etc

Minor Defect

Type: E

Clean out gutters to prevent blockage, potential for over-flow into eaves voids and corrosion.

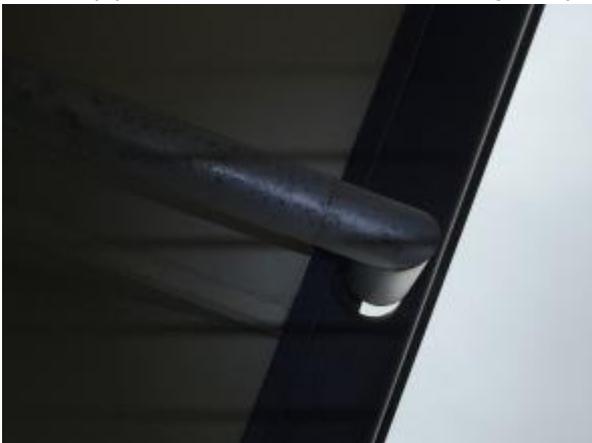
Down pipes

Leakage at gutter pop

Minor Defect

Type: E

Downpipe needs to be installed into the gutter pop.

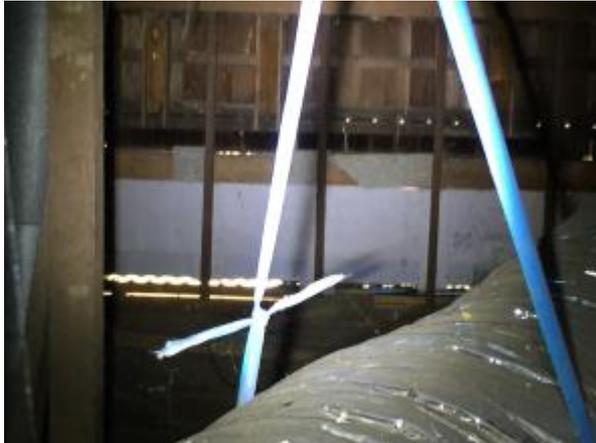
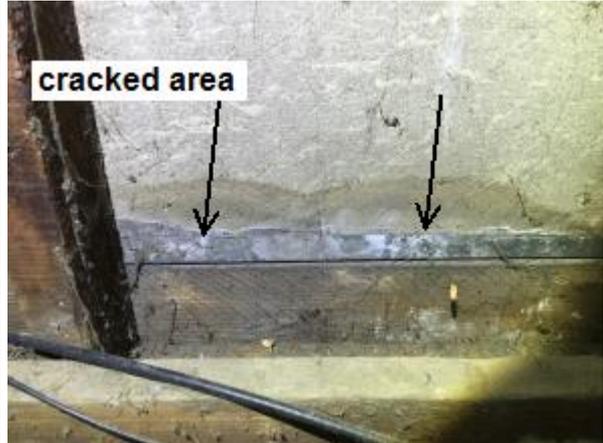
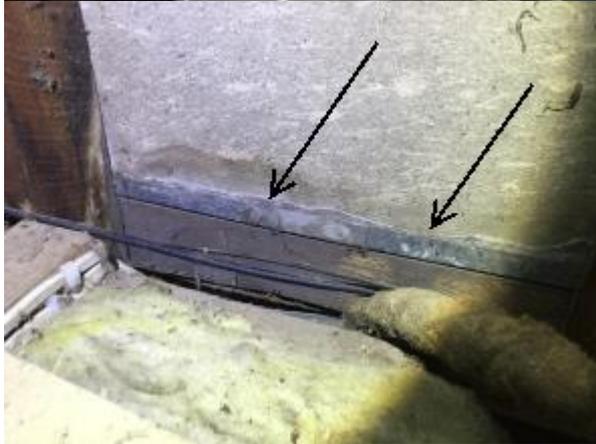
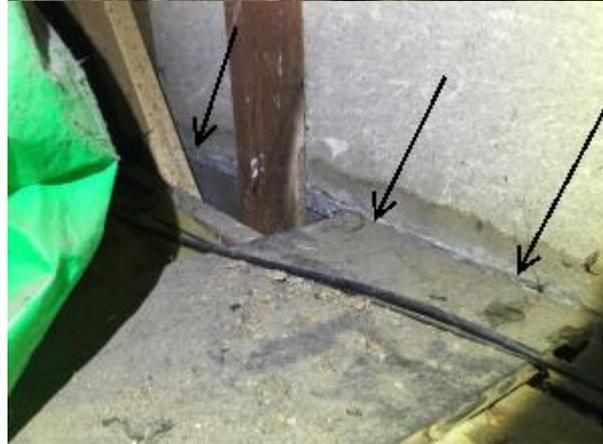
Barges & gables

Cracking to gable end cladding at the south elevation

Further Investigation Type: A

A hazardous materials inspection is required by a suitably qualified person as the gable end material may contain asbestos.

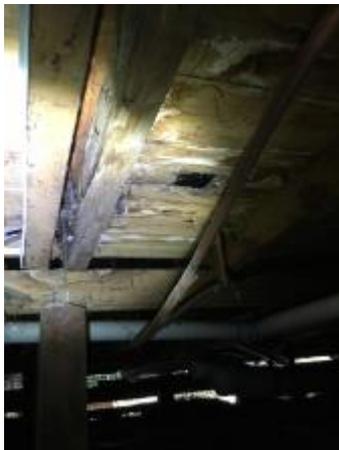
Moisture seepage from underside of bathroom

Minor Defect

Type: D, C

Replacement is not essential. There are no safety concerns. Replacement can be carried out when the renovation is undertaken.

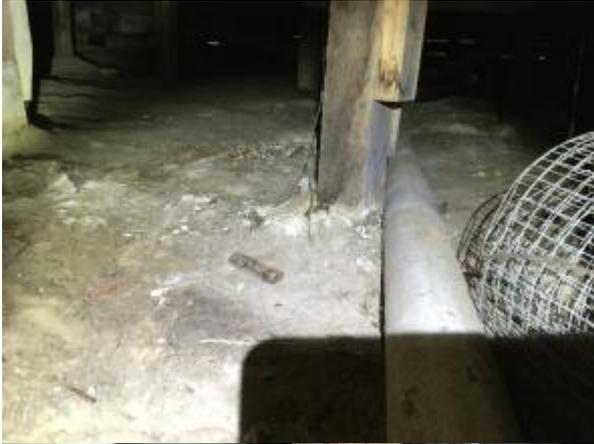
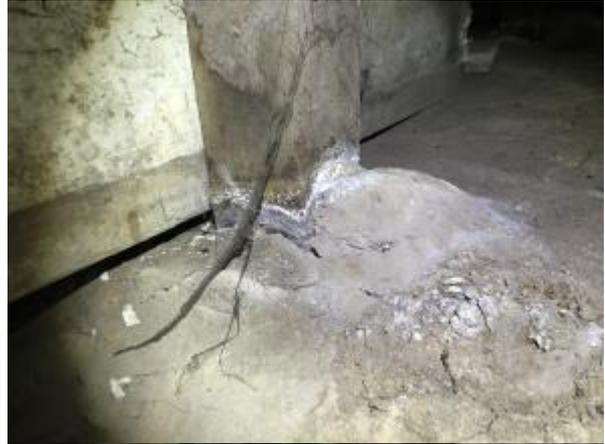
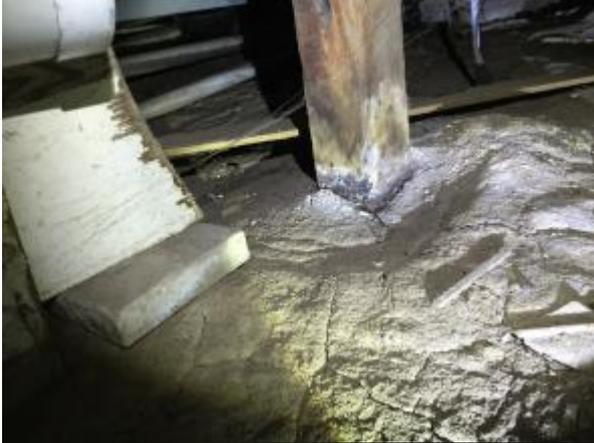
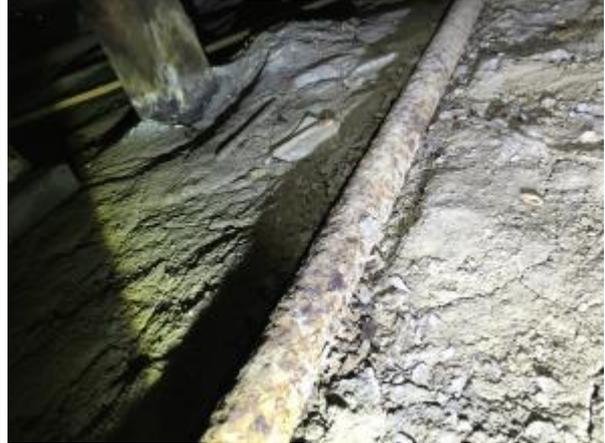
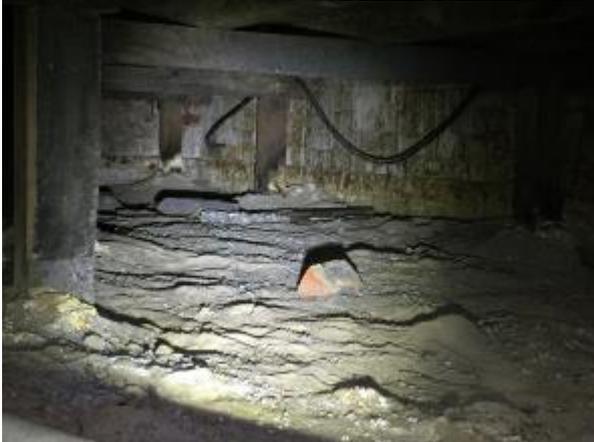
Rot to under floor timbers

Major Defect

Type: D

Various timber stops show evidence of rot to the original home. Replacement required. Stumps can be left in their current condition until the renovation is undertaken. Some examples depicted below.

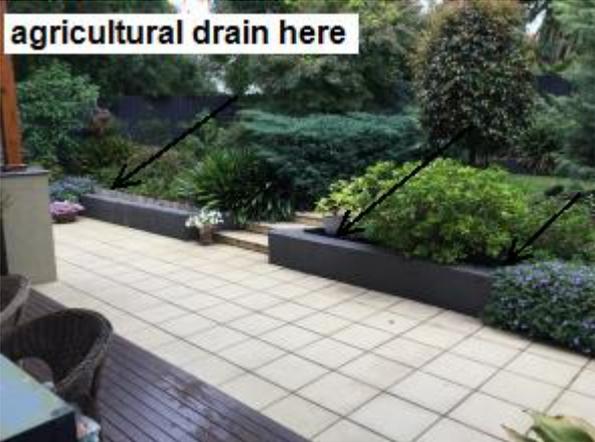
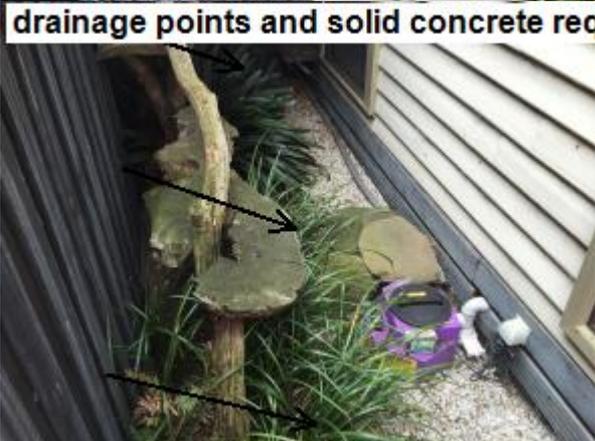
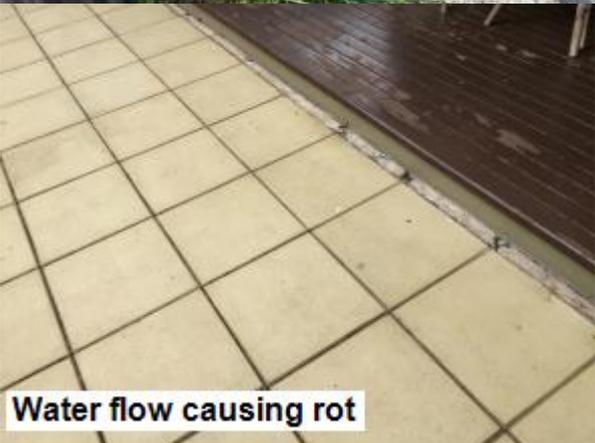
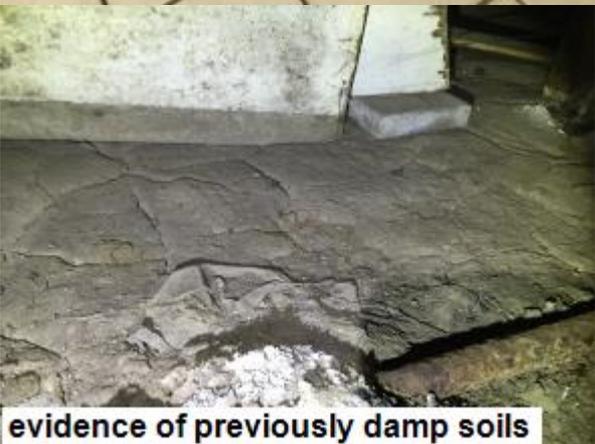
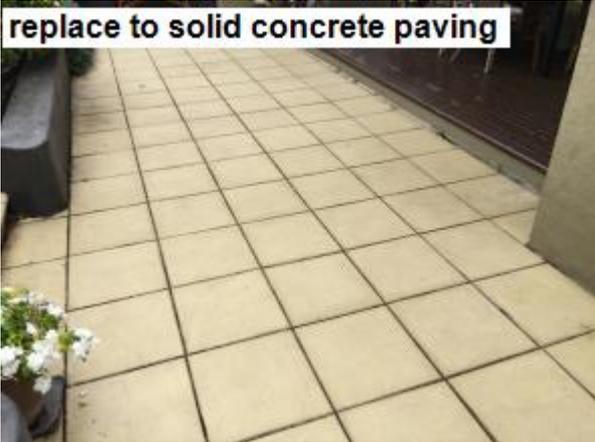
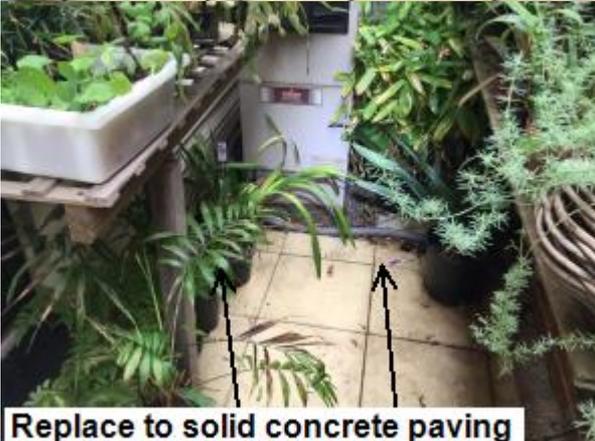
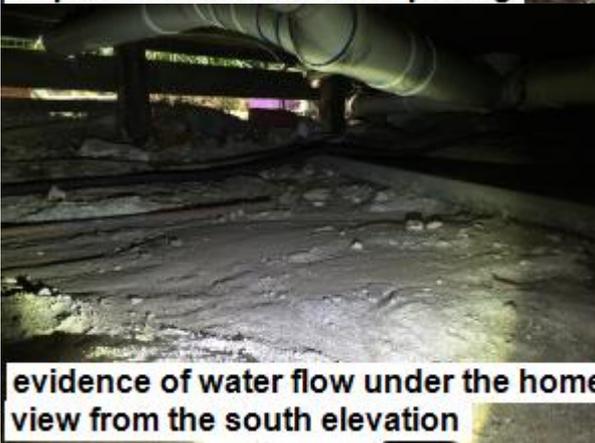
Restricted access

Further Investigation Type: F

An invasive inspection may determine further defects in the subfloor.

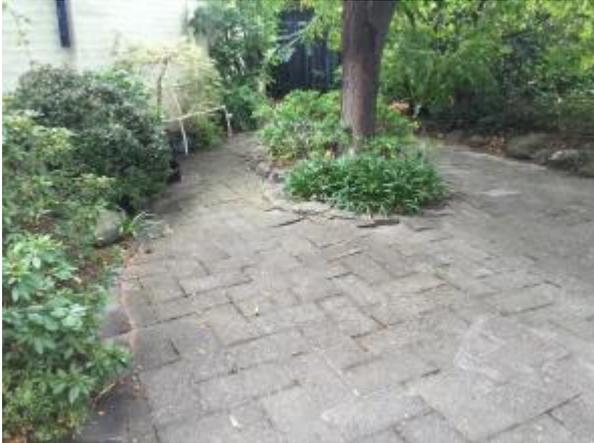
Pathways

Trip hazard

Safety Hazard

Type: A

Tree roots have caused heave through paving. The construct pavers and remove although this may kill trees – an arborist is required to provide further advice.

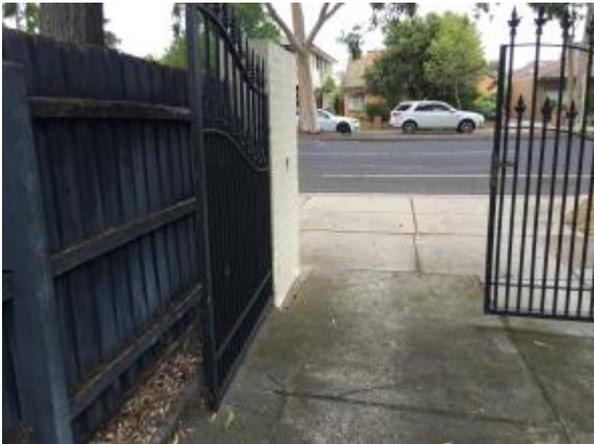
Gate damaged

Minor Defect

Type: A

Even ground because my tree roots resulted in the right-hand side leaf of the driveway gave become jammed on the concrete pavers. Damage has also occurred to the masonry pier to which the gate is attached as a result of the same movement. Reinstallation is required.

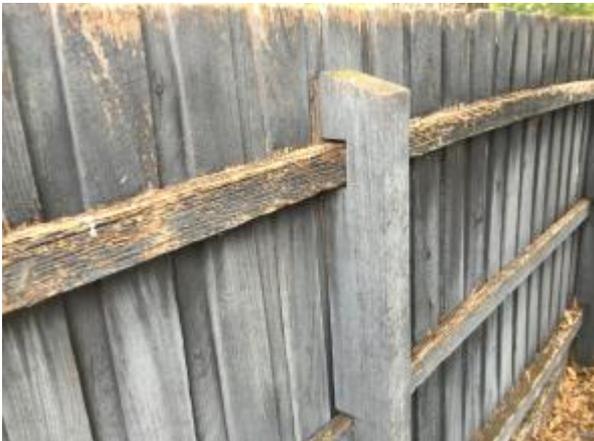
Rotted fencing

Minor Defect

Type: D

Monitor and time and replaces becomes required. Fencing will last for the medium term

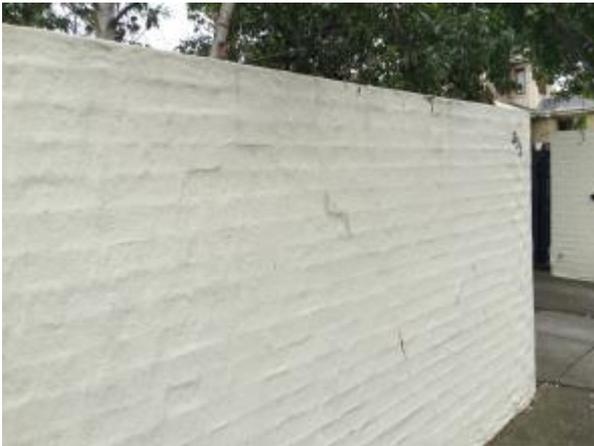
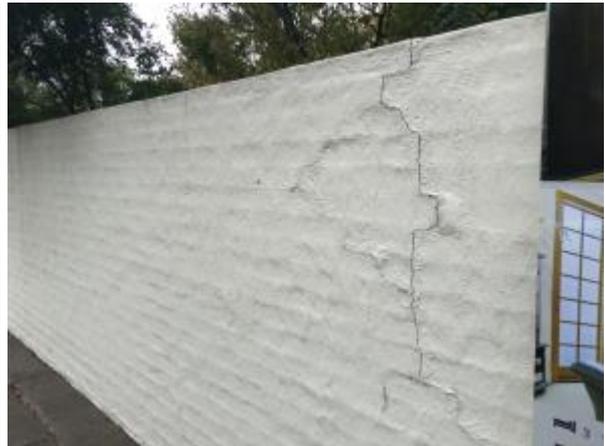
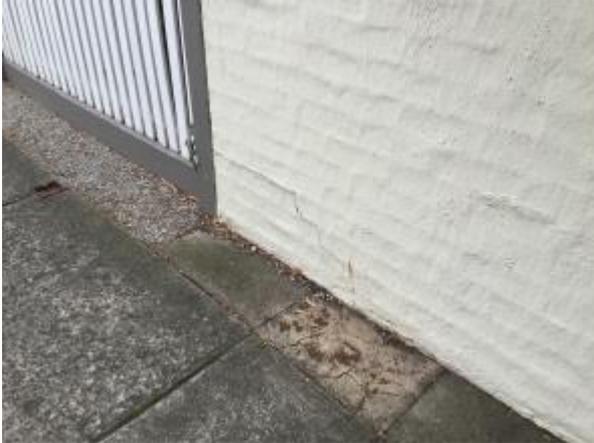
Cracking to masonry fence

Minor Defect

Type: A

Likely caused as a result of free roots growing toward footings of the masonry wall resulting in pressure on the footings and therefore movement of the wall. Monitor over time.

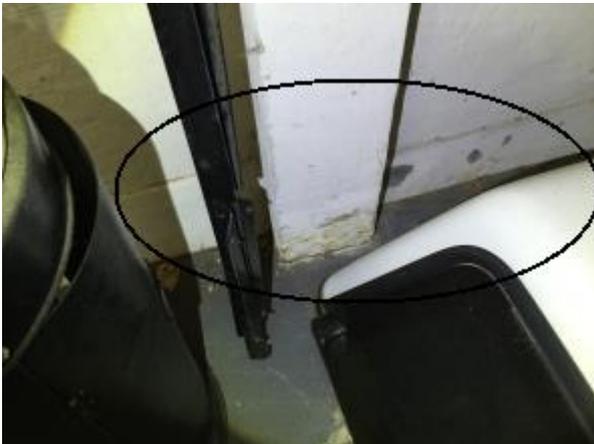
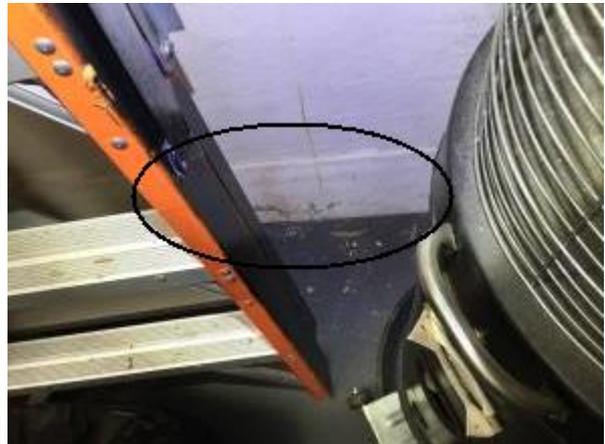
Garage

Further Investigation Type: D, C

Invasive inspection of the neighbouring properties required to determine effects of poor site drainage on the garage wall and therefore rectification methods. Continuing decay will occur over a period of time resulting in further damage. Rectification is considered essential.

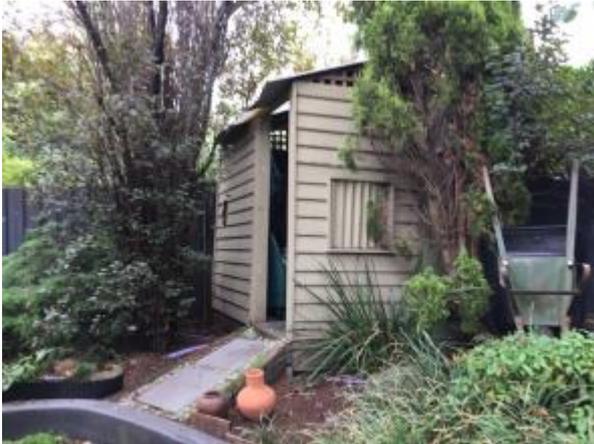
General condition

Major Defect

Type: A

Site > Rear shed > General condition > Severe structural movement

Demolition and reconstruction highly recommended.
