Residential Structural Inspection Report

Date of inspection: Monday, 15 February 2016 12:15 PM

Property address	9 Malahang Parade HEIDELBERG HEIGHTS VIC 3081
Report prepared for	Mandeep Sample UNKNOWN SUBURB
Client's contact details	Mobile 4987 441 094 shoulden@barryplant.com.au
Real estate agent's details	Name Sarah Company Barry Plant Mobile 0401 241 070
Type of inspection report	Standard Inspection, Defect Only
Persons present	
Weather conditions	Fine
Inspector	Joe Noto, Bachelor Applied Science (Construction Mgt) (Economics) Registered Building Practitioner - Domestic Builder - Unlimited DB-U 28857

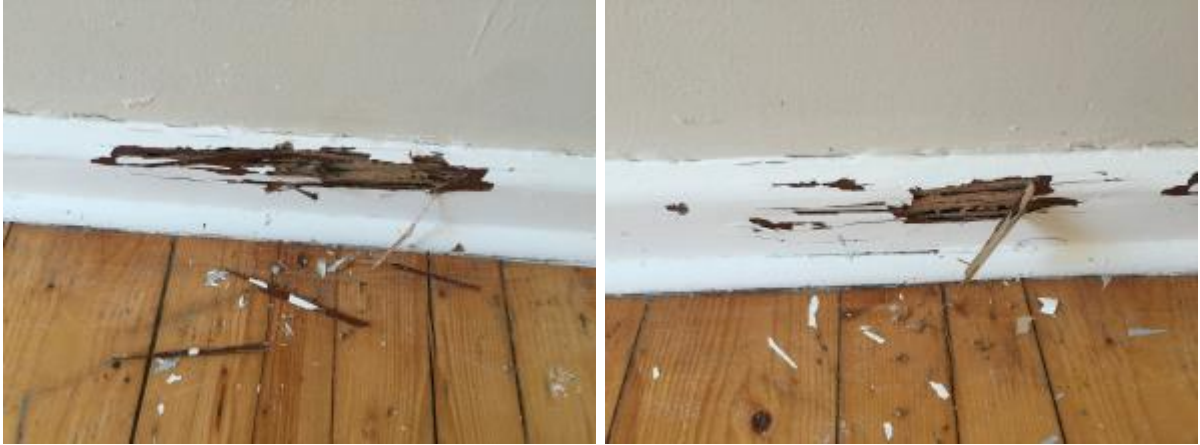
Interior - Bedroom 2

Walls

Termite damage

Further Investigation Type: A

An invasive inspection of the sub-floor and wall cavities is required to determine extent of damage to structural timbers.

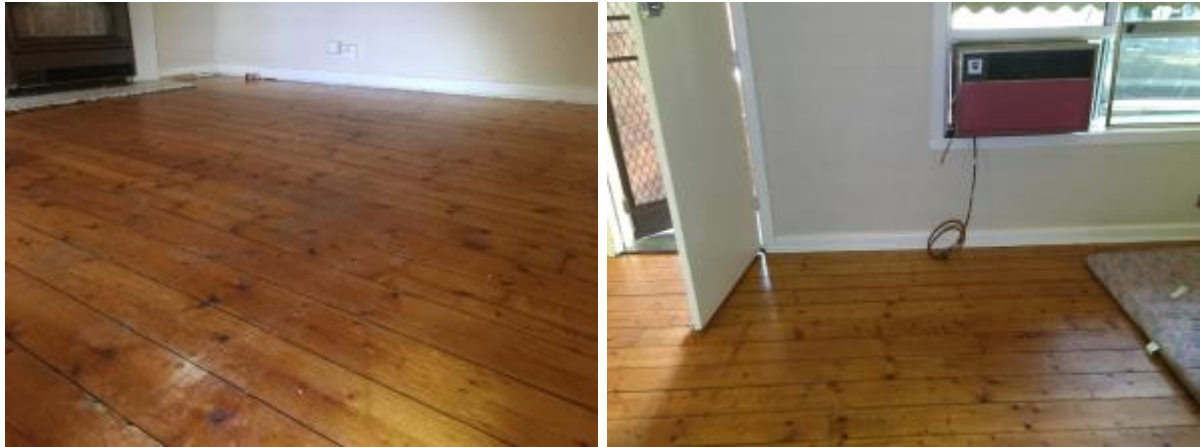
Interior - Various rooms

Structural movement
defects

Various defects

Major Defect

Various movement defects including the following items have been recorded;

- 1. Cracking to walls & ceilings.*
- 2. Movement of window & door opening's out of square.*
- 3. Movement of floors out of level.*
- 4. Movement of various ceilings out of level / bowed ceilings.*

These defects have occurred as a result of movement through the foundations most likely as a result of natural movement over time and poor site drainage leading to residual defects such as decay & lateral movement/subsidence of stumps.

Rectification of the above mentioned items should only be carried out once site drainage issues have been rectified / an invasive inspection of the sub-floor area has been carried out.

Re-stumping is required as a minimum after external rectifications are carried.

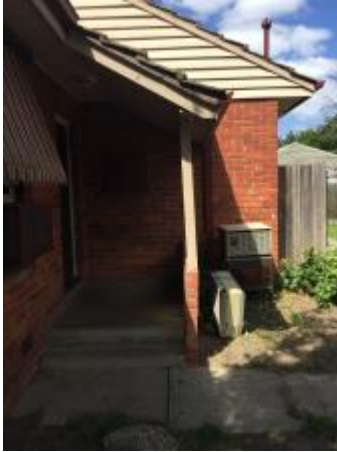
Exterior - Front Elevation

Walling Lateral movement of wall and post Safety Hazard Type: A
 supporting veranda roof

Re-construction of the wall and post is required.

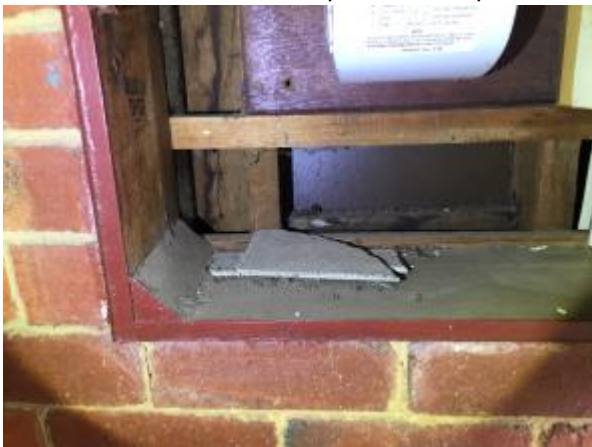
Walling Damaged materials within electrical Safety Hazard Type: A
 meter box

A hazardous materials inspection is required to determine asbestos.

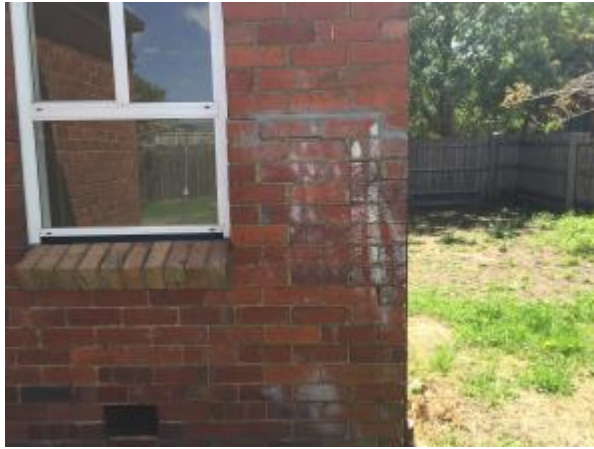
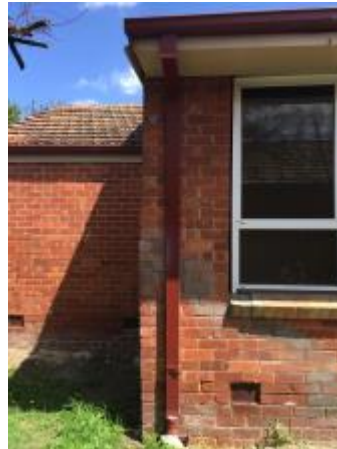
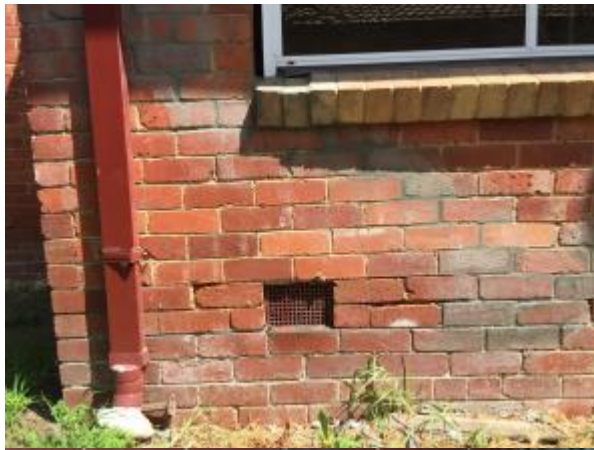
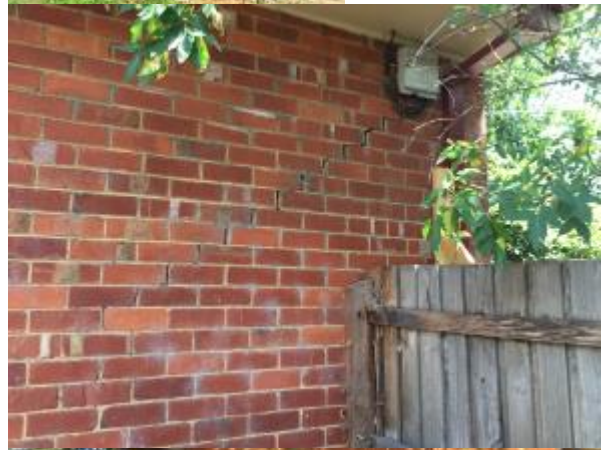
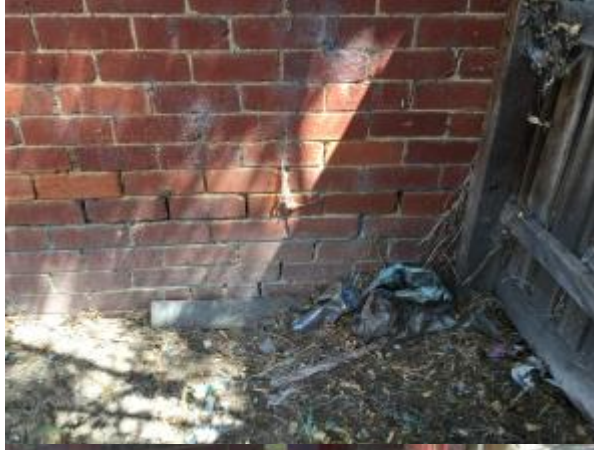
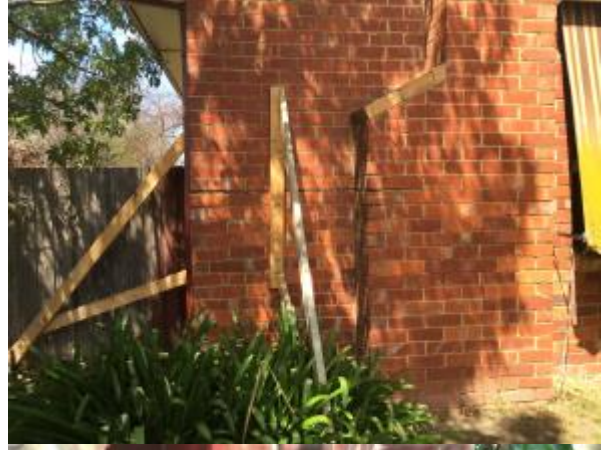
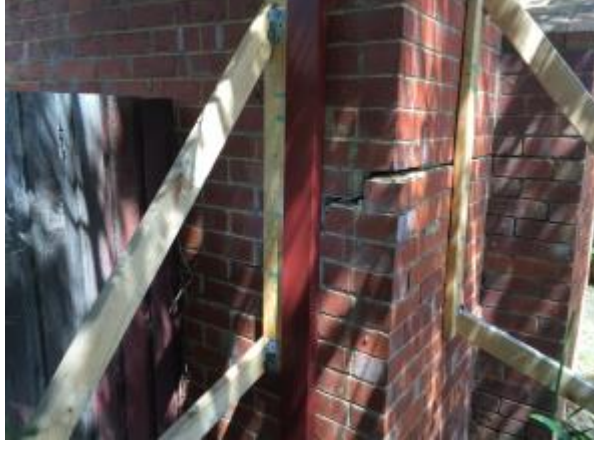
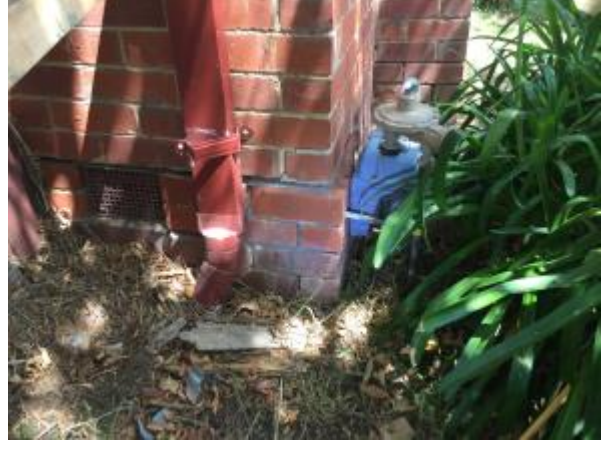
Exterior - Default Elevation

Walling Major structural movement Major Defect Type: A

Severe movement of the foundations has resulted in major cracking of perimeter walls to various elevations.

The front wall has moved so much that the gas meter pipes are at risk of rupturing should further movement occur.

The entire perimeter of the home requires under-pinning and various walls will require re-construction as they are currently safety hazards.

Rectification of timber framing to perimeter walls will also be required although the extent of damage is unknown as visibility is restricted.

Costs to repair considering internal repairs also will be excessive to the point where re-construction is the only option.

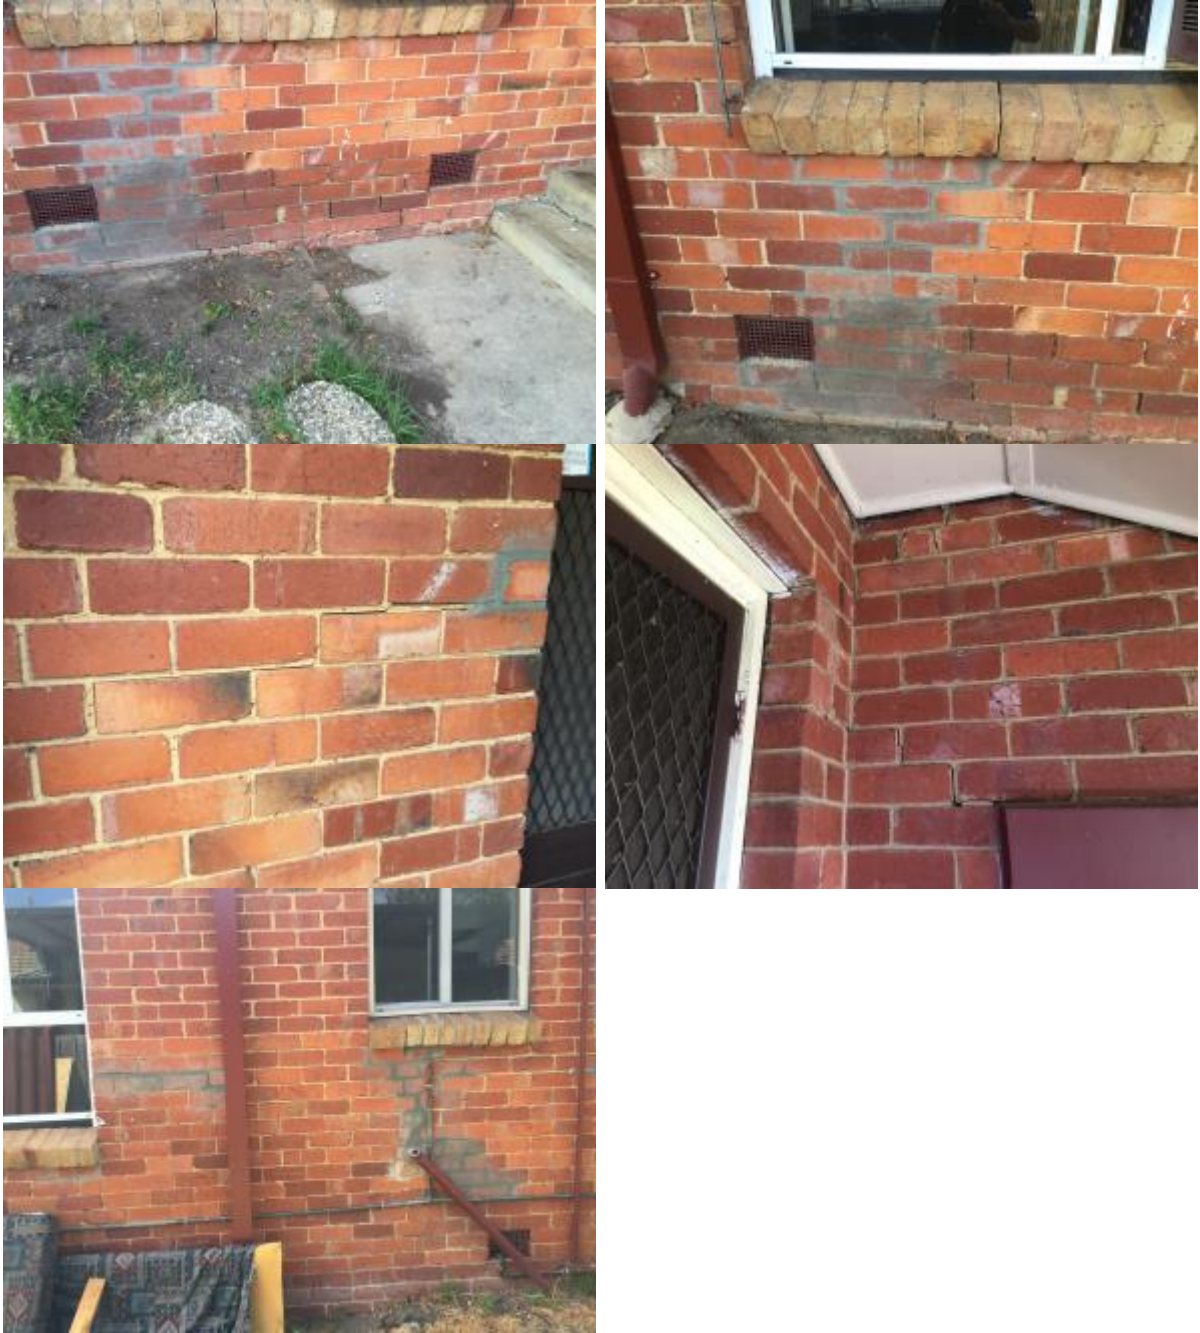
Walling

Repaired cracking to other elevations Minor Defect

Minor cracks are evident to other areas. Under-pinning to all perimeters is required in any case.

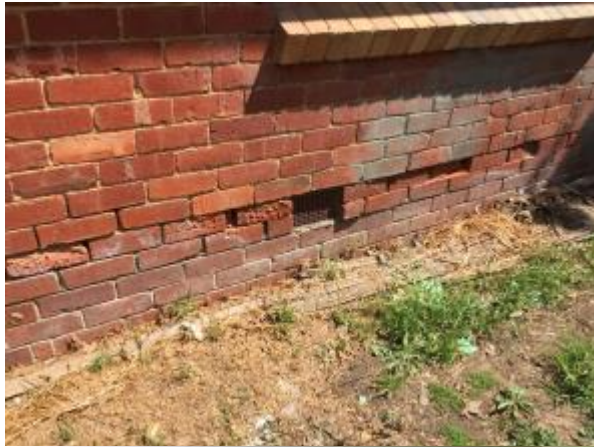
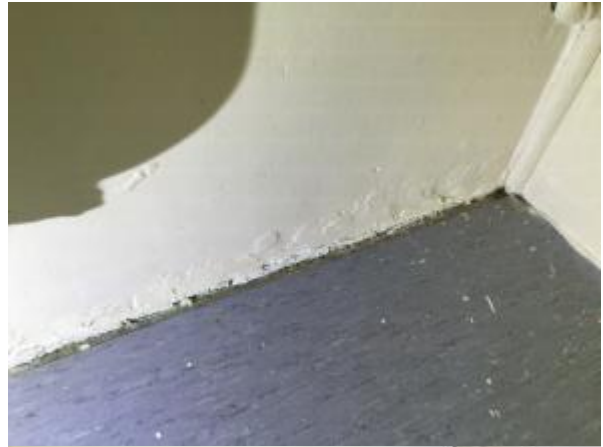
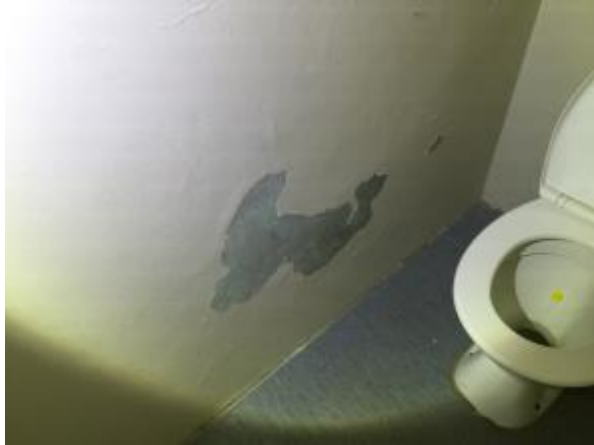
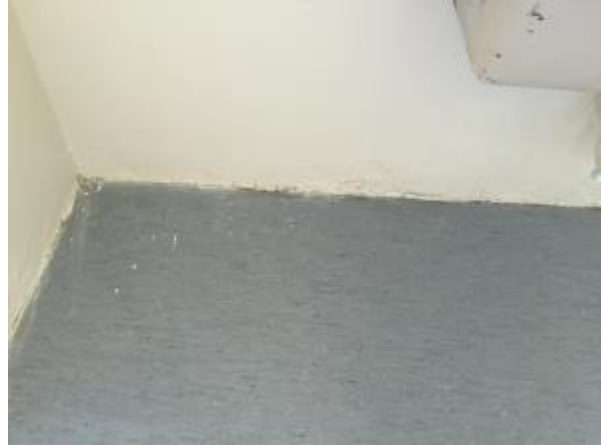
Walling

Decay of bricks and mortar

Further Investigation Type: D, C

Generally caused by rising damp and damp soils under the home. An invasive inspection of the sub-floor cavity is highly recommended however, rectification could include;

- 1. Rectification of sub-floor cavity ventilation.*
- 2. Rectification of site drainage or the prevention of water flow toward any perimeter of the home.*

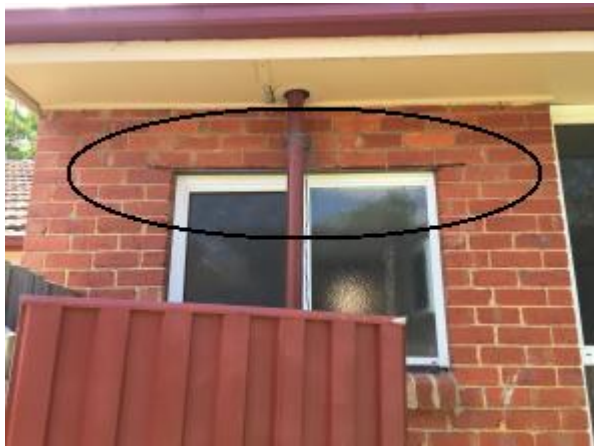
Lintels

Lintel sagged

Minor Defect

Replace all bowed lintels once under-pinning has been carried out. Continuing movement will cause pressure to be applied to windows over time possible causing damage.

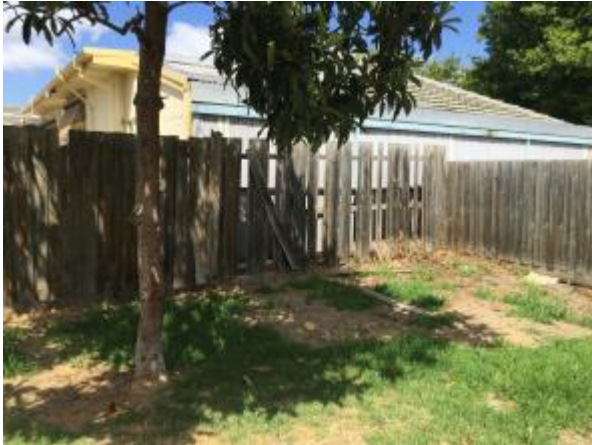
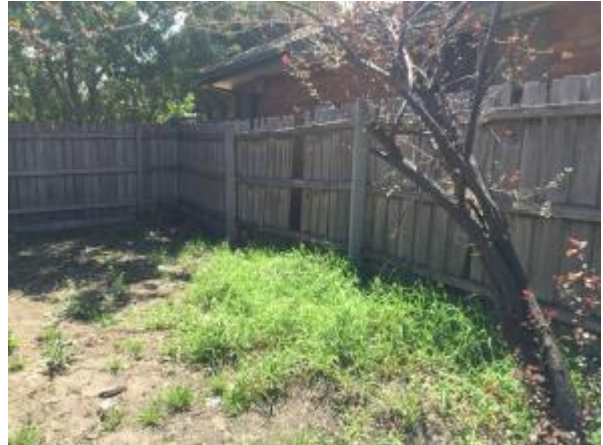
Site - Grounds

Property fencing

Damaged fencing

Minor Defect

Replacement of various elements is required.
