Residential Handover Inspection Report

Date of inspection: Wednesday, 12 March 2014 12:30 PM

Property address	20 Goulborn Way EYNESBURY VIC 3338
Report prepared for	Nathan ***** ***** HOPPERS CROSSING VIC 3029
Client's contact details	*****@hotmail.com
Real estate agent's details	Name n/a Company n/a
Type of inspection report	Standard Inspection, Complete
Persons present	Client, Builder
Weather conditions	Fine
Inspector	Joe Noto, Bachelor Applied Science (Construction Mgt) (Economics) Registered Building Practitioner - Domestic Builder - Unlimited DB-U 28857

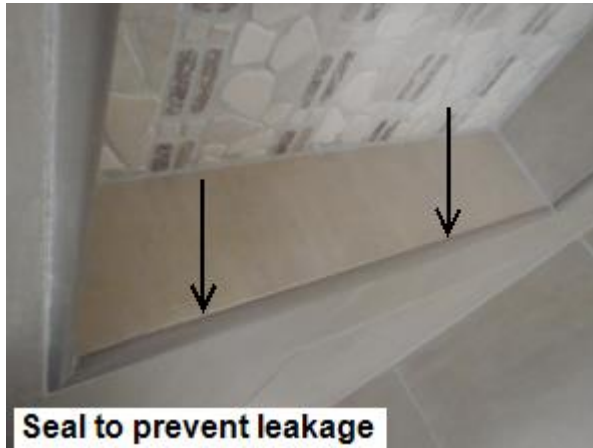
Interior - Bathroom

Walls Water entry point to shower niche requires sealant Minor Defect Type: F

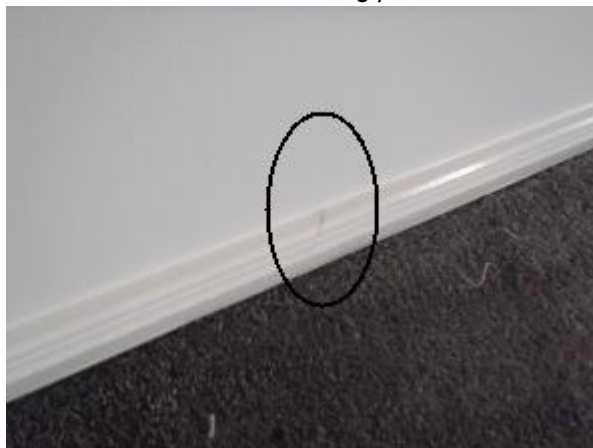
Interior - Bedroom 1

Walls Lip in skirting joint Minor Defect Type: F
Visible from a normal viewing position. Rectification required.

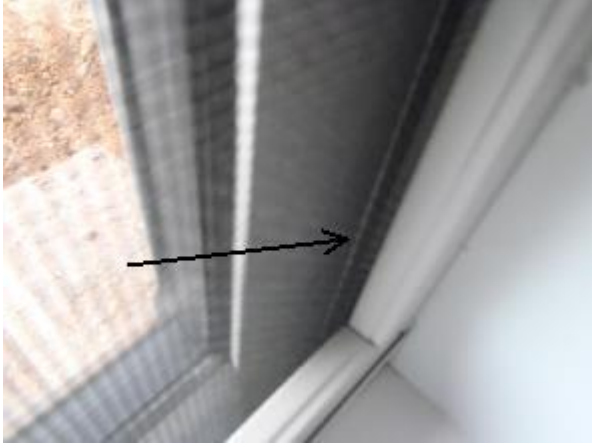
Interior - Bedroom 3

Window does not close hard up against the weather seal

Minor Defect

Type: F

Adjustment required.

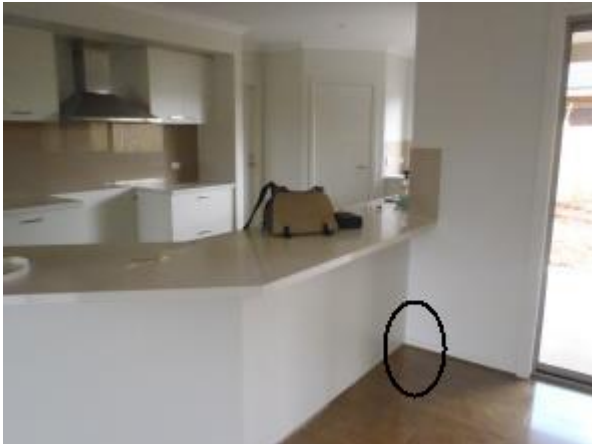
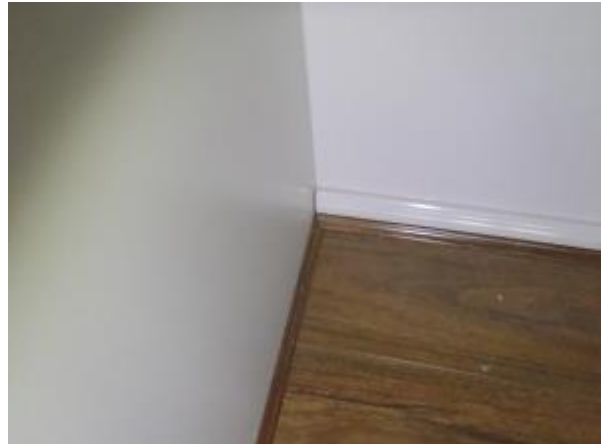
Interior - Kitchen

Skirting runs short of cupboard wall

Minor Defect

Type: F

Apply sealant to skirting/kitchen cupboard junction.

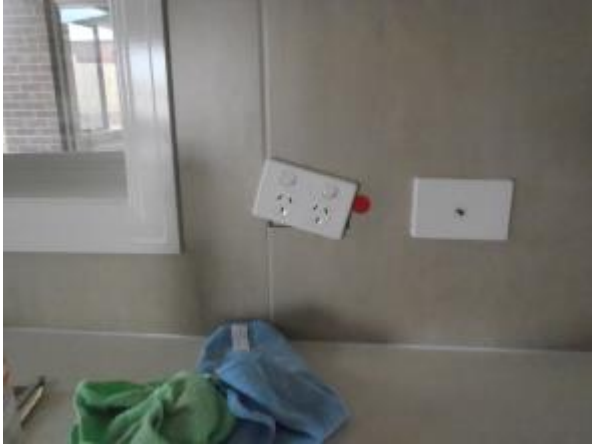
Power points

Loose

Minor Defect

Type: F

Licensed electrician to re-install ensuring penetration is completely covered by the cover plate.

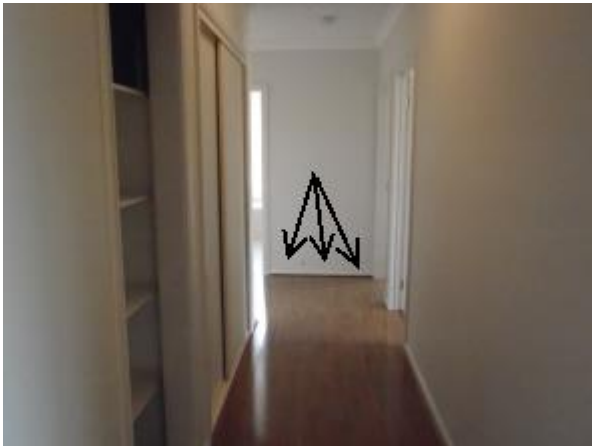
Interior - Passages

Patching required to fixing nails at passage way floor quad

Minor Defect

Type: F

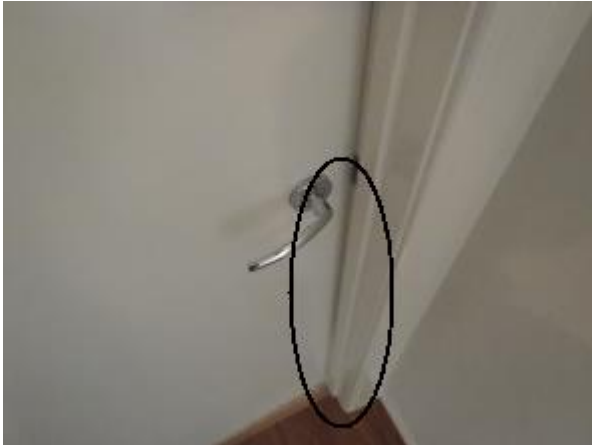
Interior - Separate WC

Doors and frames Binding doors
Adjustment required.

Minor Defect

Type: F

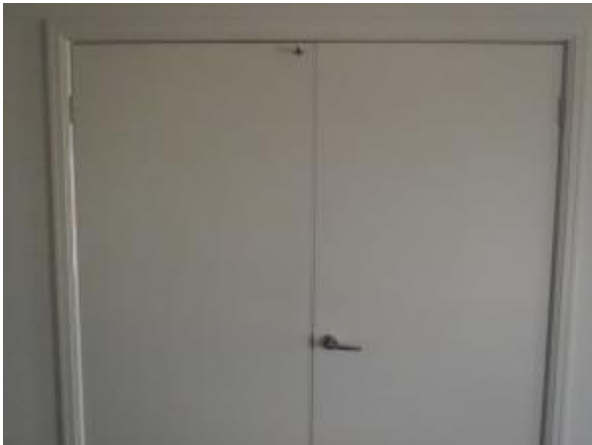
Interior - Home Theatre

Doors and frames Sub-standard door clearance Minor Defect
Minimum door clearance required is 2mm. Rectification required.

Type: F

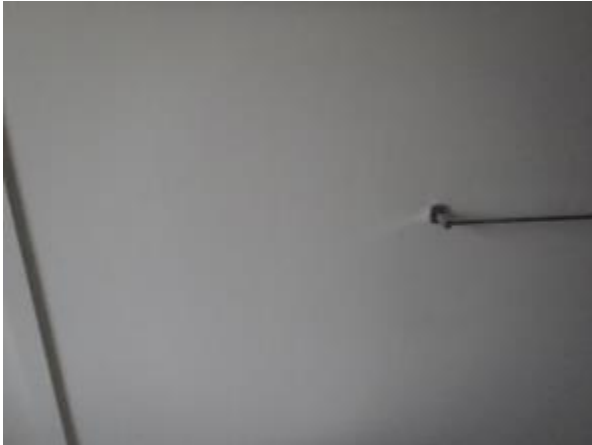
Interior - Ensuite

Walls Undulations through wall surface Minor Defect Type: F

Wall cladding is defective as it can be seen from a normal viewing position. Replacement is required.

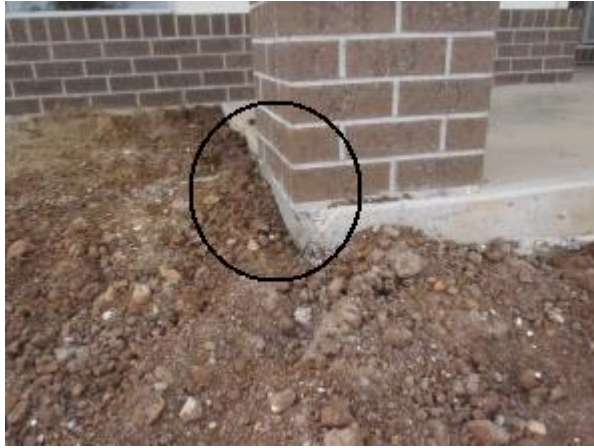
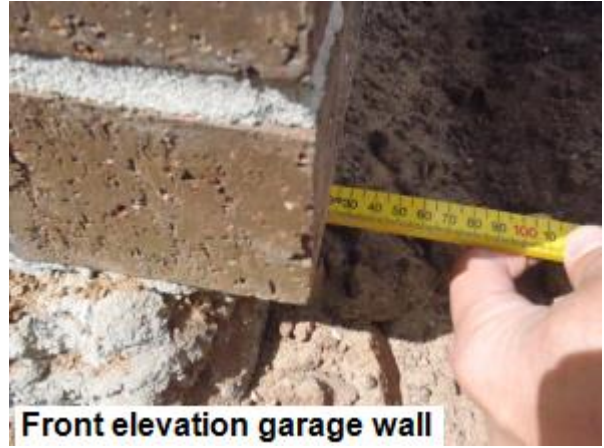
Exterior - Front Elevation

Brick over-hang

Minor Defect

Type: F

Rectification to the front elevation column has not been carried out as generally required by structural engineer's advice. A structural engineer is required to provide adequate rectification methods.

It is generally required that a galvanised steel angle is bolted to the slab edge hard up to the underside of the over-hanging brickwork.

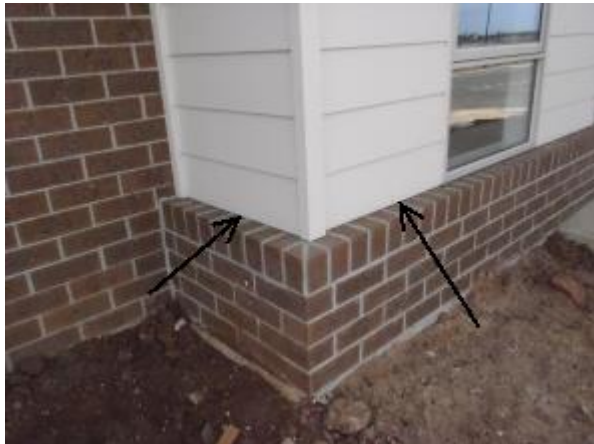
Walling

Missing sealant

Minor Defect

Type: F

It is recommended caulking compound be applied to the brick / light weight cladding junction to prevent water ingress. One example depicted below. Apply to all similar details.

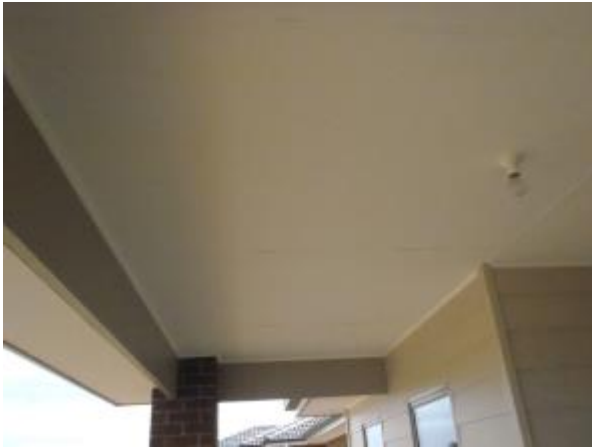
Patio/veranda

Gapping to ceiling joints

Minor Defect

Type: F

Paint fill gaps.

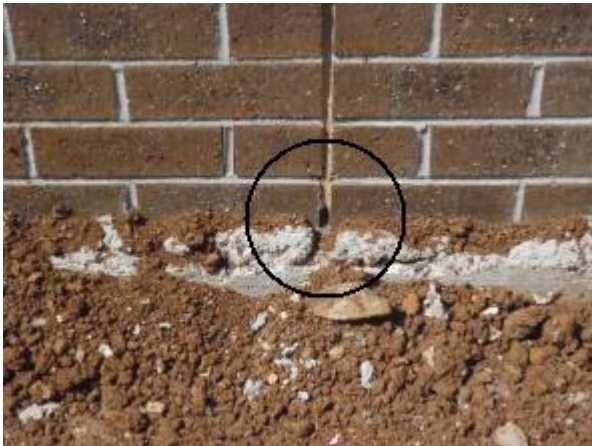
Exterior - Default Elevation

Missing caulking compound to garage wall AJ

Minor Defect

Type: F

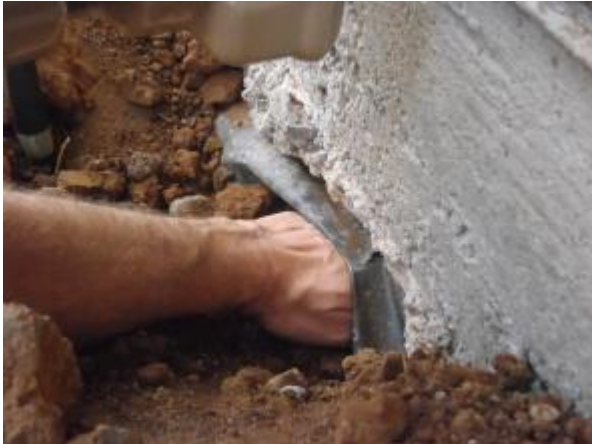
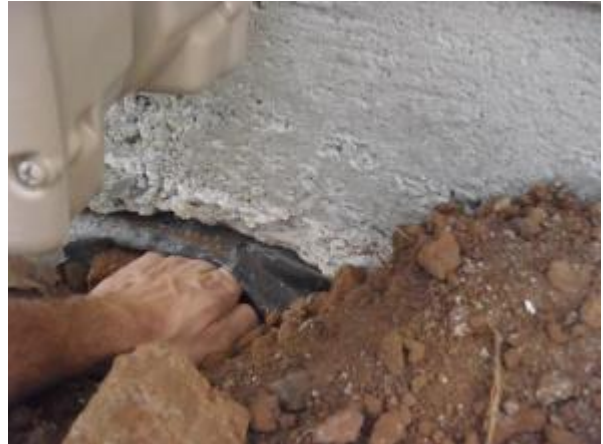
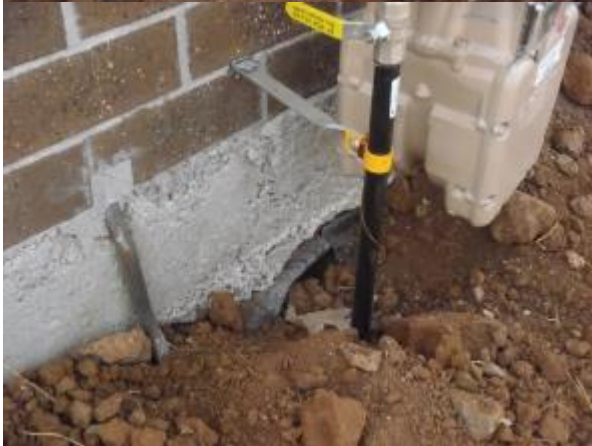
Concrete slab/Edge
beam

Significant void exists under slab

Further Investigation Type: F

Significant voids occur at the slab edge. Structural engineer to provide further advice on rectification methods. Excavation of soils surrounding the home is required to determine other areas of concern.

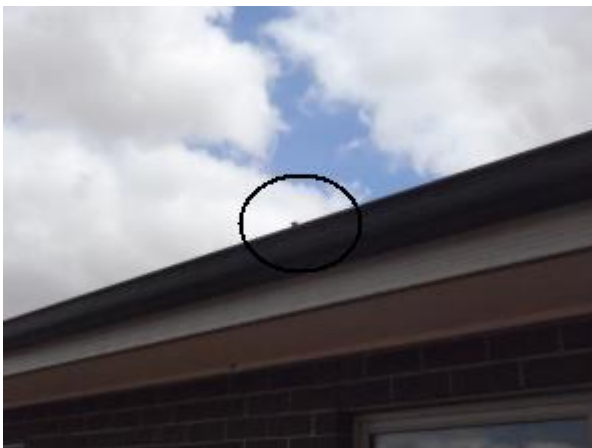
Guttering

Loose gutter clip

Minor Defect

Type: F

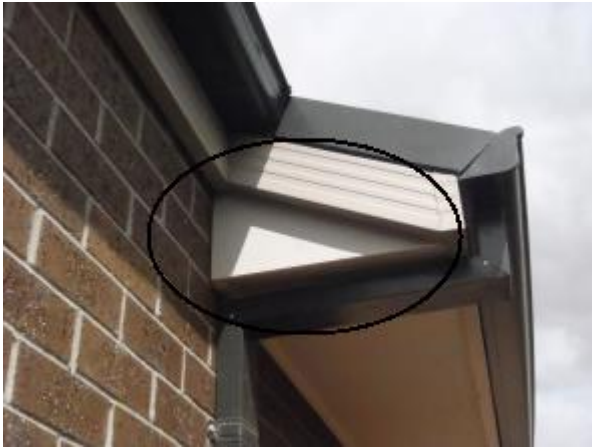
Eaves

Incomplete painting

Minor Defect

Type: F

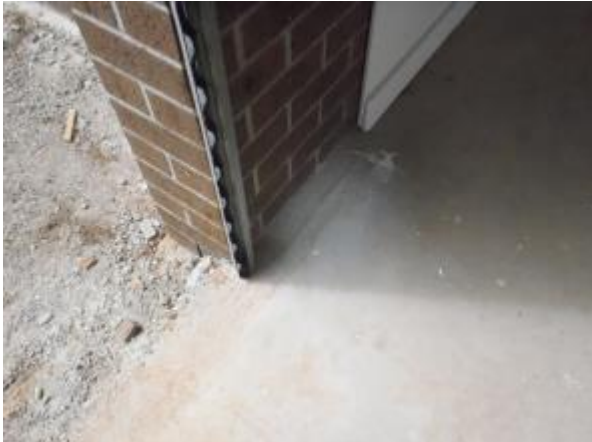
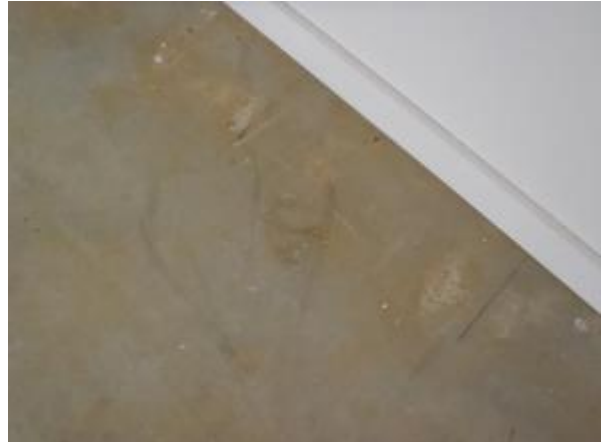
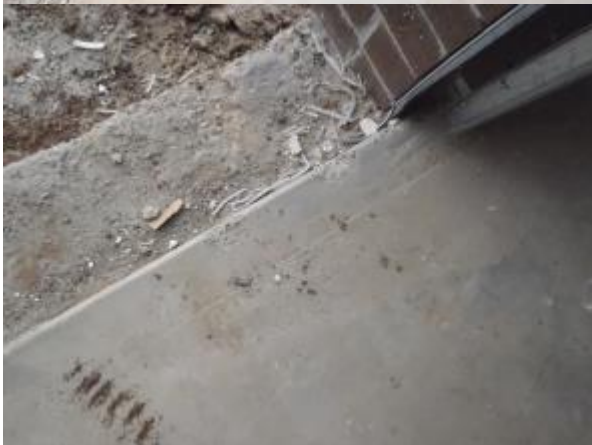
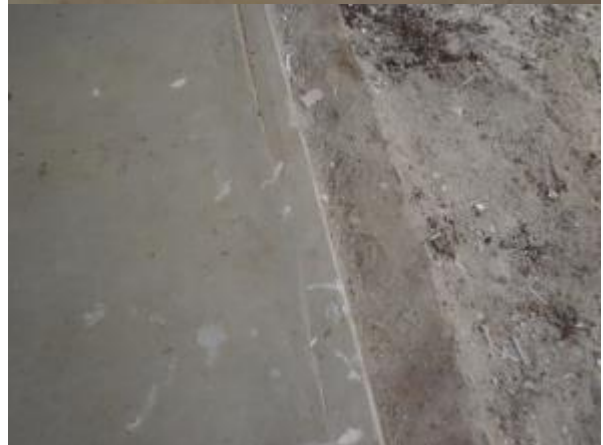
Garage

Damage concrete slab surface

Minor Defect

Type: A

Rectification to be carried out as described by site supervisor.
