Date of inspection: Thursday, 17 March 2016 08:30 AM

# Pre-handover Inspection Report

Property address	4 Livingstone Street MERNDA VIC 3754	
Report prepared for	Carlo Sample 6 Mernda Terrace EPPING VIC 3076	
Client's contact details	Mobile	9083 159 858 <a href="mailto:sample@hotmail.com">sample@hotmail.com</a>
Real estate agent's details	Name	n/a
	Company	n/a
Type of inspection report	Standard Inspection, Defect Only	
Persons present	Client, Builder's representative	
Weather conditions	Fine	
Inspector	Joe Noto, Bachelor Applied Science (Construction Mgt) (Economics) Registered Building Practitioner - Domestic Builder - Unlimited DB-U 28857

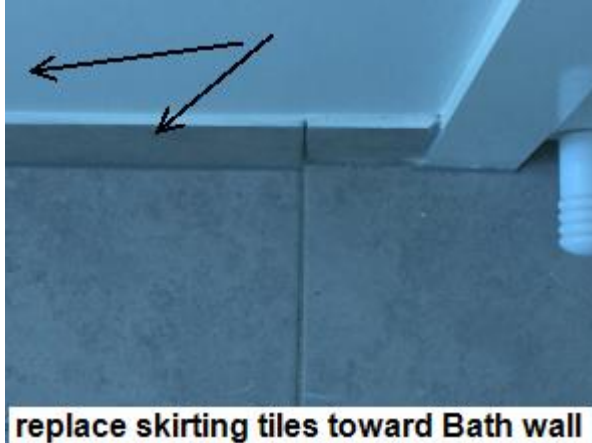
Uneven surface to skirting tiles  
adjacent door architrave

*The skirting tile adjacent the door sits perfectly however neighbouring skirting tiles are being laid on a slight angle. The tiles between the bath of wall and the skirting adjacent the architrave are to be replaced.*

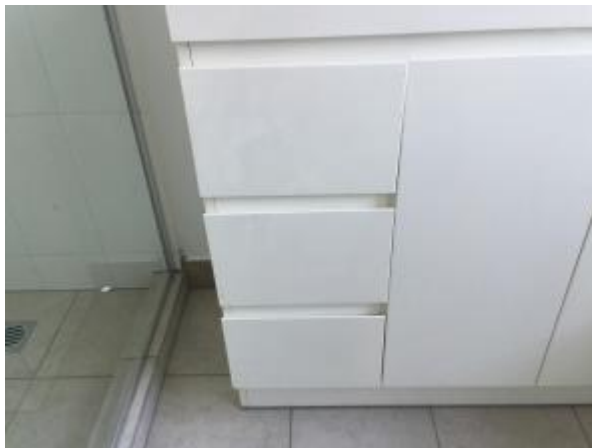
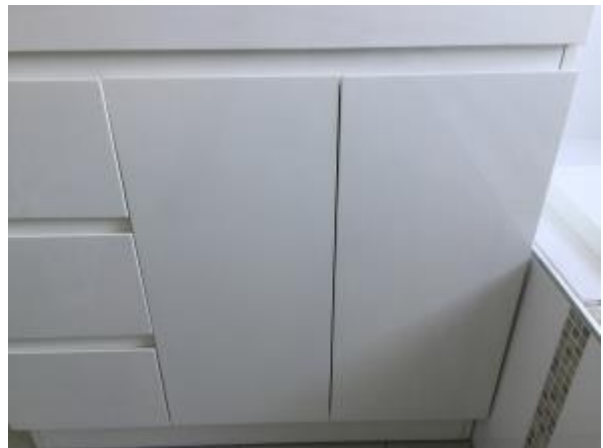
Adjustment of drawers and cupboard  
doors required

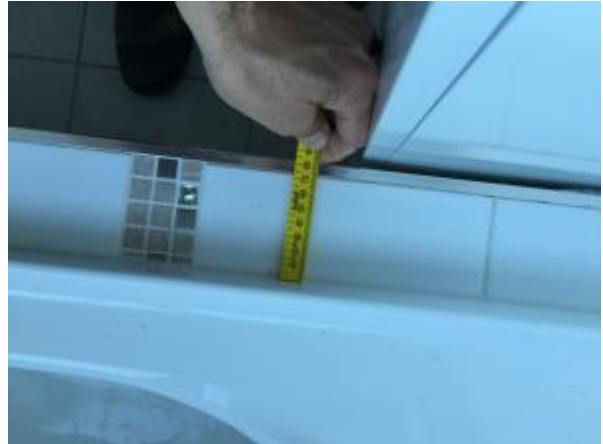
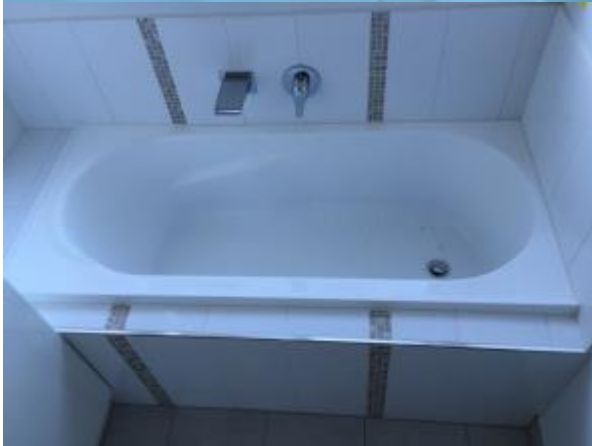
Bath installed out of square with bath  
hob

*Rectification will required reconstruction.*

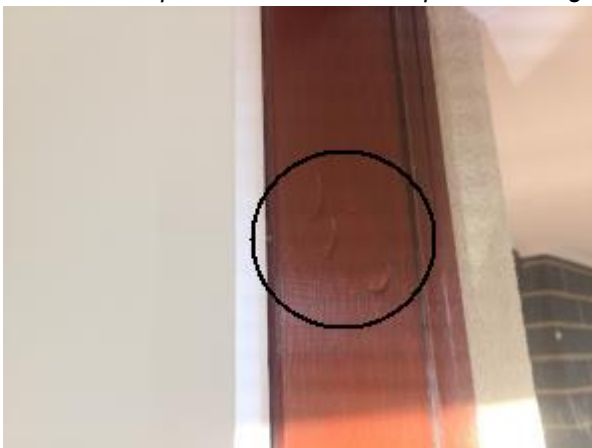
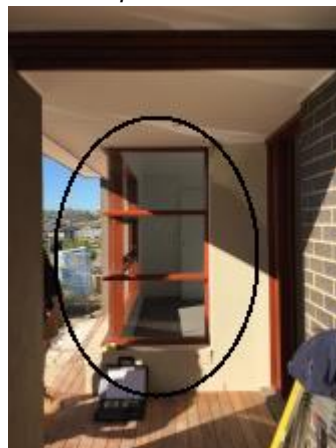
Hammer marks to window frame &  
Window installed out of level

*Window requires reinstallation. Repair of damage is also required.*

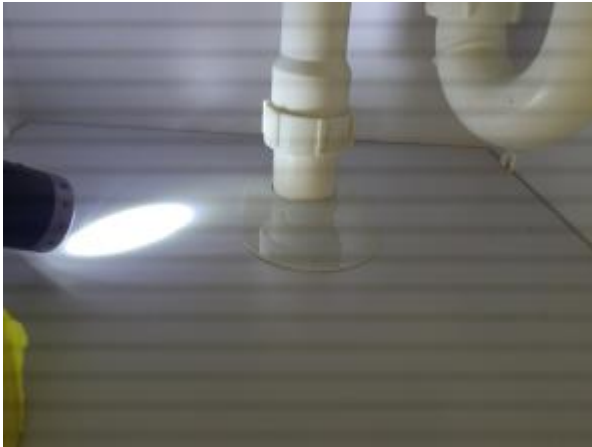
Leakage to waste pipe under vanity

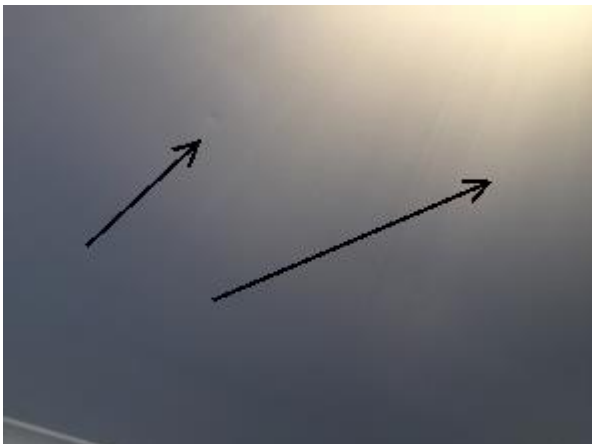
Visible plaster screws to be rectified

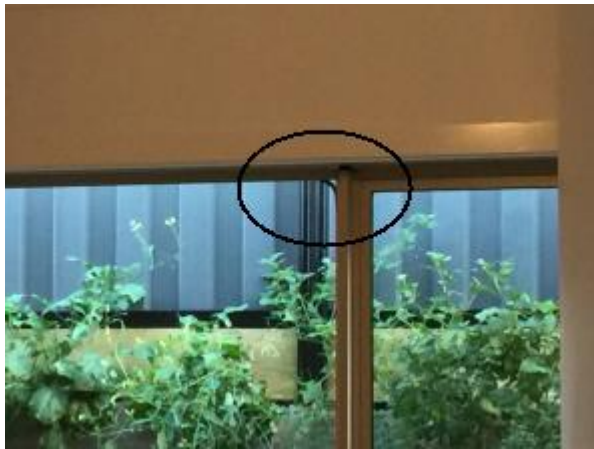
Glazing seal to be rectified

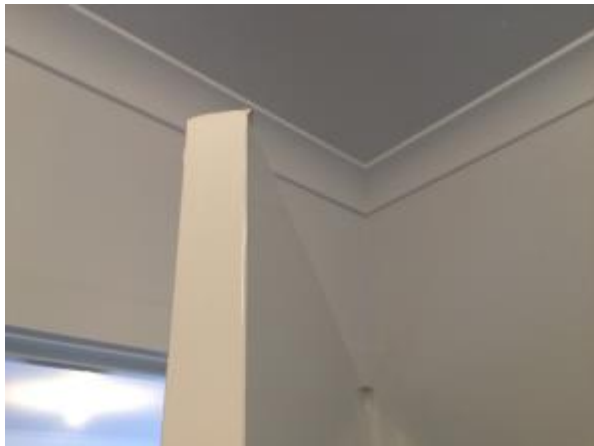
Sand back and repaint damage  
section of bedroom three door

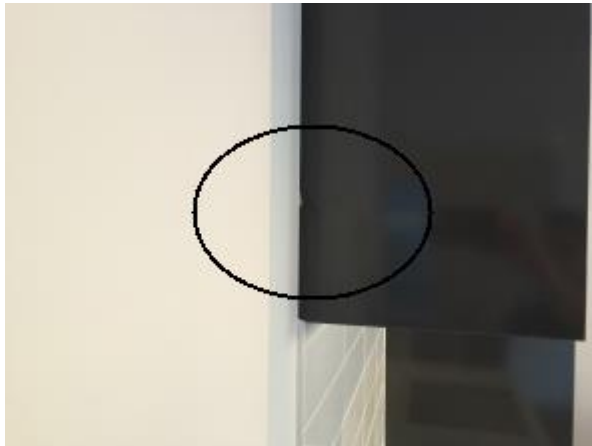
Replace damaged walls to overhead  
cupboard

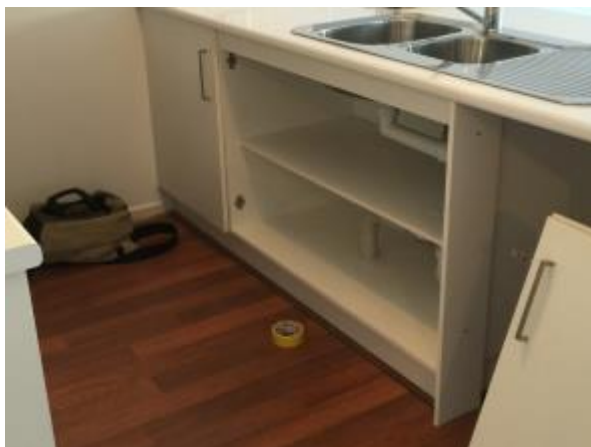
Cupboard doors to be installed

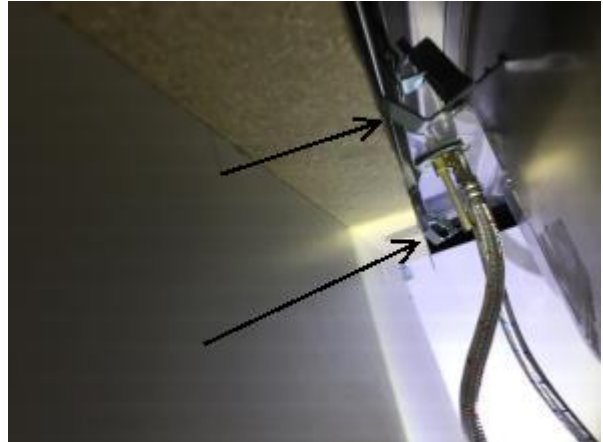
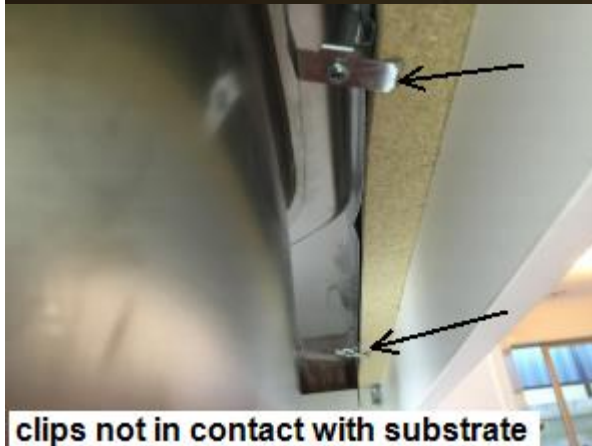
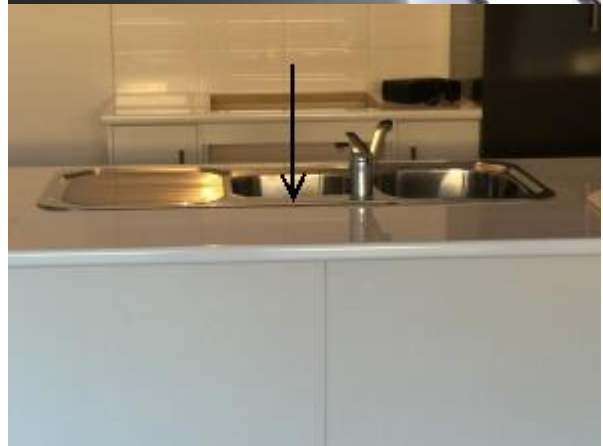
Sink does not sit flush with benchtop to various locations Minor Defect

*Sink clips are not been installed correctly. Additional sink clips may be required. Re-evaluate once clips have been installed.*

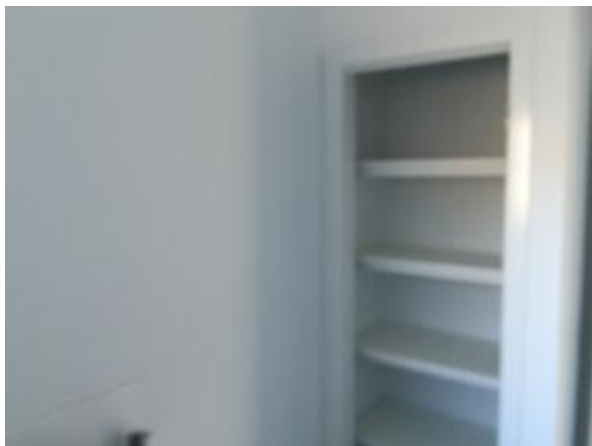
Door to built-in robe to be installed

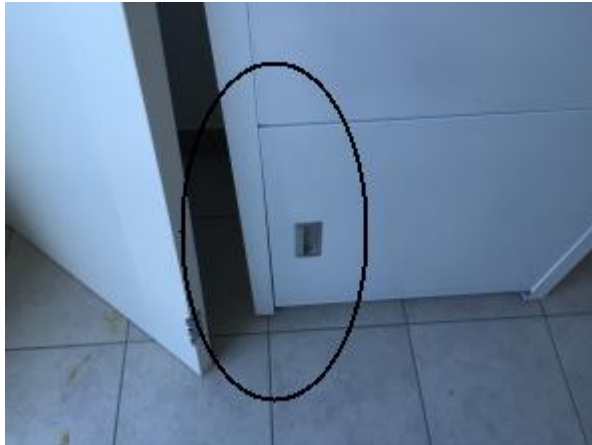
Trough cabinet/cupboard Binding trough cabinet door  
*Adjustment is required.*

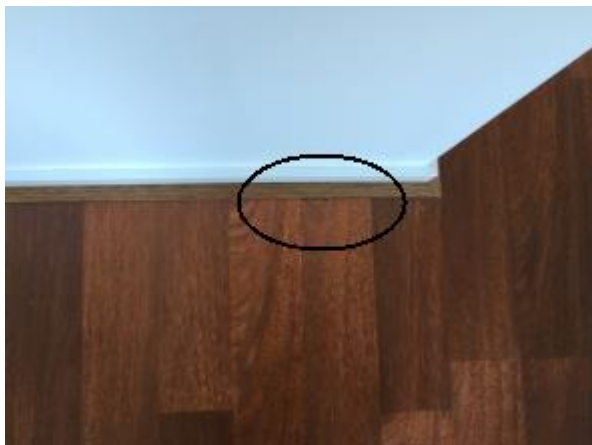
Floors Flooring runs short  
*Floor to be reinstalled.*

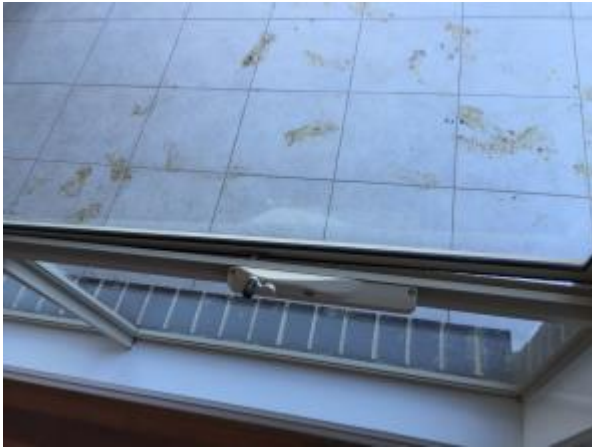
Window operation

*Adjustment required.*

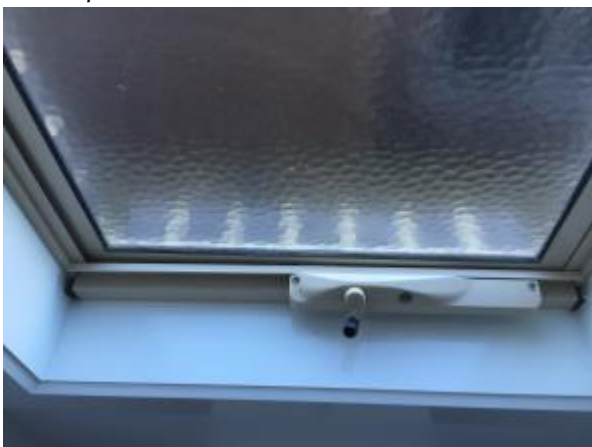
Window jamb installed out of square

*The awning window does not shut evenly around the frame as a result. Re-Installation of the window is required.*

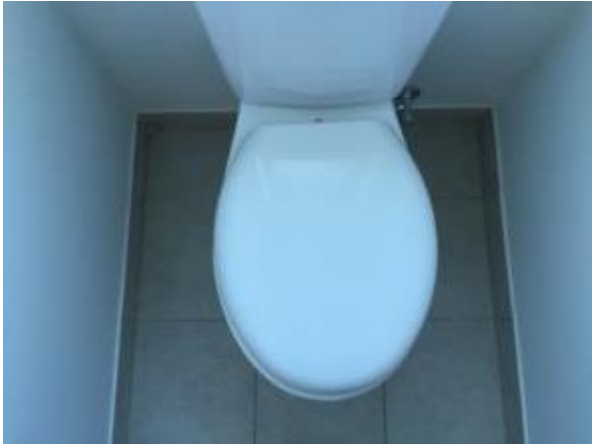
Pan seat to be adjusted to sit flush with the pan

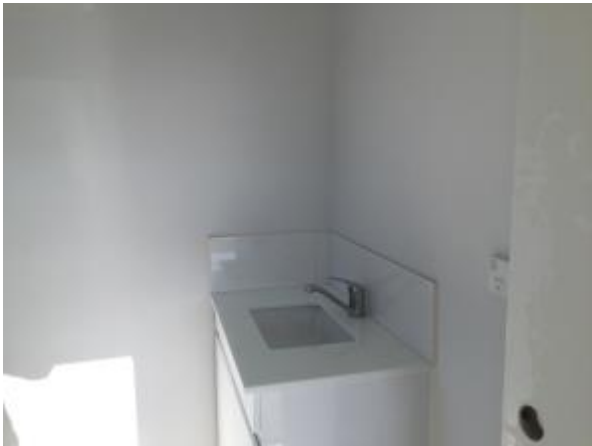
Mirrors to be installed

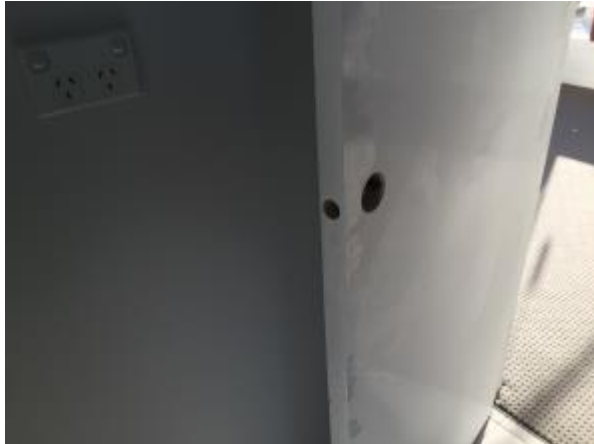
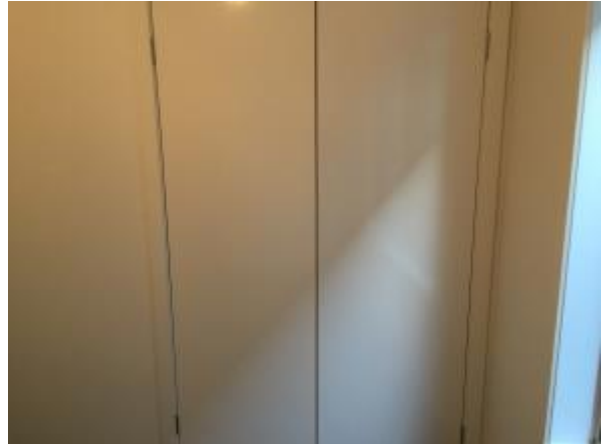
Missing door hardware to various doors

*Occurs to entry doors and built-in robe doors.*

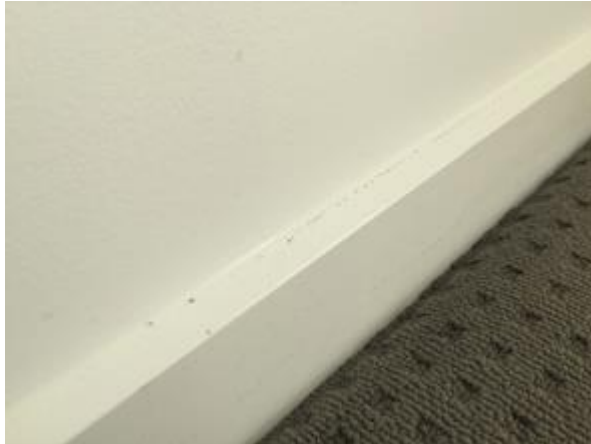
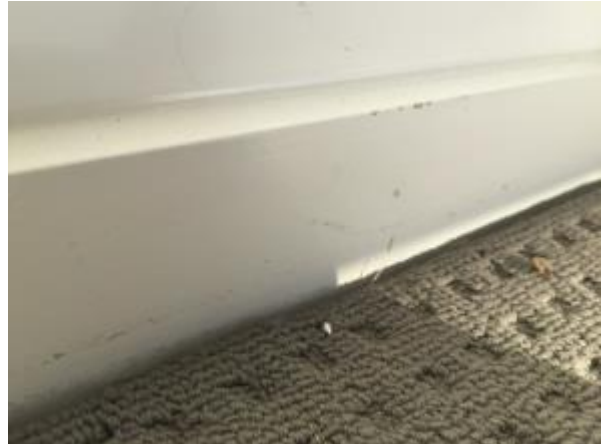
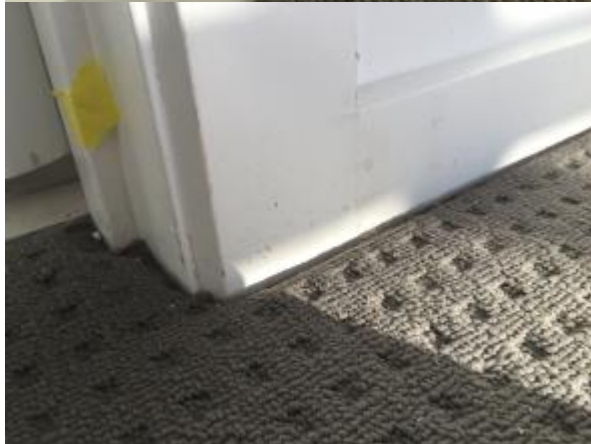
*Paint defects to other areas of the home including walls, door jambs, door architraves and ceilings et cetera have been recorded on site in yellow tape.*

**Interior > Various rooms > Walls > Damaged skirtings caused by carpet laying**

*Re-painting of all skirtings required.*

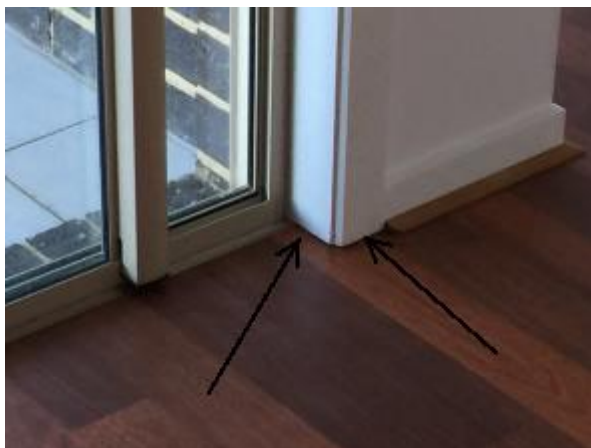
**Interior > Various rooms > Walls > Excessive gaps to underside of door jambs/architraves**

*Apply silicon sealant to prevent water damage through cleaning over time. One example depicted below.*

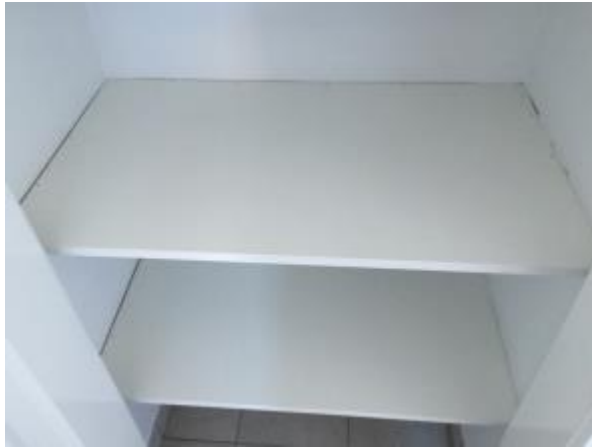
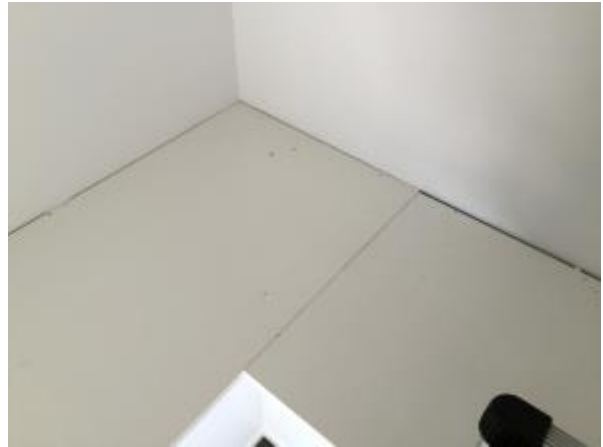
Incomplete installation

*Fill damage to fixings and apply sealant at wall junctions. Some examples depicted below.*

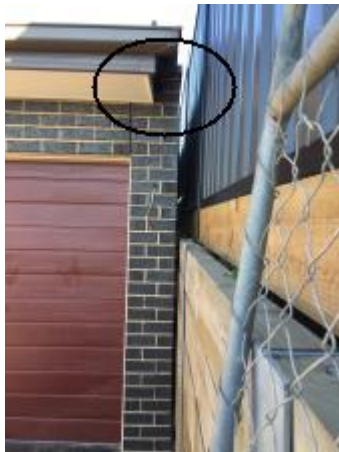
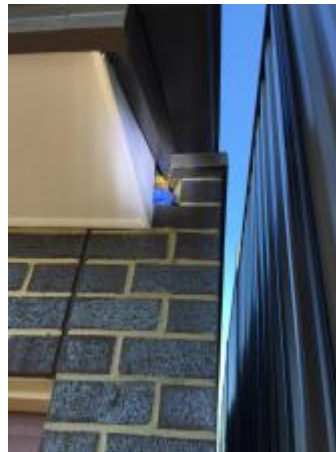
Gap to wall board/fascia junction

*Remove eaves lining return and lay two bricks to cover gaps.*

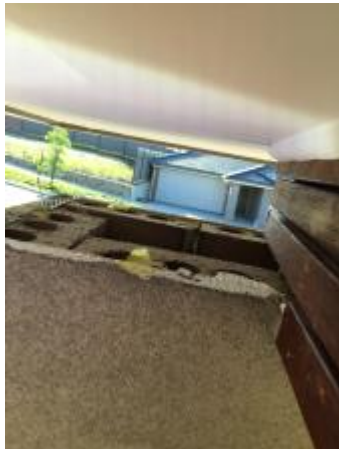
Missing metal capping

*Roof plumber to manufacture and install metal capping.*

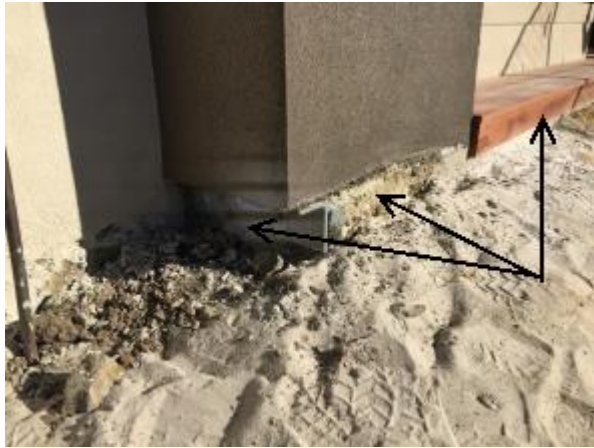
Walling	Brick overhang rectification	Minor Defect	Type: F
---------	------------------------------	--------------	---------

*Builder to cut away excess metal and concrete to enable the baseboard of the timber deck to run through and around the rendered section.*

*Builder to install treated timber to the void under the metal angle flush with the surface of the rendered wall to the east elevation to ensure the plinth has a structure to be fixed to.*

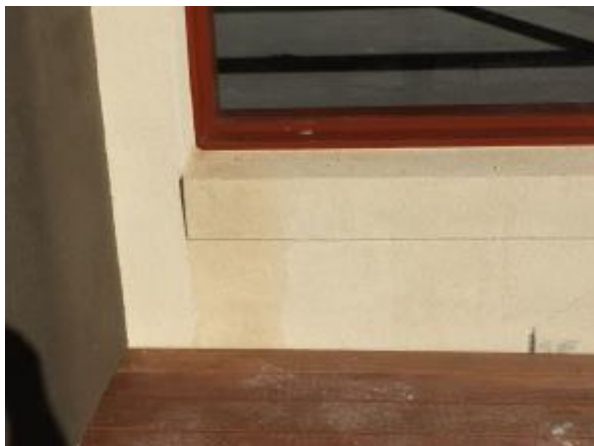
Walling	Staining to rendered wall – re-painting required	Minor Defect	Type: F
---------	--	--------------	---------

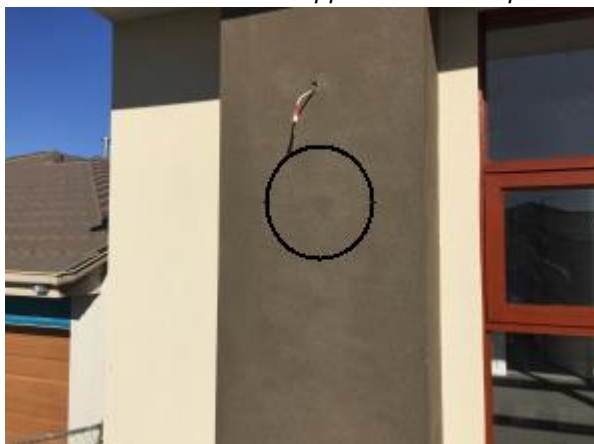
Walling	Sub-standard render application	Minor Defect	Type: F
---------	---------------------------------	--------------	---------

*Additional render to be applied to area depicted below.*

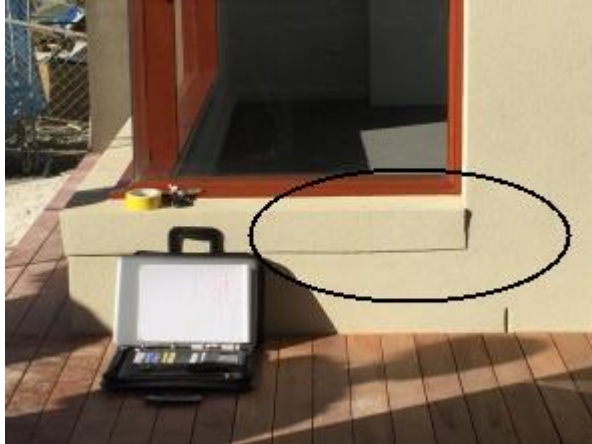
Brick sill out of level

*Replace brick and re-render wall.*

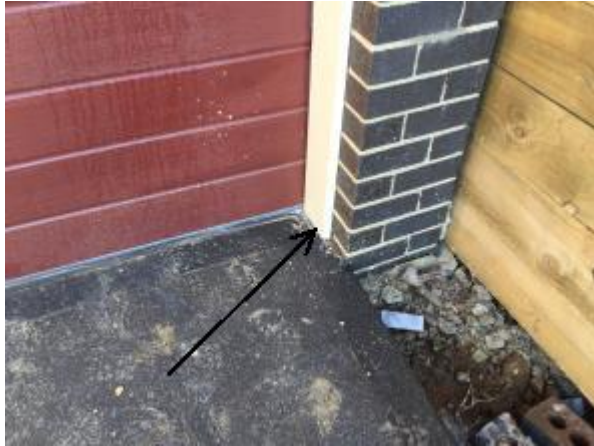
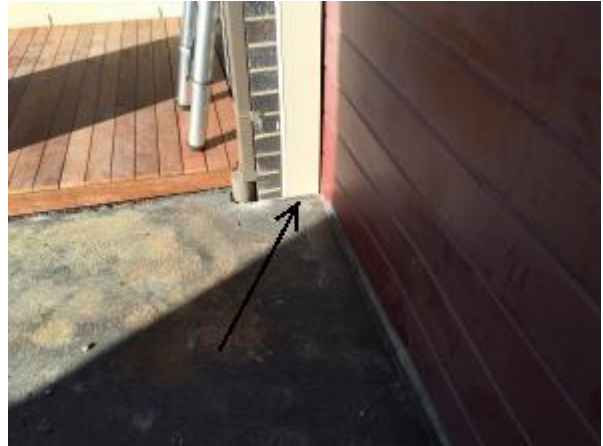
Timber in contact with the ground  
susceptible to decay

*Apply caulking compound to prevent decay over time. Regular maintenance will be required.*

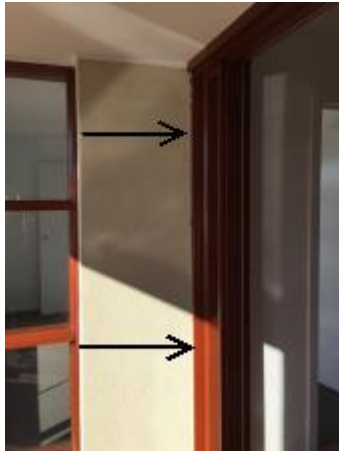
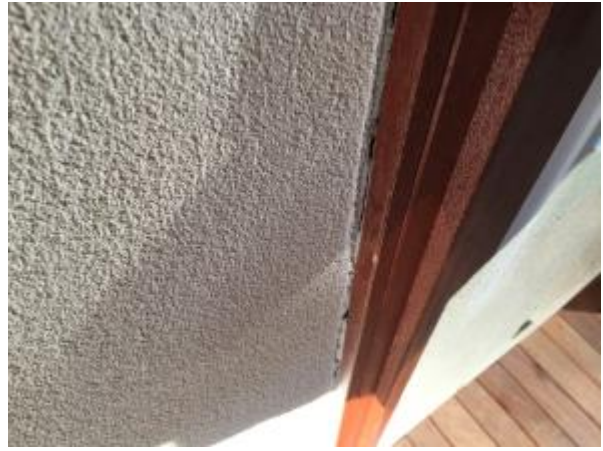
Apply caulking compound to rectify  
poor placement of the door jamb

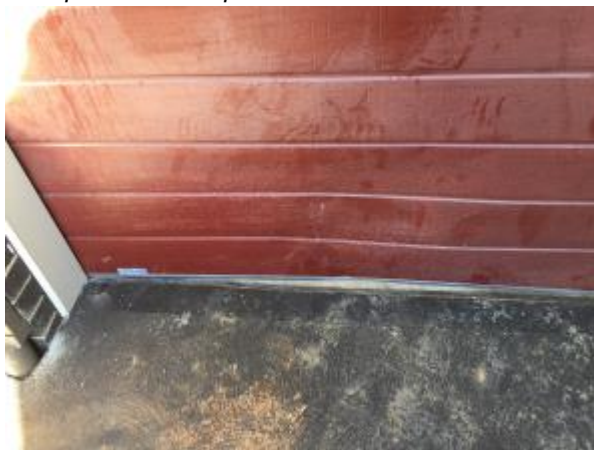
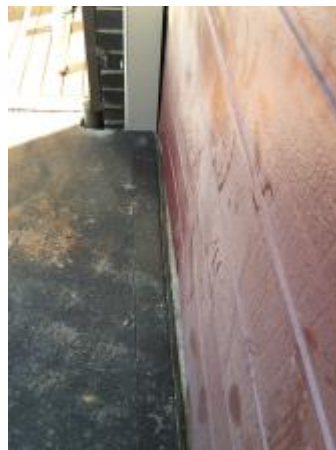
Damaged garage door

*Replacement required.*

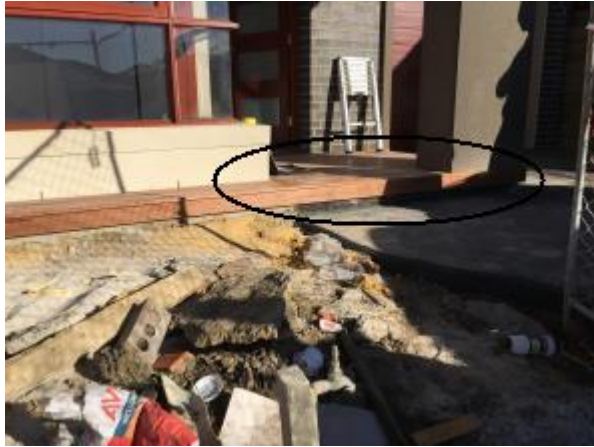
Timber deck surface out of level

*Remove deck timbers to enable straightening of the deck structure. An invasive inspection of the deck structure may reveal further defects.*

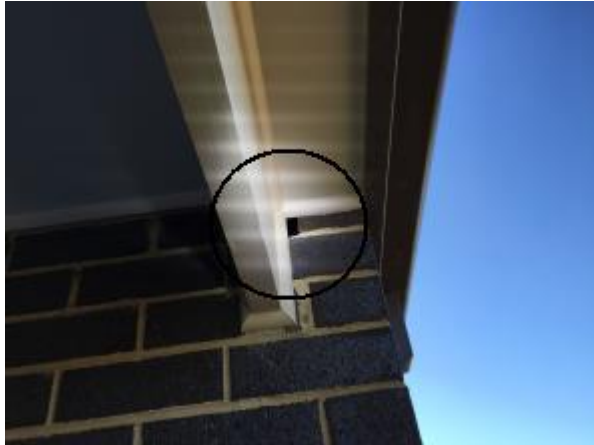
Gap to wall board/fascia junction

*Remove eaves lining return and lay one brick to cover gap.*

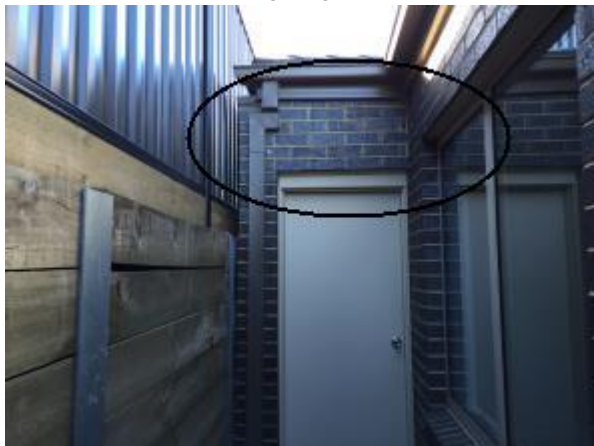
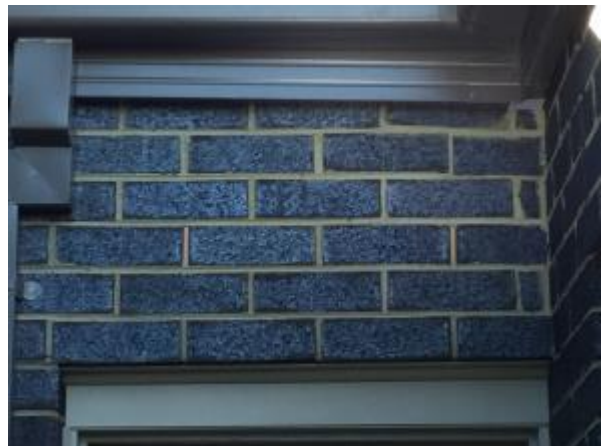
Sub-standard brickwork – does not meet AS 3700

*Relate bricks above garage door.*

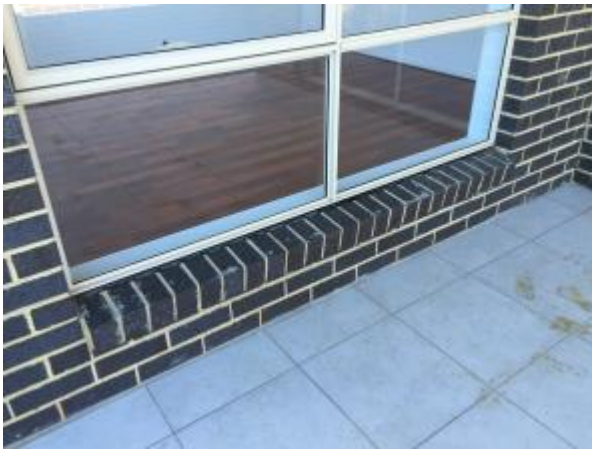
Brick cleaning required

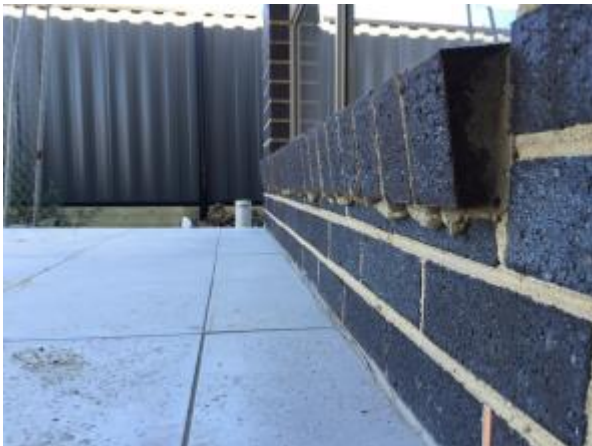
Removal of excess mortar under brick sill is required

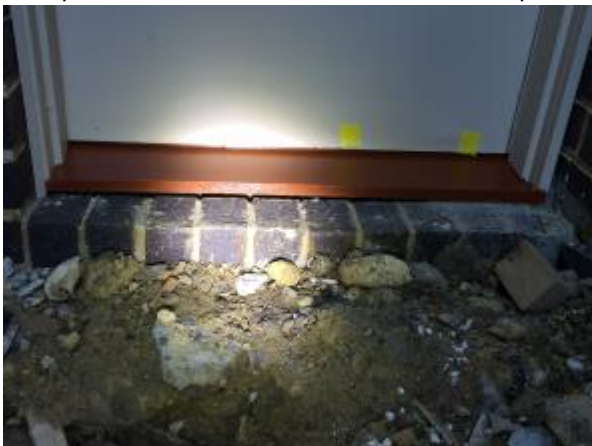
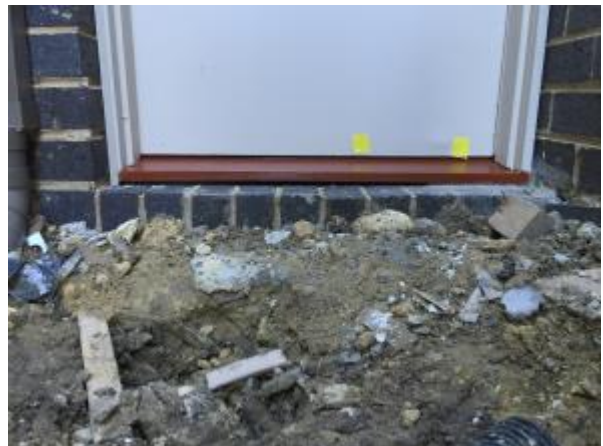
Bowed door sill to be replaced

*Replace brick sill to enable timber sill to be placed level across the brick sill.*

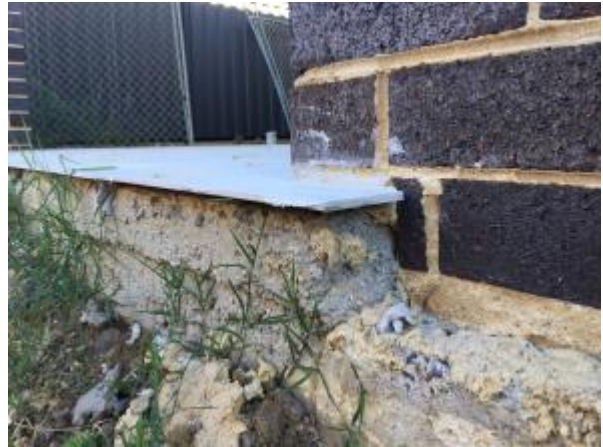
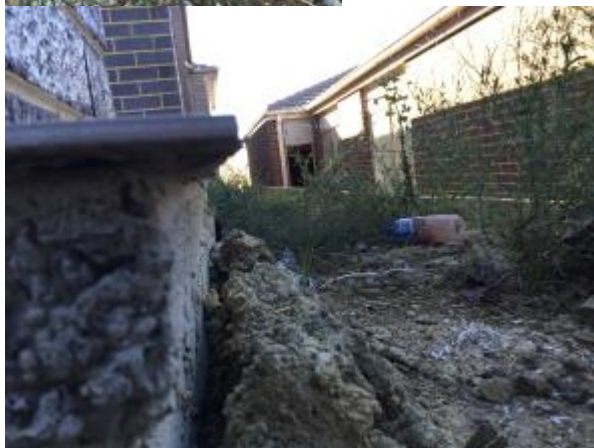
No tile substrate under tiles to edges of alfresco

*Tile layer to cut tiles and install edge trim.*

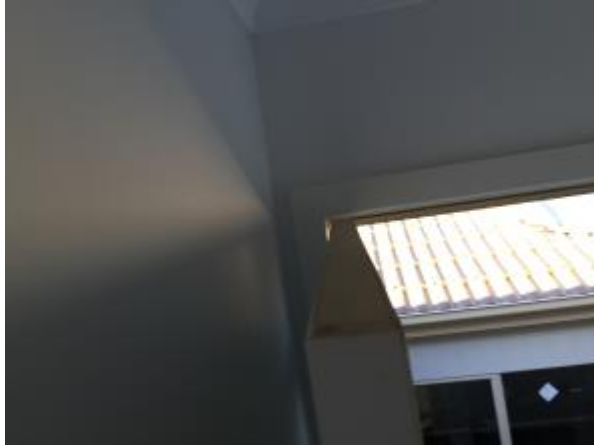
Painted missing to top and bottom  
door edge

*Remove door to enable painting to top and bottom door edges in order to prevent early on set of decay..*

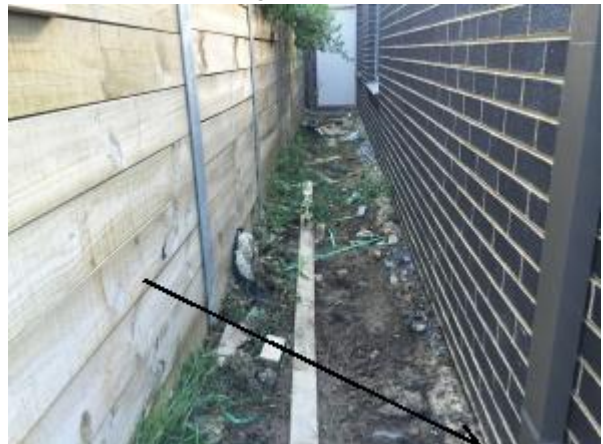
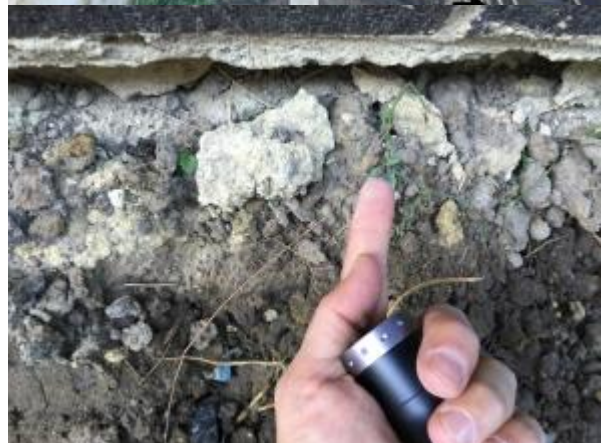
Brick overhang exceeding tolerance

*Rectify brick overhang to a similar fashion to the east elevation overhang.*

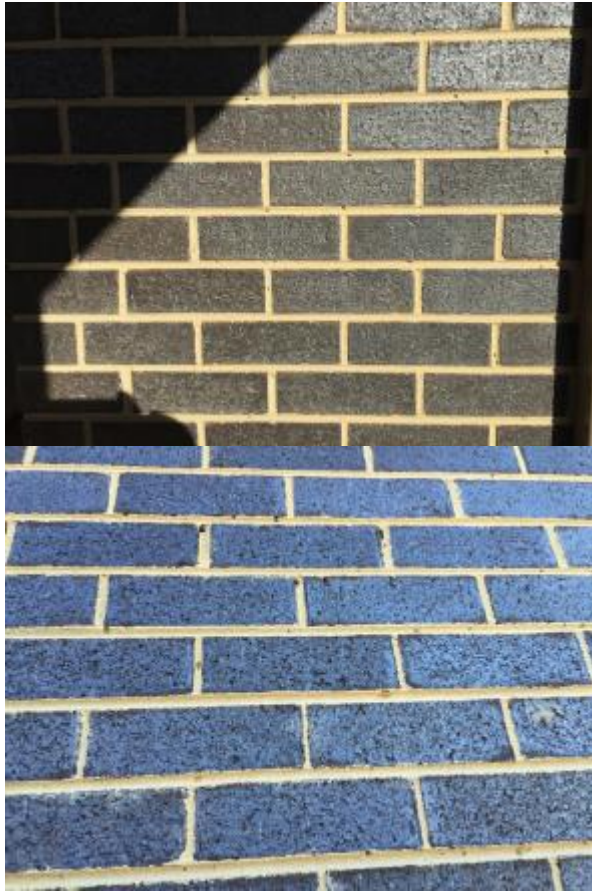
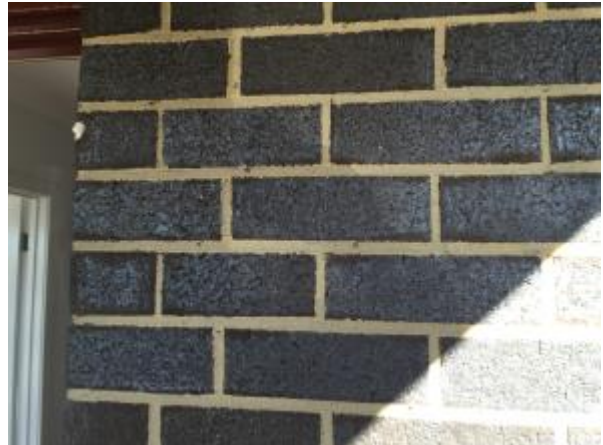
Mortar blowouts

*Extent of mortar blowouts to the North and East elevations do not meet relevant Australian standards. It is highly recommended the company specialising in mortar rectification is sought to undertake rectification in this case. Some examples depicted below.*

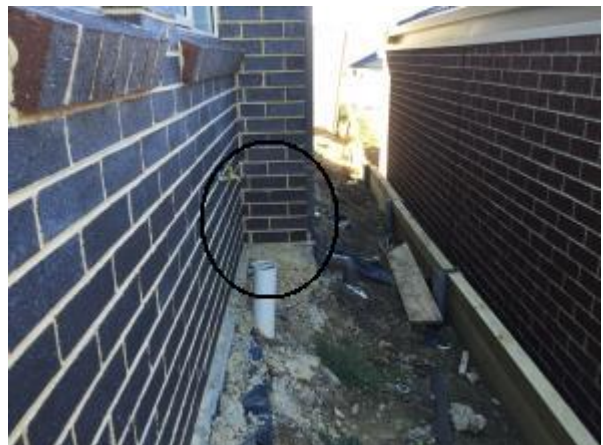
Sub-standard brickwork – does not meet AS 3700

*Bricklayer to rectify.*

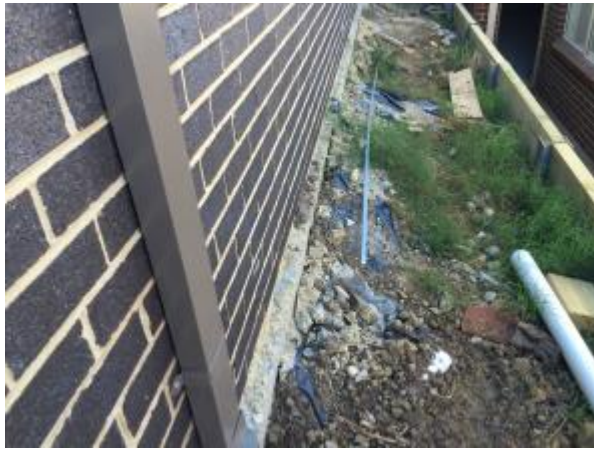
Slab and wall location      Slab or wall installed to incorrect location      Further Investigation Type: F

*A land surveyor is required to carry out further investigation. It is highly likely that the wall cavity does not meet relevant Australian standards to the east elevation - an invasive inspection is required to make further determinations.*

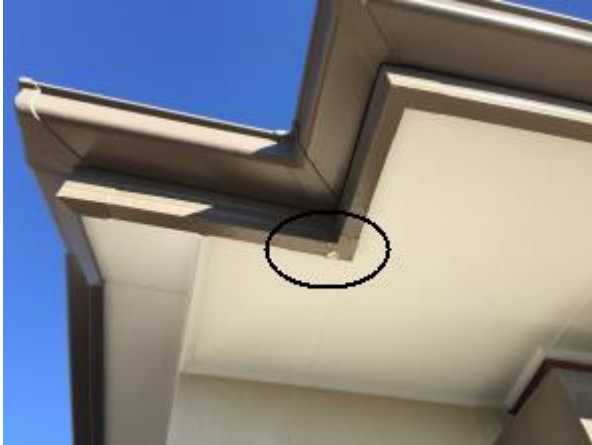
Remove paint to fascia at front elevation

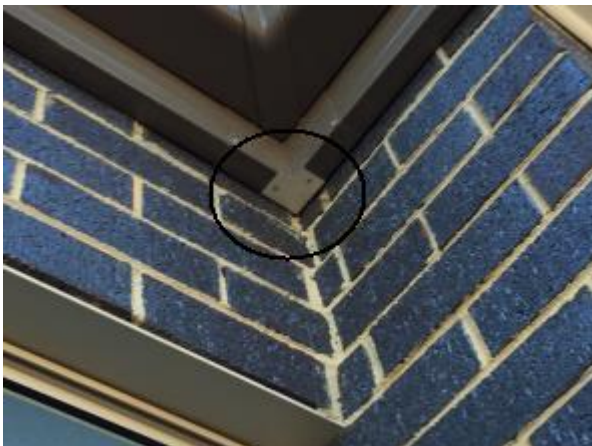
Replace fascia joiner to match correct colour

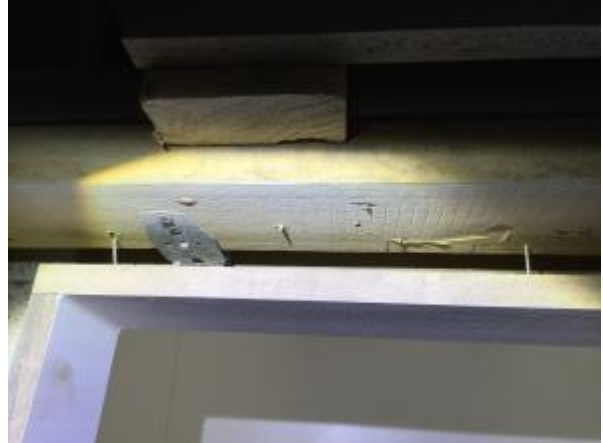
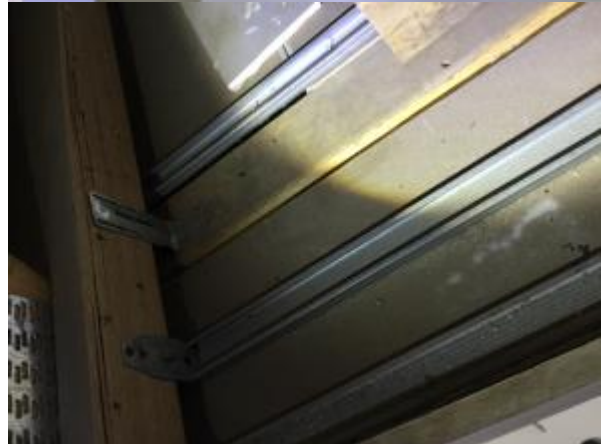
Sub-standard framing around  
manhole void

*Qualified carpenter to rectify.*

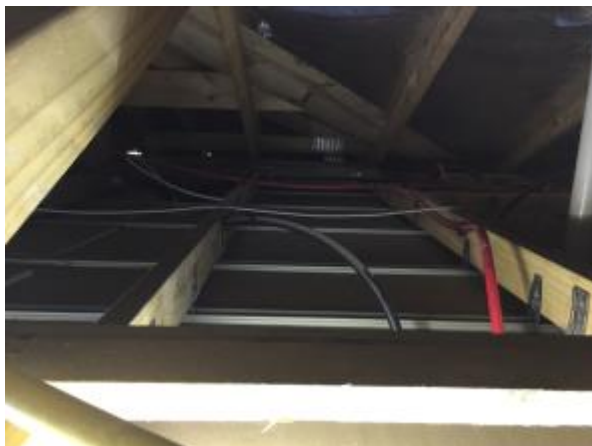
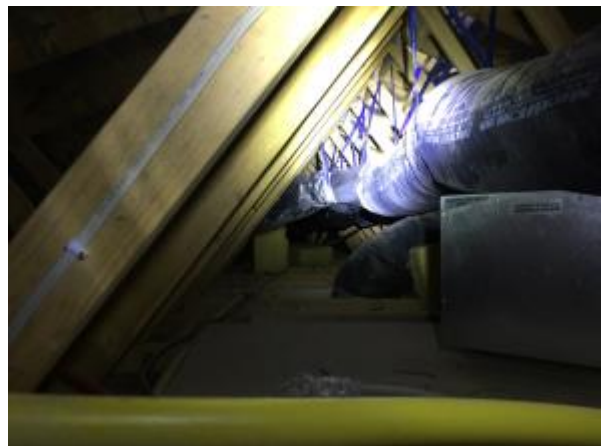
No roof insulation

*Roof installation to be installed.*

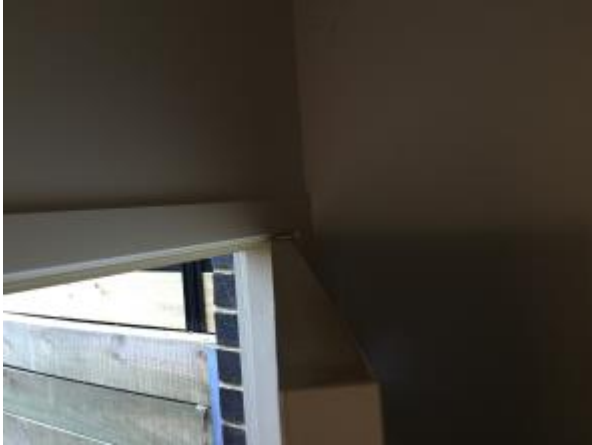
Garage                      Missing paints to top and bottom door   Minor Defect                      Type: F  
edge  
*Remove door to enable painting to top and bottom door edges in order to prevent early on set of decay..*

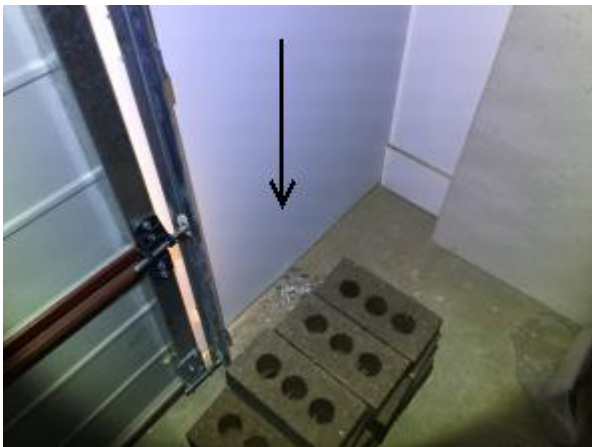
Garage                      Missing skirting                      Minor Defect                      Type: F
