# Frame Inspection Report

Prepared within the limitations and conditions specified in  
Australian Standard AS 4349.1 - 2007 Pre-purchase Inspections - Residential buildings

| Property address | Lot 5 Dellamore Boulevard<br>GREENVALE VIC 3059 | |

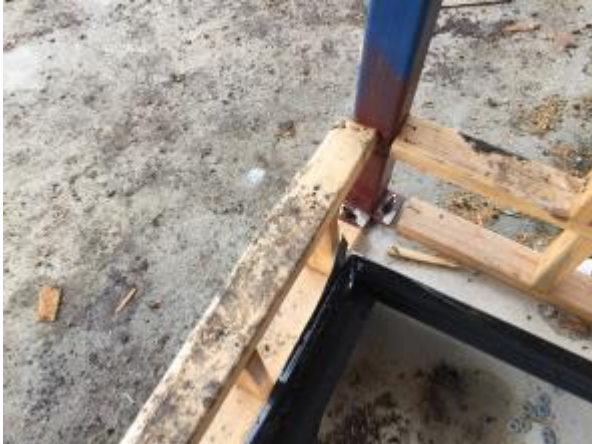
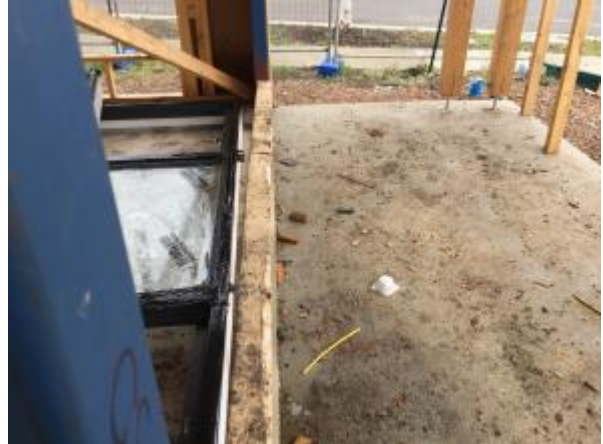
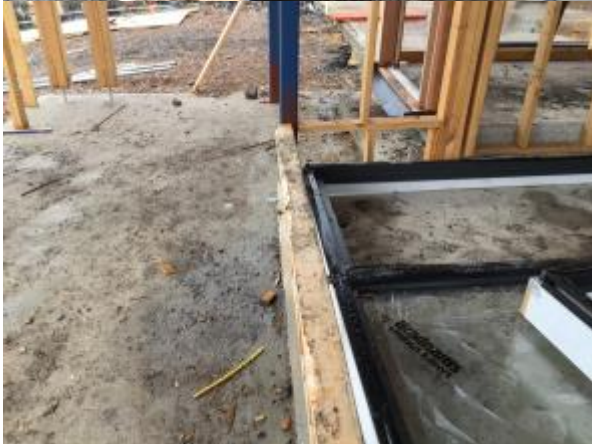
## Exterior - Front Elevation

Walling

Hob wall to be mechanically fixed

Minor Defect

Type: F

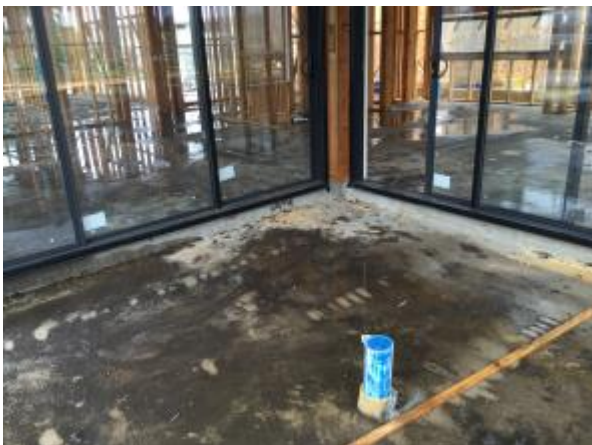
## Exterior - Rear Elevation

Windows

Additional supports to the sill is required

Minor Defect

Type: F

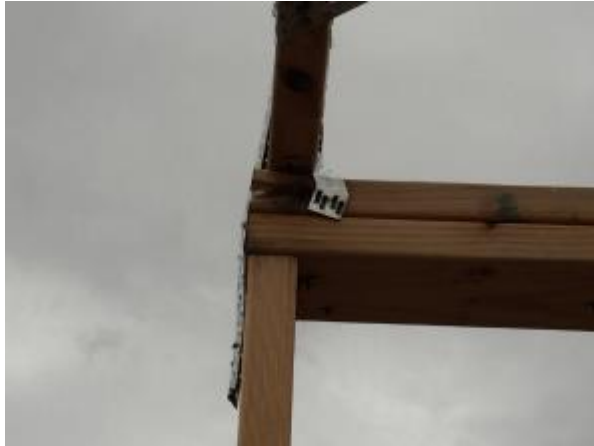
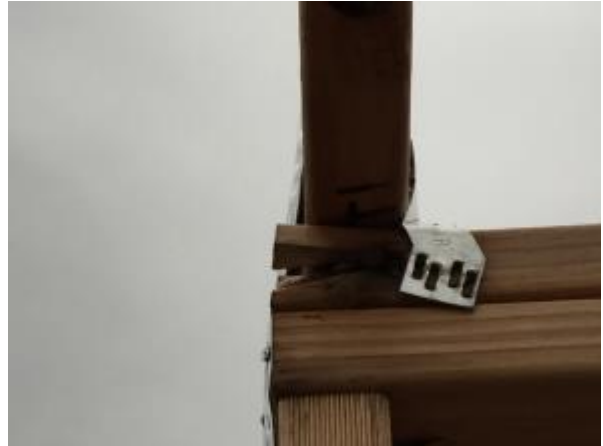
## Exterior - West Elevation

Walling                      Damaged top plate to garage wall                      Minor Defect                      Type: A  
*Cut out and replace damaged section.*

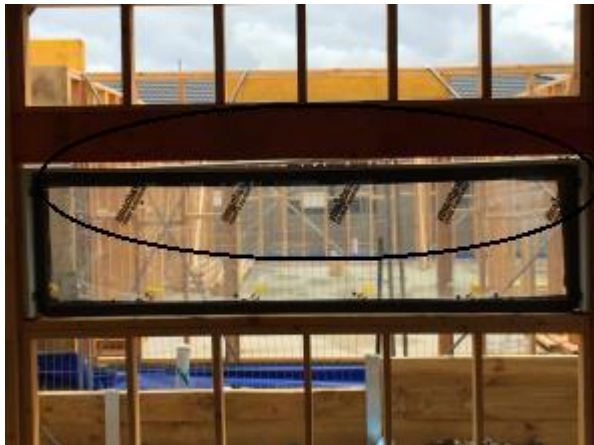
Windows                      Horizontal bow to window                      Minor Defect                      Type: F  
*Inadequate gauge in material over that particular span. Replacement recommended.*

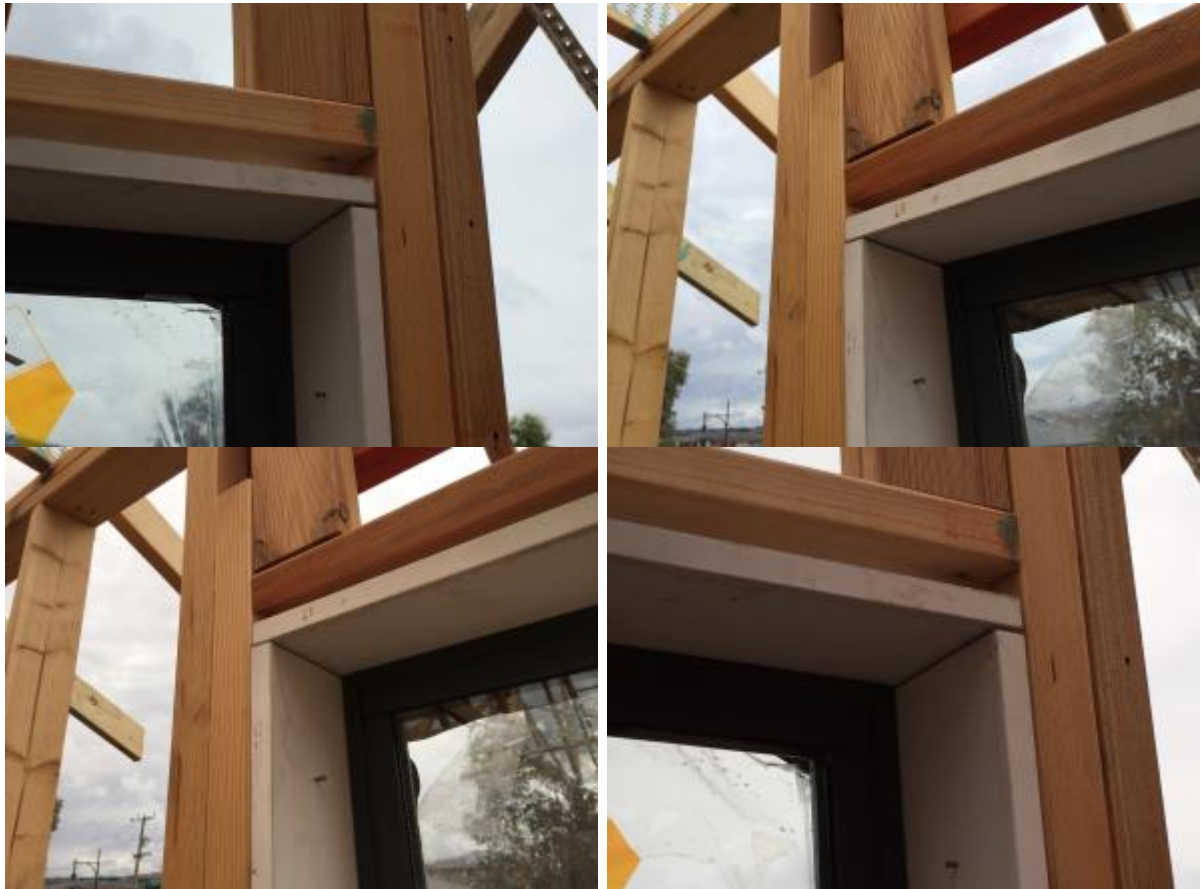
### Exterior - Default Elevation

Windows                      Separations to jambs                      Minor Defect                      Type: F  
*Jambs to be rectified. Some examples depicted tonight.*

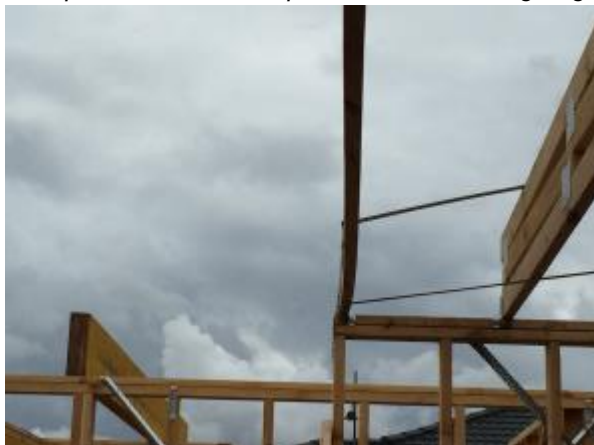
### Roof - Roof Void

Roof framing                      Bowed roof truss                      Minor Defect                      Type: F  
*Replacement truss required. Occurs over garage.*

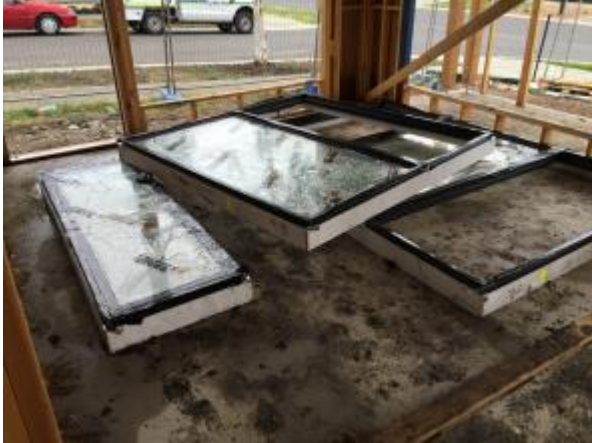
## Site - Site Management

Window storage

Windows stored in direct contact with the slab Minor Defect

Type: F

*Windows to be stored off ground level to prevent water damage.*
