Date of inspection: Thursday, 17 March 2016 08:30 AM

# Pre-handover Inspection Report

Property address	4 Livingstone Street MERNDA VIC 3754	
Report prepared for	Carlo Sample 6 Mernda Terrace EPPING VIC 3076	
Client's contact details	Mobile	9083 159 858 <a href="mailto:sample@hotmail.com">sample@hotmail.com</a>
Real estate agent's details	Name	n/a
	Company	n/a
Type of inspection report	Standard Inspection, Defect Only	
Persons present	Client, Builder's representative	
Weather conditions	Fine	
Inspector	Joe Noto, Bachelor Applied Science (Construction Mgt) (Economics) Registered Building Practitioner - Domestic Builder - Unlimited DB-U 28857

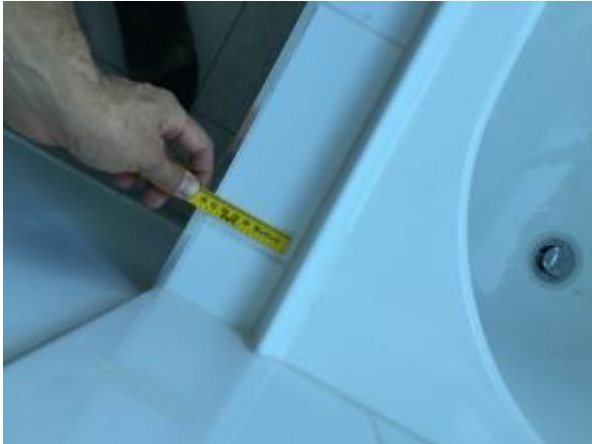
Minor Defect

Type: F

*Rectification will required reconstruction.*

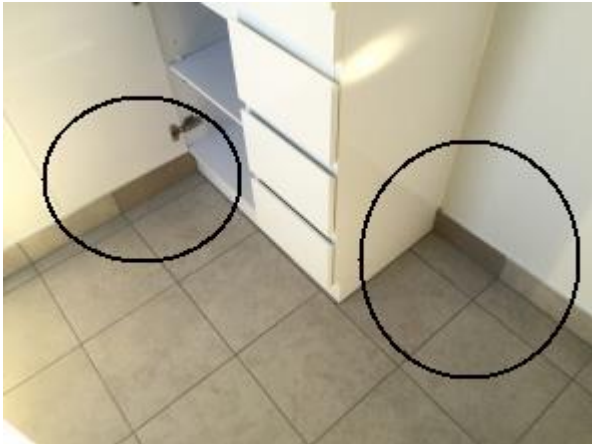
Builder to replace skirting tiles either side of vanity unit

Minor Defect

Type: F

*Ensure colour matching.*

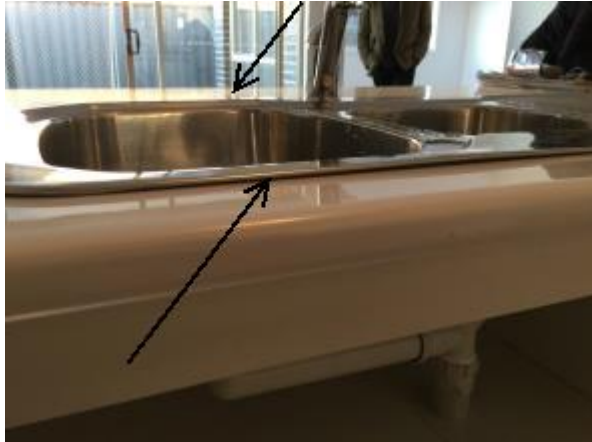
Sink does not sit flush with benchtop to various locations Minor Defect

Type: F

*Sink clips are not been installed correctly. Additional sink clips may be required. Re-evaluate once clips have been installed.*

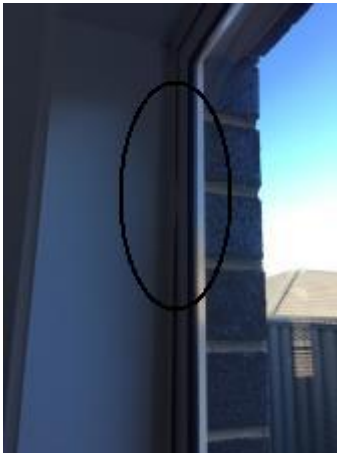
Damaged window frame

Minor Defect

Type: A

*Rectification can be carried out.*

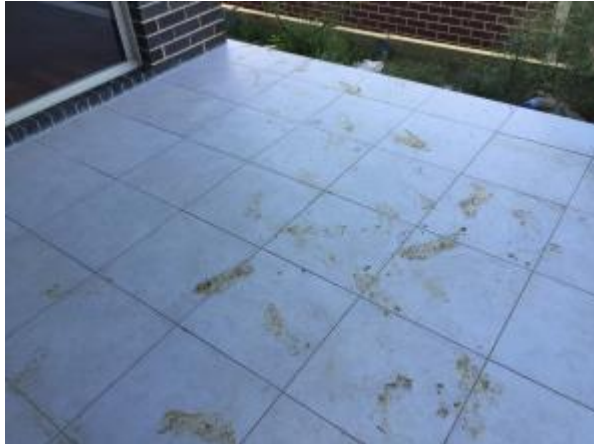
Further Investigation Type: F

*Tile manufacturer to be queried in relation to tile use.*

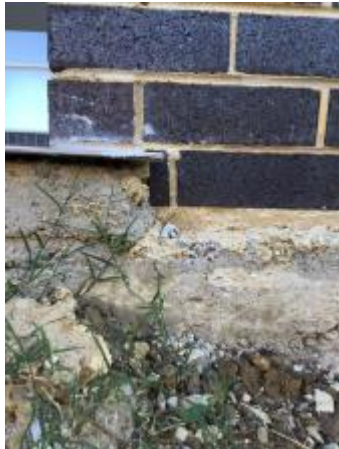
No tile substrate under tiles to edges of alfresco

Type: F

*Tile layer to cut tiles and install edge trim.*

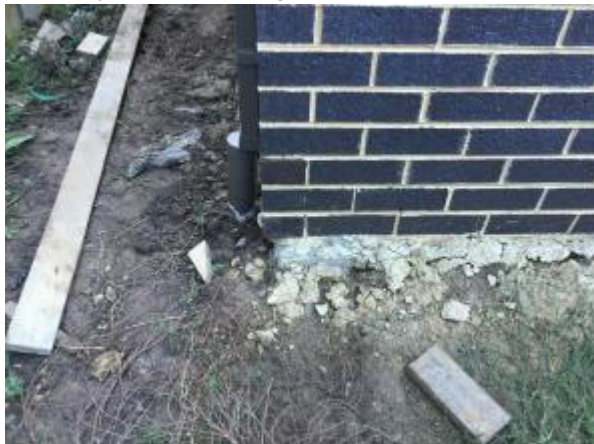
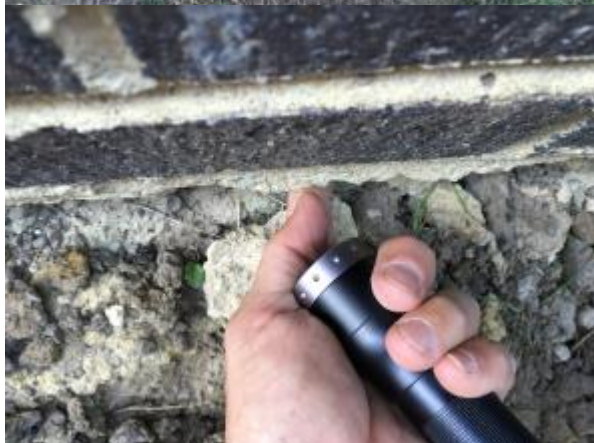
Type: F

*Rectify brick overhang to a similar fashion to the east elevation overhang.*

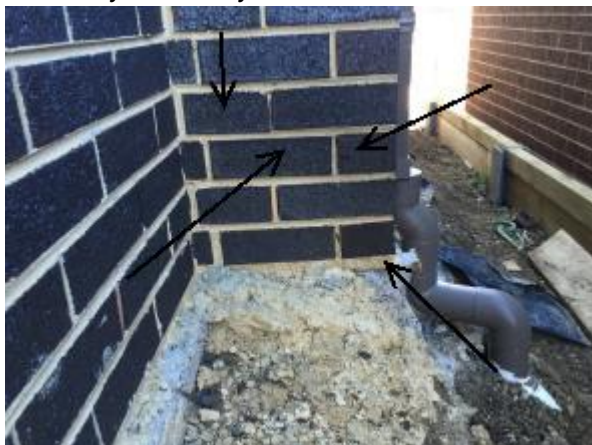
Type: F

*Bricklayer to rectify.*

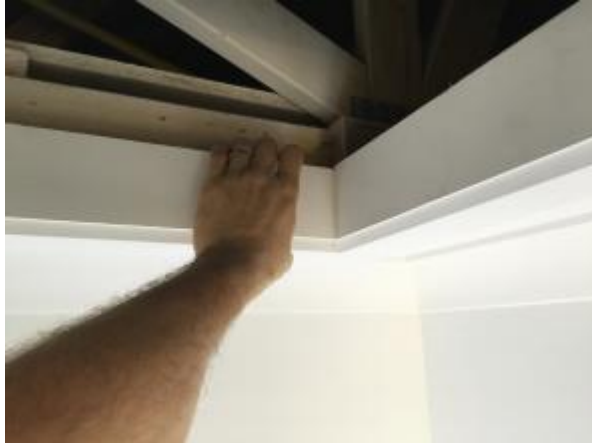
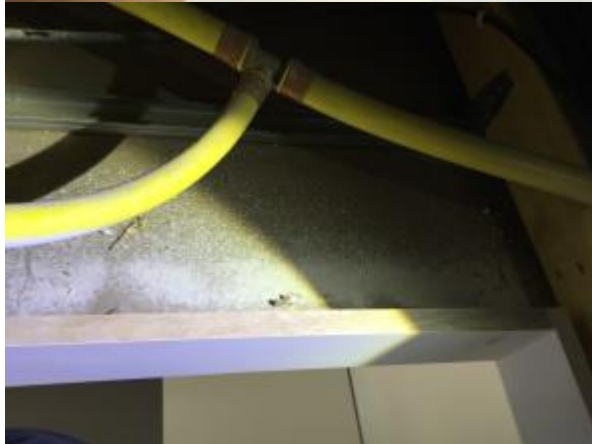
Type: F

*Qualified carpenter to rectify.*

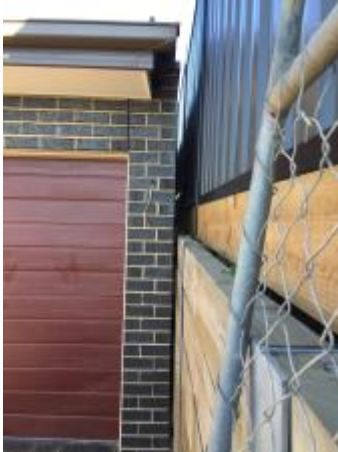
Landscaping retaining walls more than 700mm high  
Monitor for lateral movement of the retaining wall to the West elevation

Further Investigation Type: F
